Bicycle and Pedestrian Improvements in Six Urban Centers

Central Transportation Planning Staff of the **Boston Region Metropolitan Planning Organization**. The MPO is composed of state and regional agencies and authorities, and local governments.

February 2010

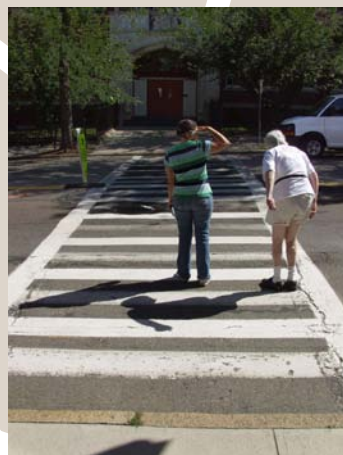
Lack of curb ramps and curb extensions

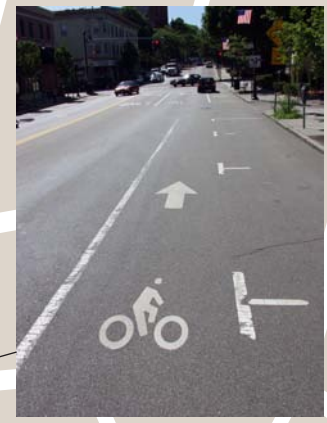
Bike lane ends at intersection

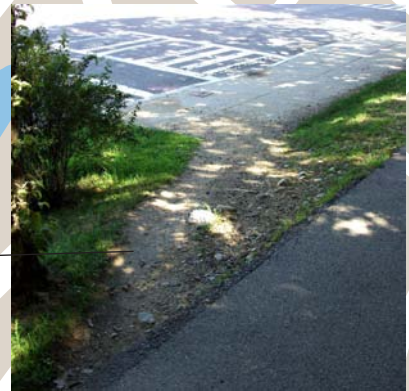
Strong desire lane connecting sidewalk and shared-use path

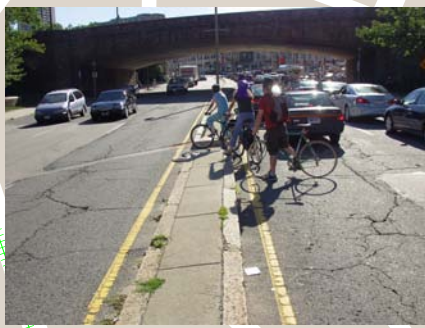
Lack of safe crossing

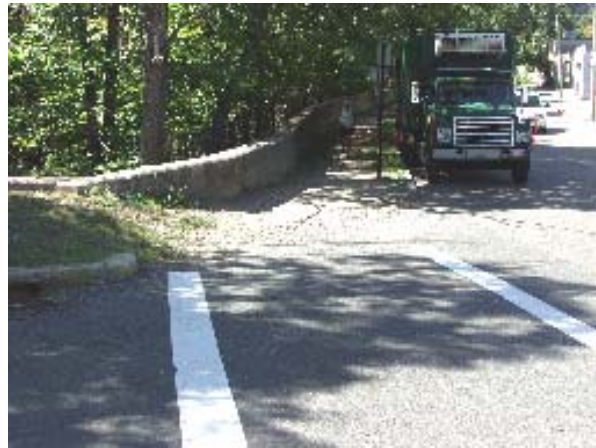
The dirt path along River Road, looking southward.

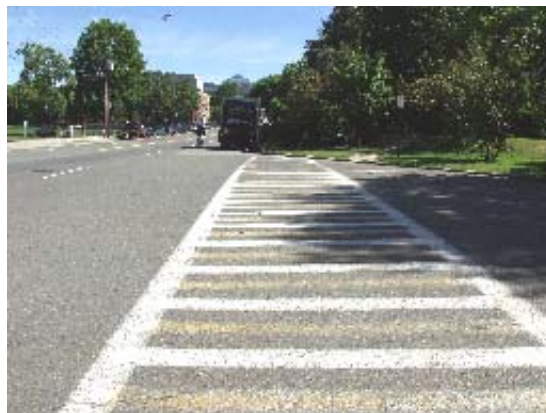
Long crosswalk on River Road at Brookline Avenue.

22. Square off the intersection of River Road and Brookline Avenue, or add an island. This will cause traffic to move more slowly, and will shorten the extremely long crossing for pedestrians.

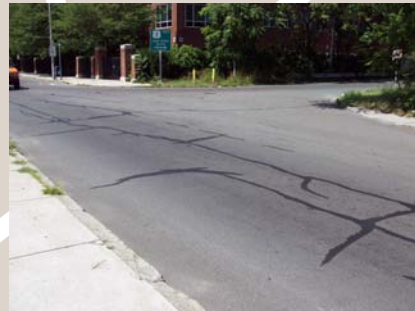
Lack of crosswalks

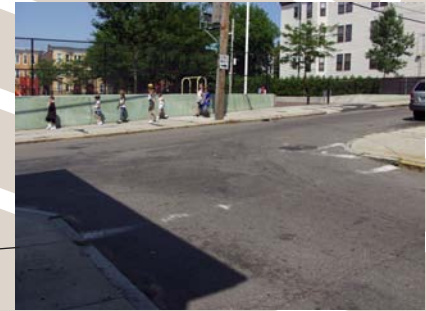
No crosswalk to park

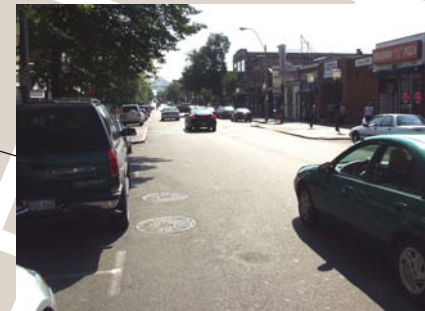
No striping and potential for bike lane

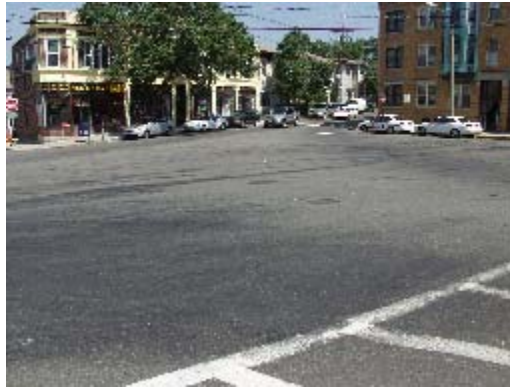
The intersection of Chestnut Street, Washington Avenue, Sixth Street, and City Hall Avenue (Fay Square) is a daunting expanse of asphalt, unaccommodating for bicyclists and pedestrians, and, with no striping, essentially a “free-for-all” for motorists.

Fay Square.

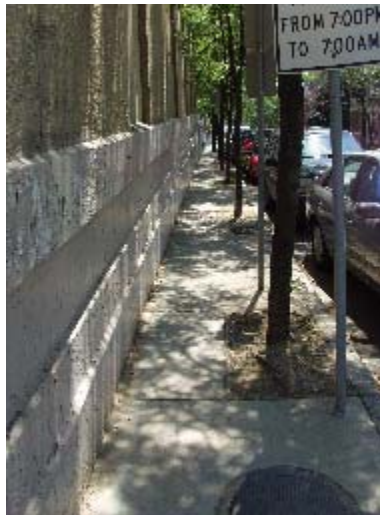
The sidewalks on both sides of Beacon Street between Chestnut and Cherry Streets are too narrow. A fence along half of Arlington Street Extension prevents pedestrians from walking on the south side. There are no sidewalks adjacent to and under the bridge on the west side of the intersection of Boatswains Way and Beacon Street. Mobility in this area is complicated by the off-ramp from Route 1.

Very narrow sidewalk along Beacon Street (but keep the trees!).

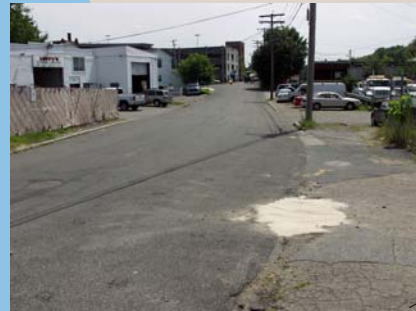
Lack of sidewalks

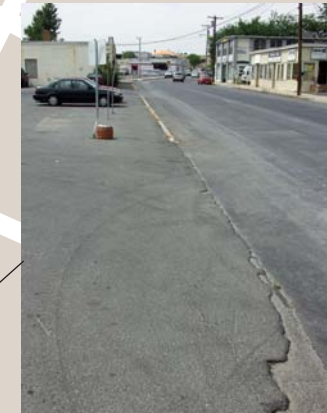
Lack of sidewalk separation

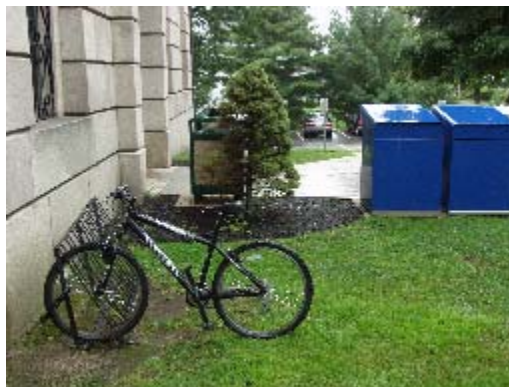
There is bicycle parking at the commuter rail station and the library. However, the parking at the library is on grass with no access walkway and does not conform to current design guidance.

Bicycle parking at the library

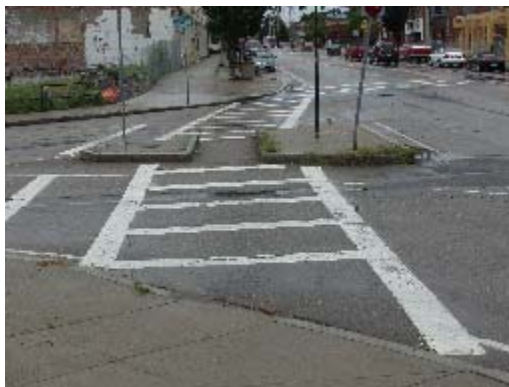
Misaligned crosswalk across Summer Street

- Realign all crosswalks to go straight across the streets

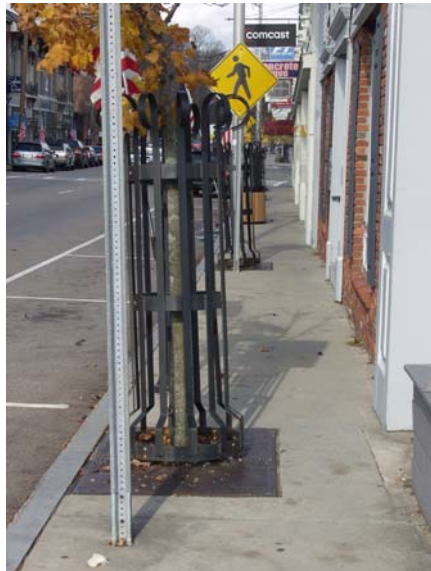
Narrow sidewalk on Main Street

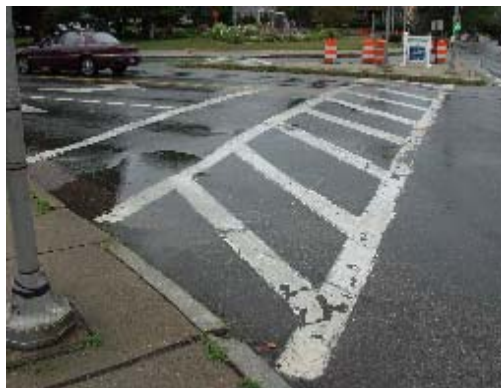
*Intersection of Main and Pleasant Streets:
no curb ramp, pole obstructing crosswalk.*

- Expand the island to provide a safer refuge for pedestrians and to slow down turning traffic
- Plant vegetation or install brick on the island for aesthetics
- Stripe approaching lanes to better separate traffic
- Make sure curb ramps are in the middle of the crosswalks
- Ensure that no signal posts are interfering with any crosswalks

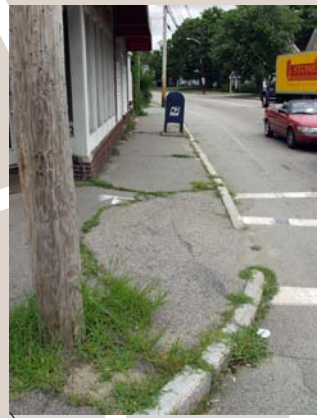
Sidewalk and curb in disrepair

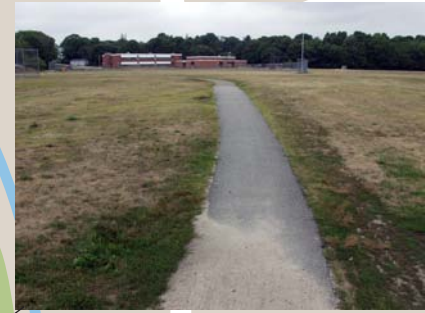
Narrow path to school

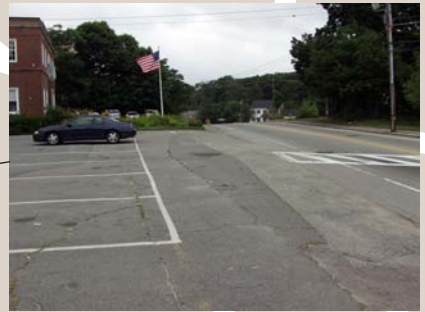
No separation between the street, sidewalk, and parking lot

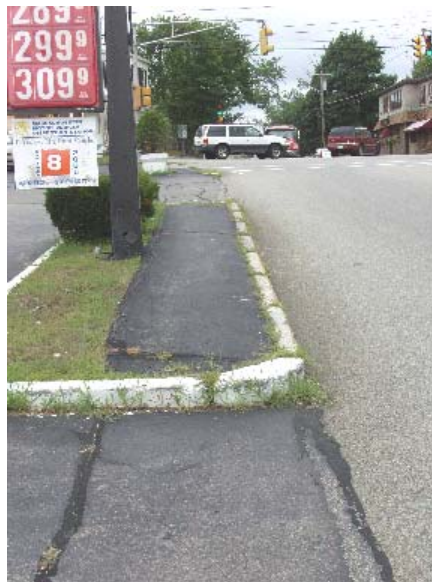
*Lack of curb ramps along Broad Street;
the Middle Street intersection is in the background*

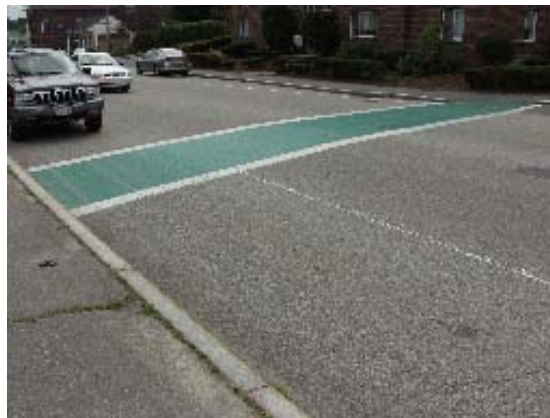
Curb ramp and extension are needed on Broad Street

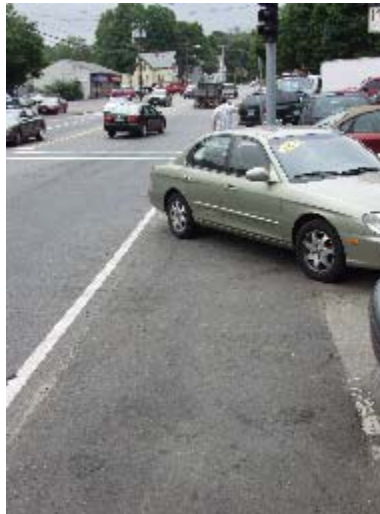
The sidewalk is not clearly separated from the roadway at the intersection of Pleasant and Water Streets

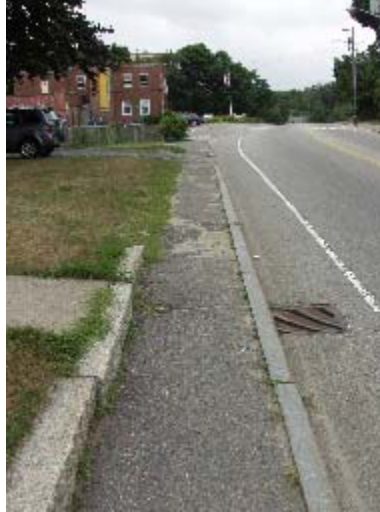
A narrow sidewalk leading to the Teen Center
