6 Framingham

**FIGURE 6-2
Downtown Framingham
Existing Conditions**

**FIGURE 6-4
Downtown Framingham
Recommendations**

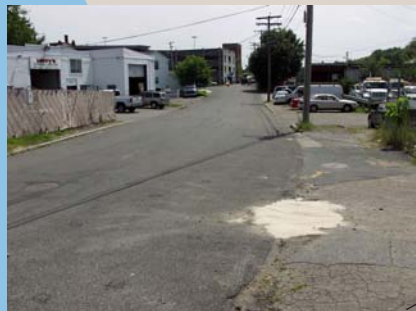
Lack of sidewalks

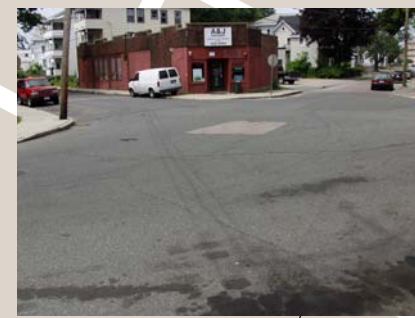
Lack of crosswalks

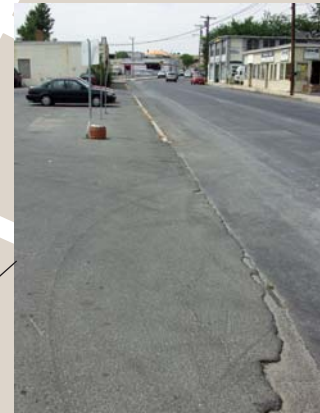
Lack of sidewalk separation

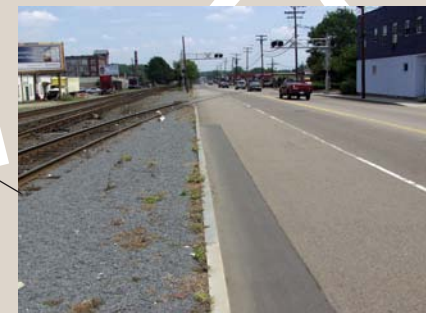
Potential for bike lanes

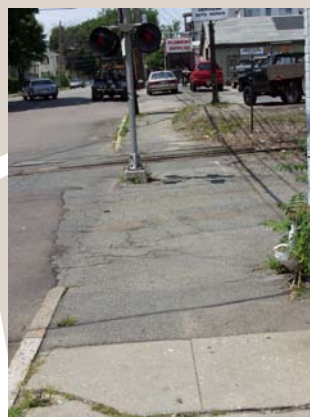
Disrepair near railroad tracks

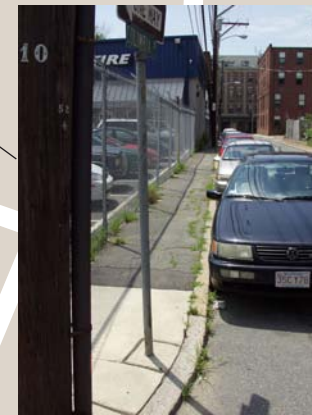
Narrow, obstructed sidewalk
