Route 9 Priority Corridor Study

Framingham and Natick, Massachusetts

July 2022

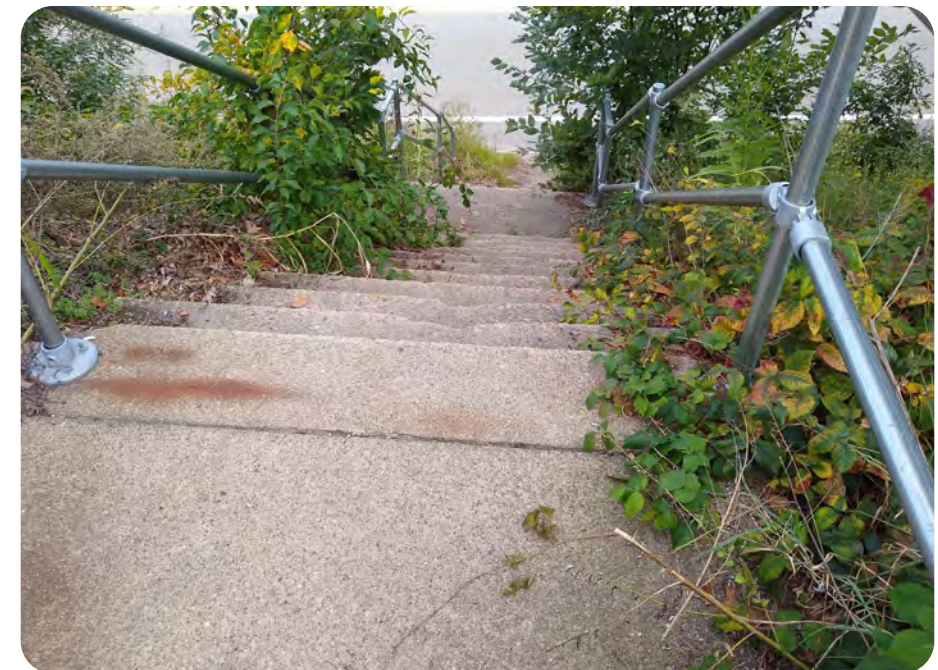
Gap in sidewalk network on Concord Street at Route 9

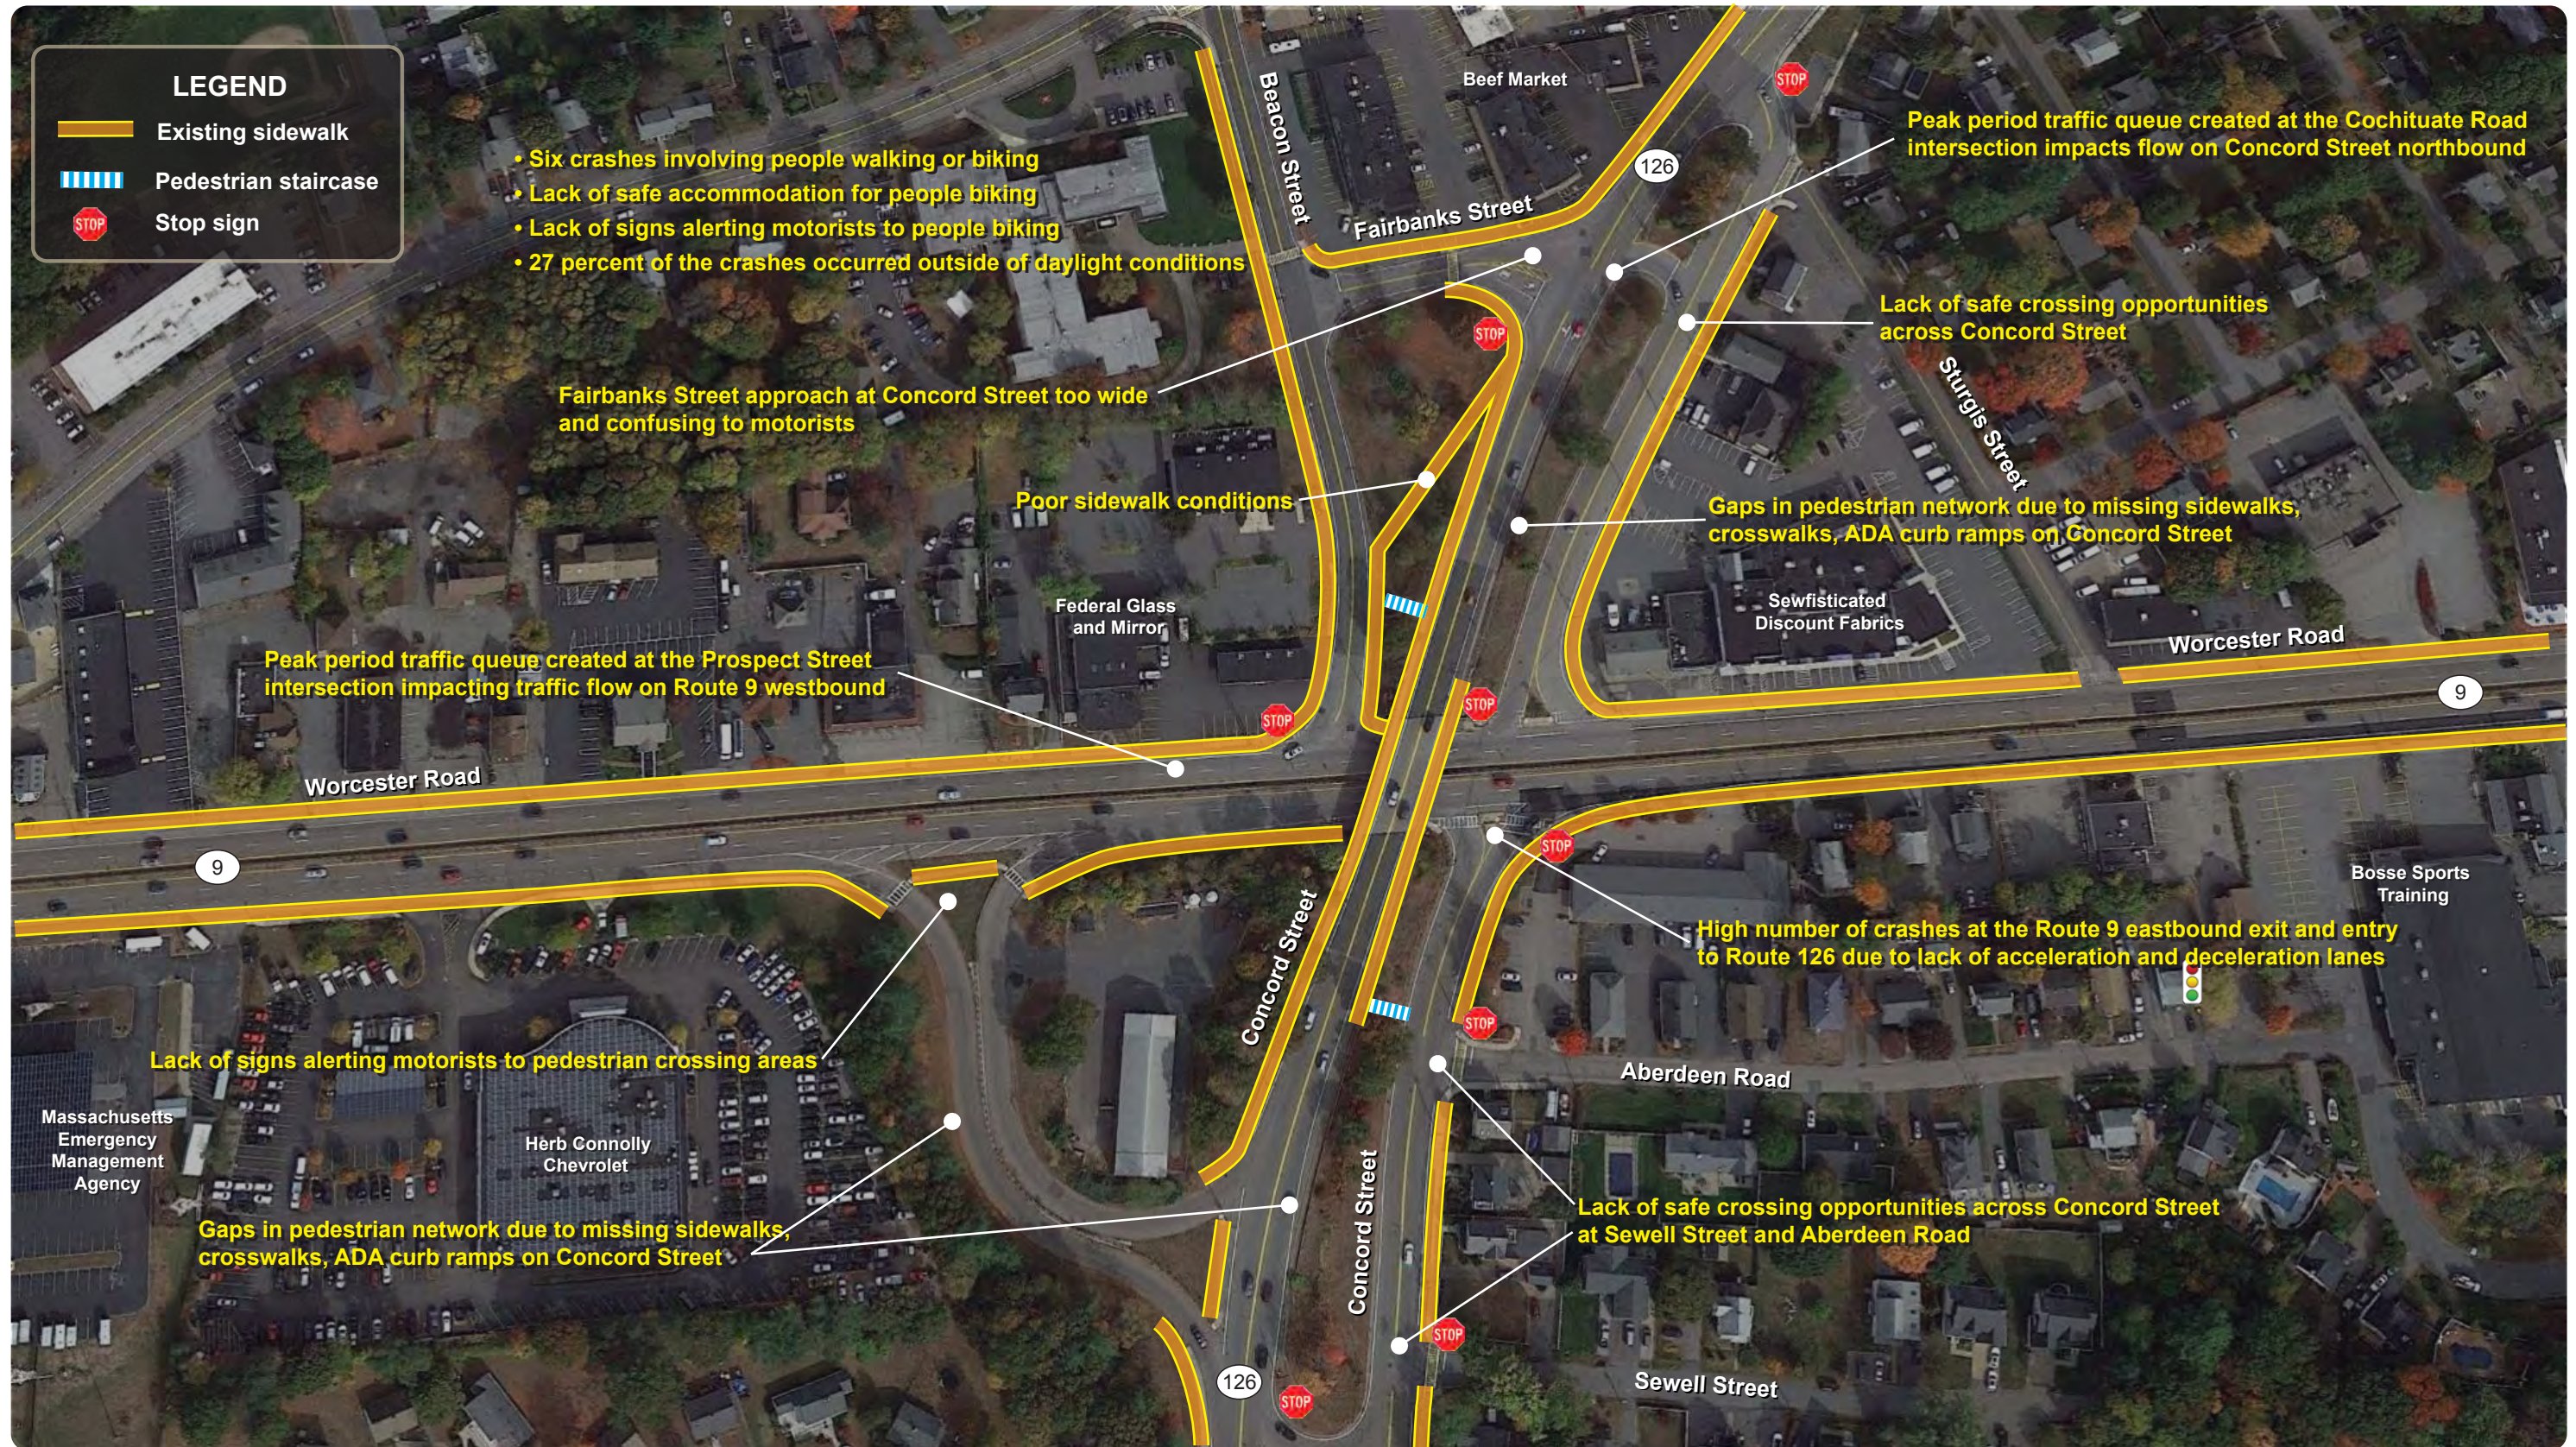
Figure 17
 Problems: Route 9 and Concord Street (Route 126) Interchange

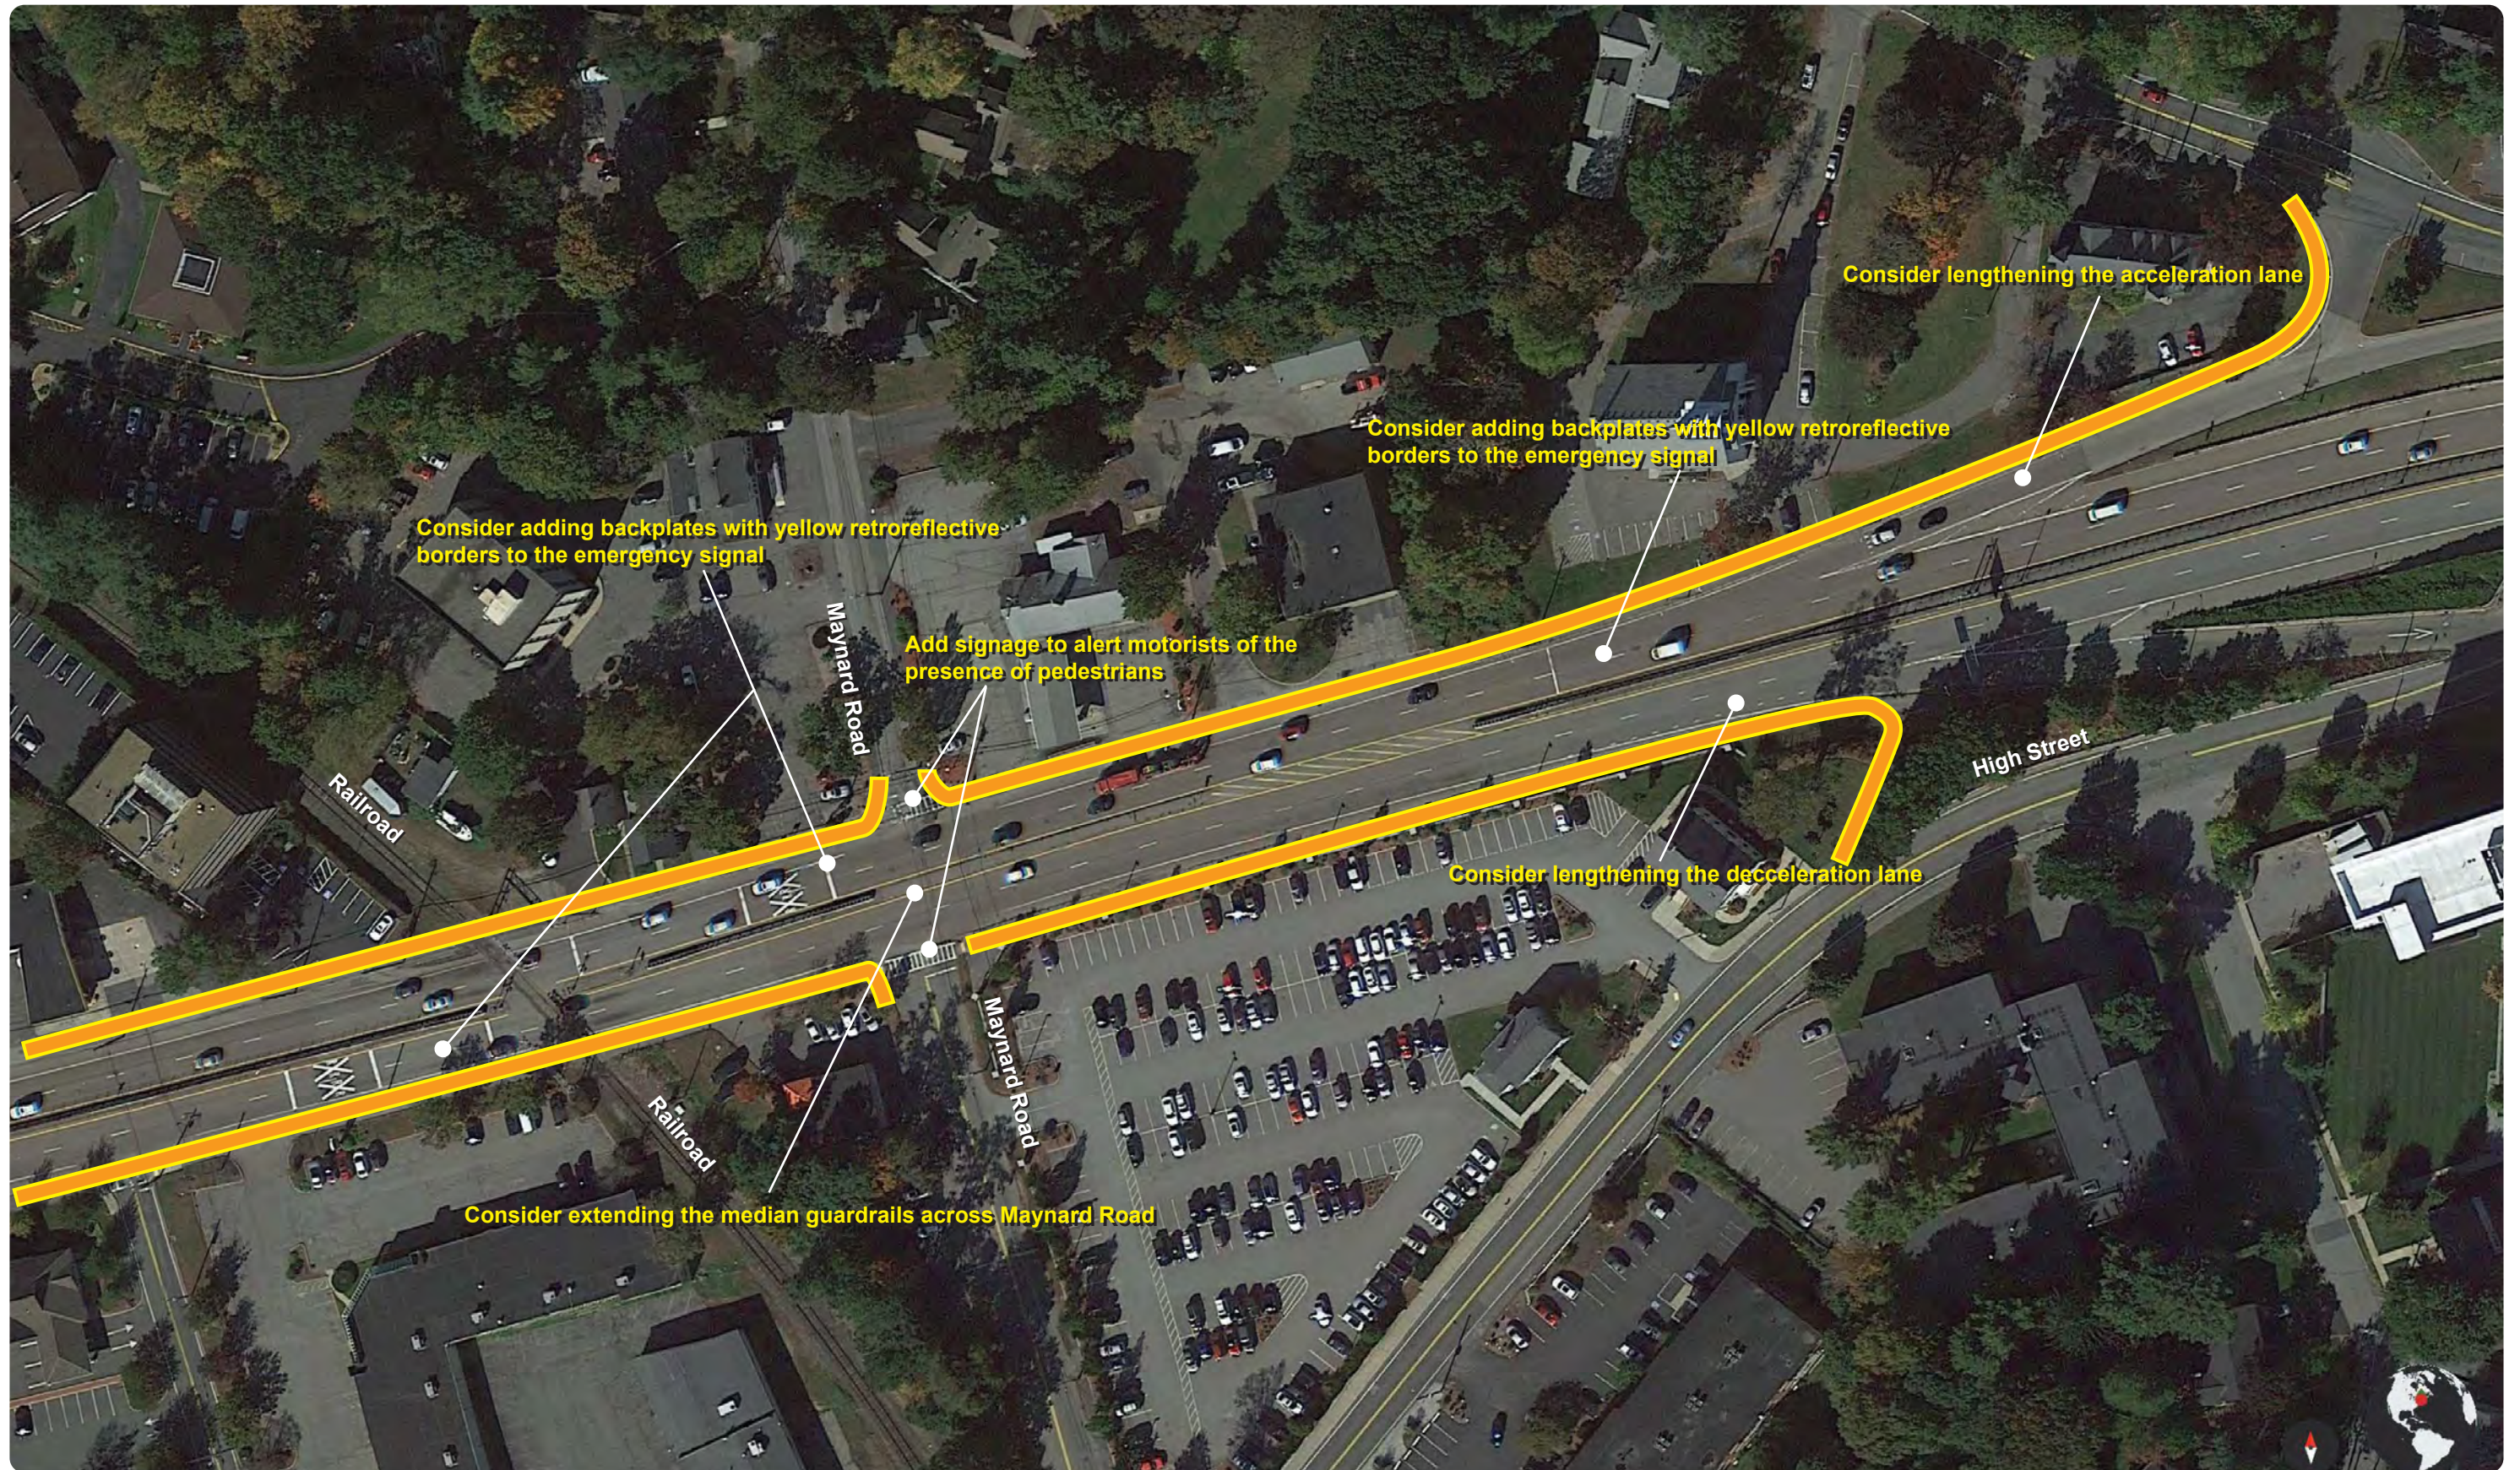
Figure 24
Improvements: Route 9 and Maynard Road Intersection

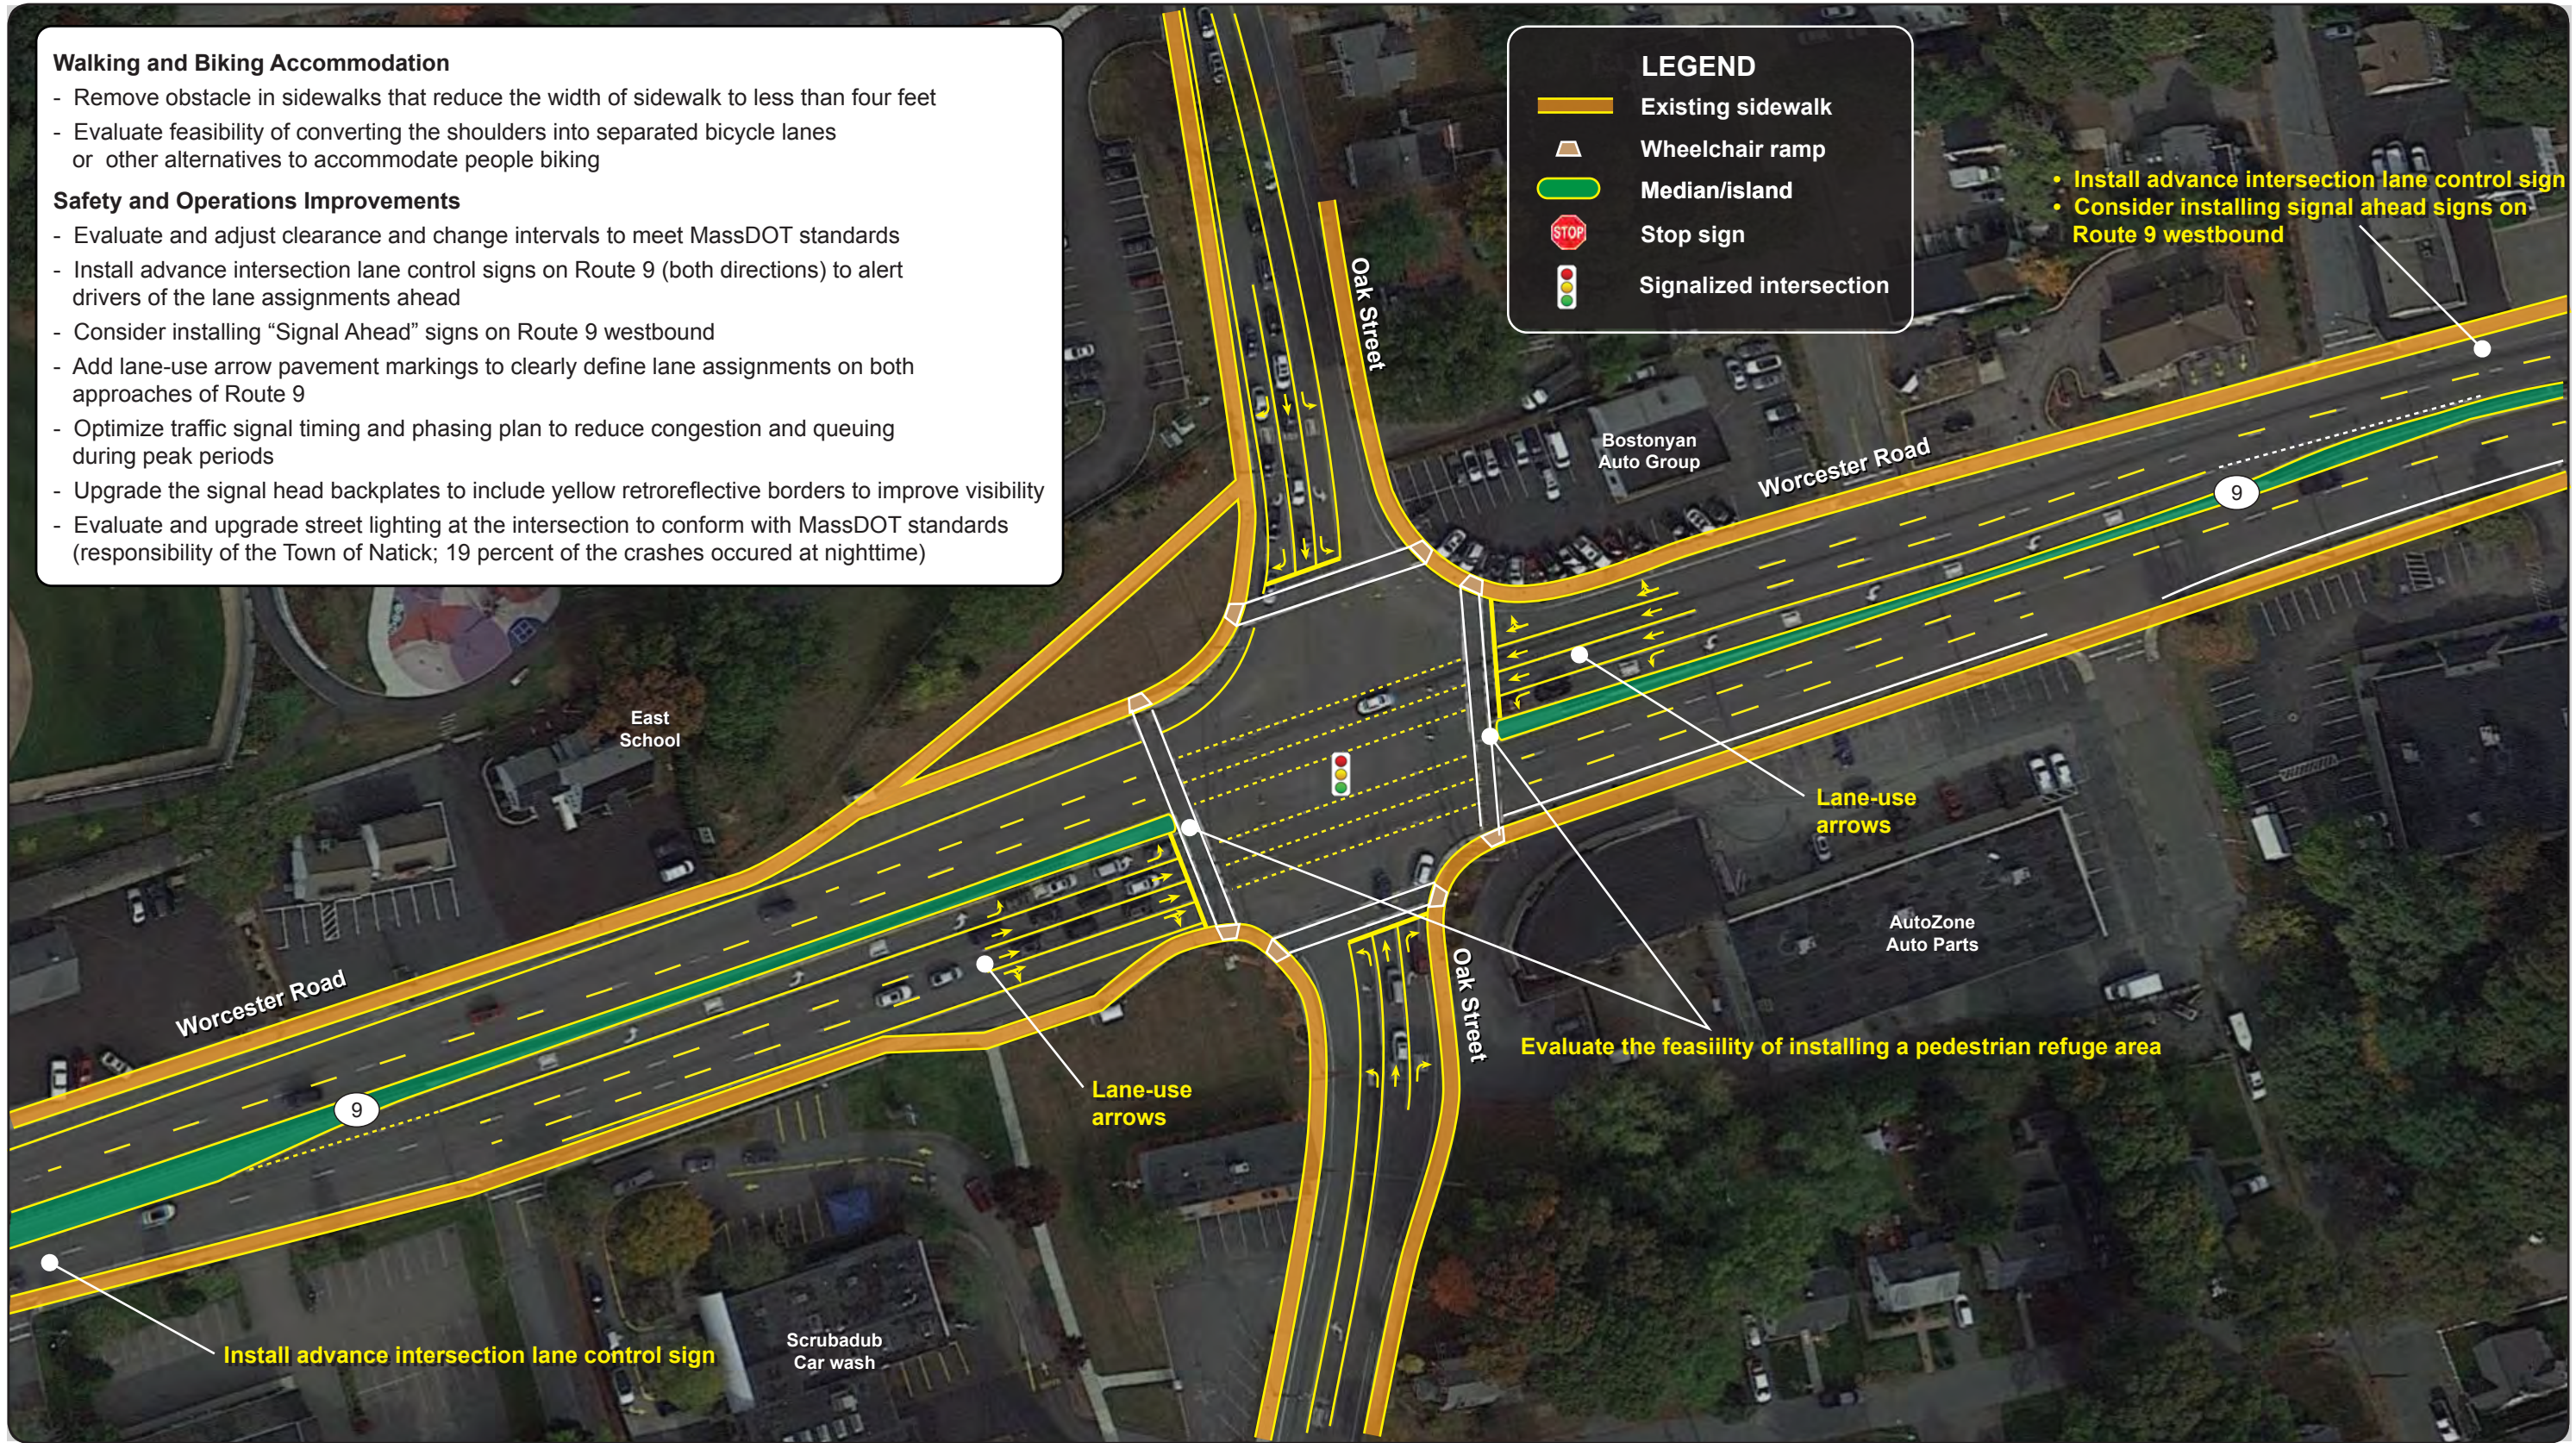
Figure 31
Improvements: Route 9 and Oak Street Intersection

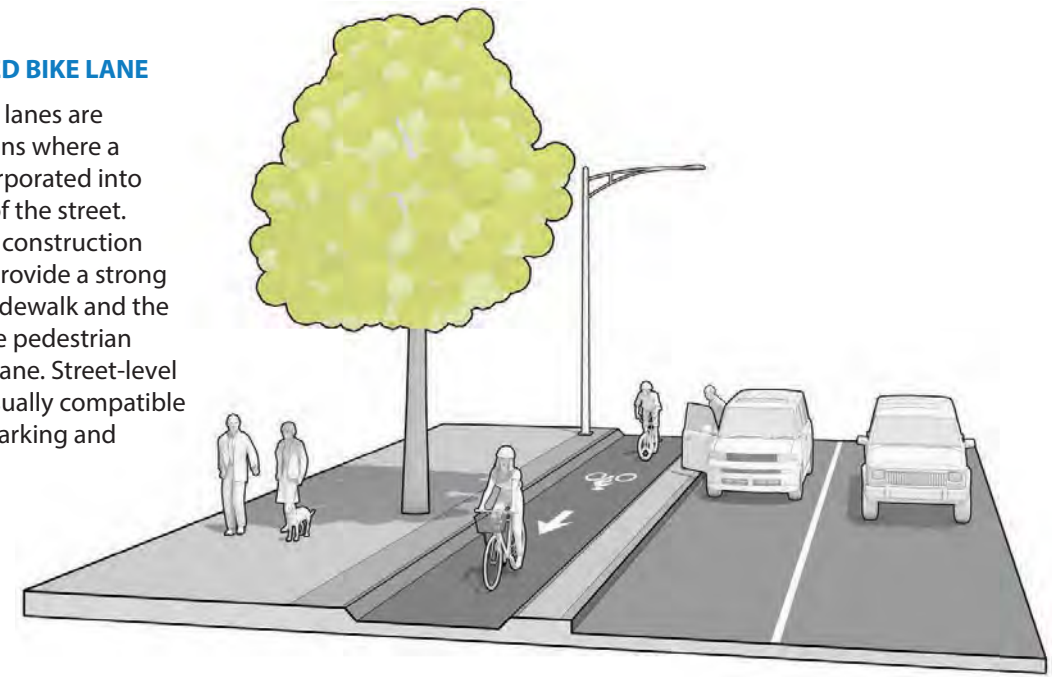
Street-level separated bike lanes are common in retrofit situations where a separated bike lane is incorporated into the existing cross section of the street. They are also used for new construction where there is a desire to provide a strong delineation between the sidewalk and the bike lane in order to reduce pedestrian encroachment in the bike lane. Street-level separated bike lanes are usually compatible with accessible on-street parking and loading zones.

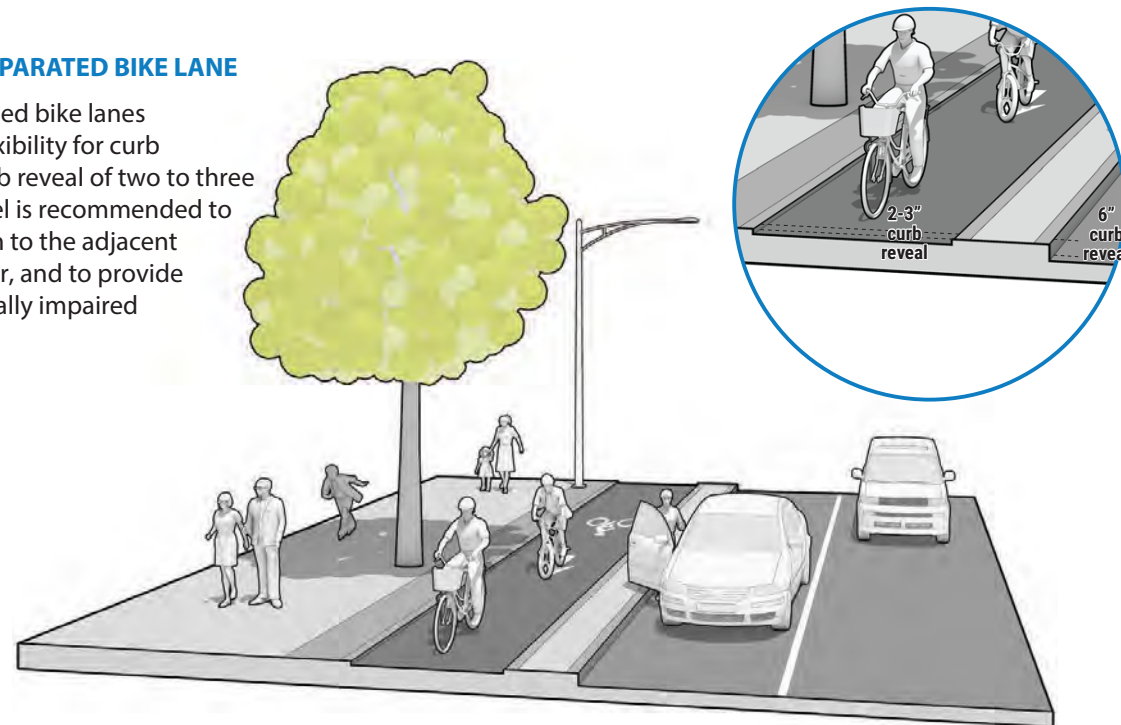
INTERMEDIATE-LEVEL SEPARATED BIKE LANE

Intermediate-level separated bike lanes provide greater design flexibility for curb reveal and drainage. A curb reveal of two to three inches below sidewalk level is recommended to provide vertical separation to the adjacent sidewalk or sidewalk buffer, and to provide a detectable edge for visually impaired pedestrians.
