BOSTON REGION METROPOLITAN PLANNING ORGANIZATION

MEMORANDUM

DATE October 4, 2012
TO MassDOT Highway Division District 4 and the Town of Wilmington
From Chen-Yuan Wang, MPO Staff
Steven Andrews, MPO Staff
RE Safety and Operations Analyses at Selected Boston Region MPO
Intersections, FFY 2012: Main Street (Route 38/129) at Church
Street/Burlington Avenue (Route 62) in Wilmington

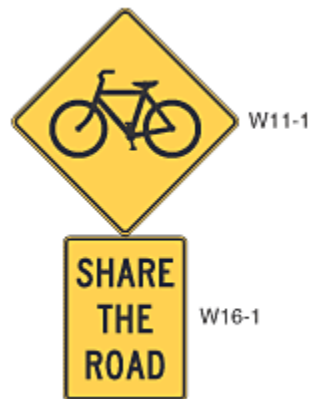
FIGURE 5**Bicycle Warning and Share the Road Warning Signs**

- Install “Bicycle Warning” (W11-1) and “Share the Road” (W16-1) warning signs, as depicted in Figure 5. Share the Road signs should be installed in conjunction with shared lane markings, and the Bicycle Warning signs would alert motorists that cyclists are present.
- Install a “Cross Only at Crosswalks” (R9-3b) or a “Use Crosswalk” (R9-2) sign (see Figure 6) on Main Street at the pedestrian walkway entrance to the commuter rail station, since there were two pedestrian crashes at this location in the last few years.
- Establish a 30 mph speed limit on the Main Street northbound approach starting about 1,500 feet south of the intersection, before the curve. The speed zone is needed because of the many driveways in the section and also because of its horizontal curve.
