BOSTON REGION METROPOLITAN PLANNING ORGANIZATION

MEMORANDUM

DATE: January 23, 2014
TO: Boston Region Metropolitan Planning Organization (MPO)
FROM: Chen-Yuan Wang, MPO Staff
RE: Route 3A Subregional Priority Roadway Study in Cohasset and Scituate

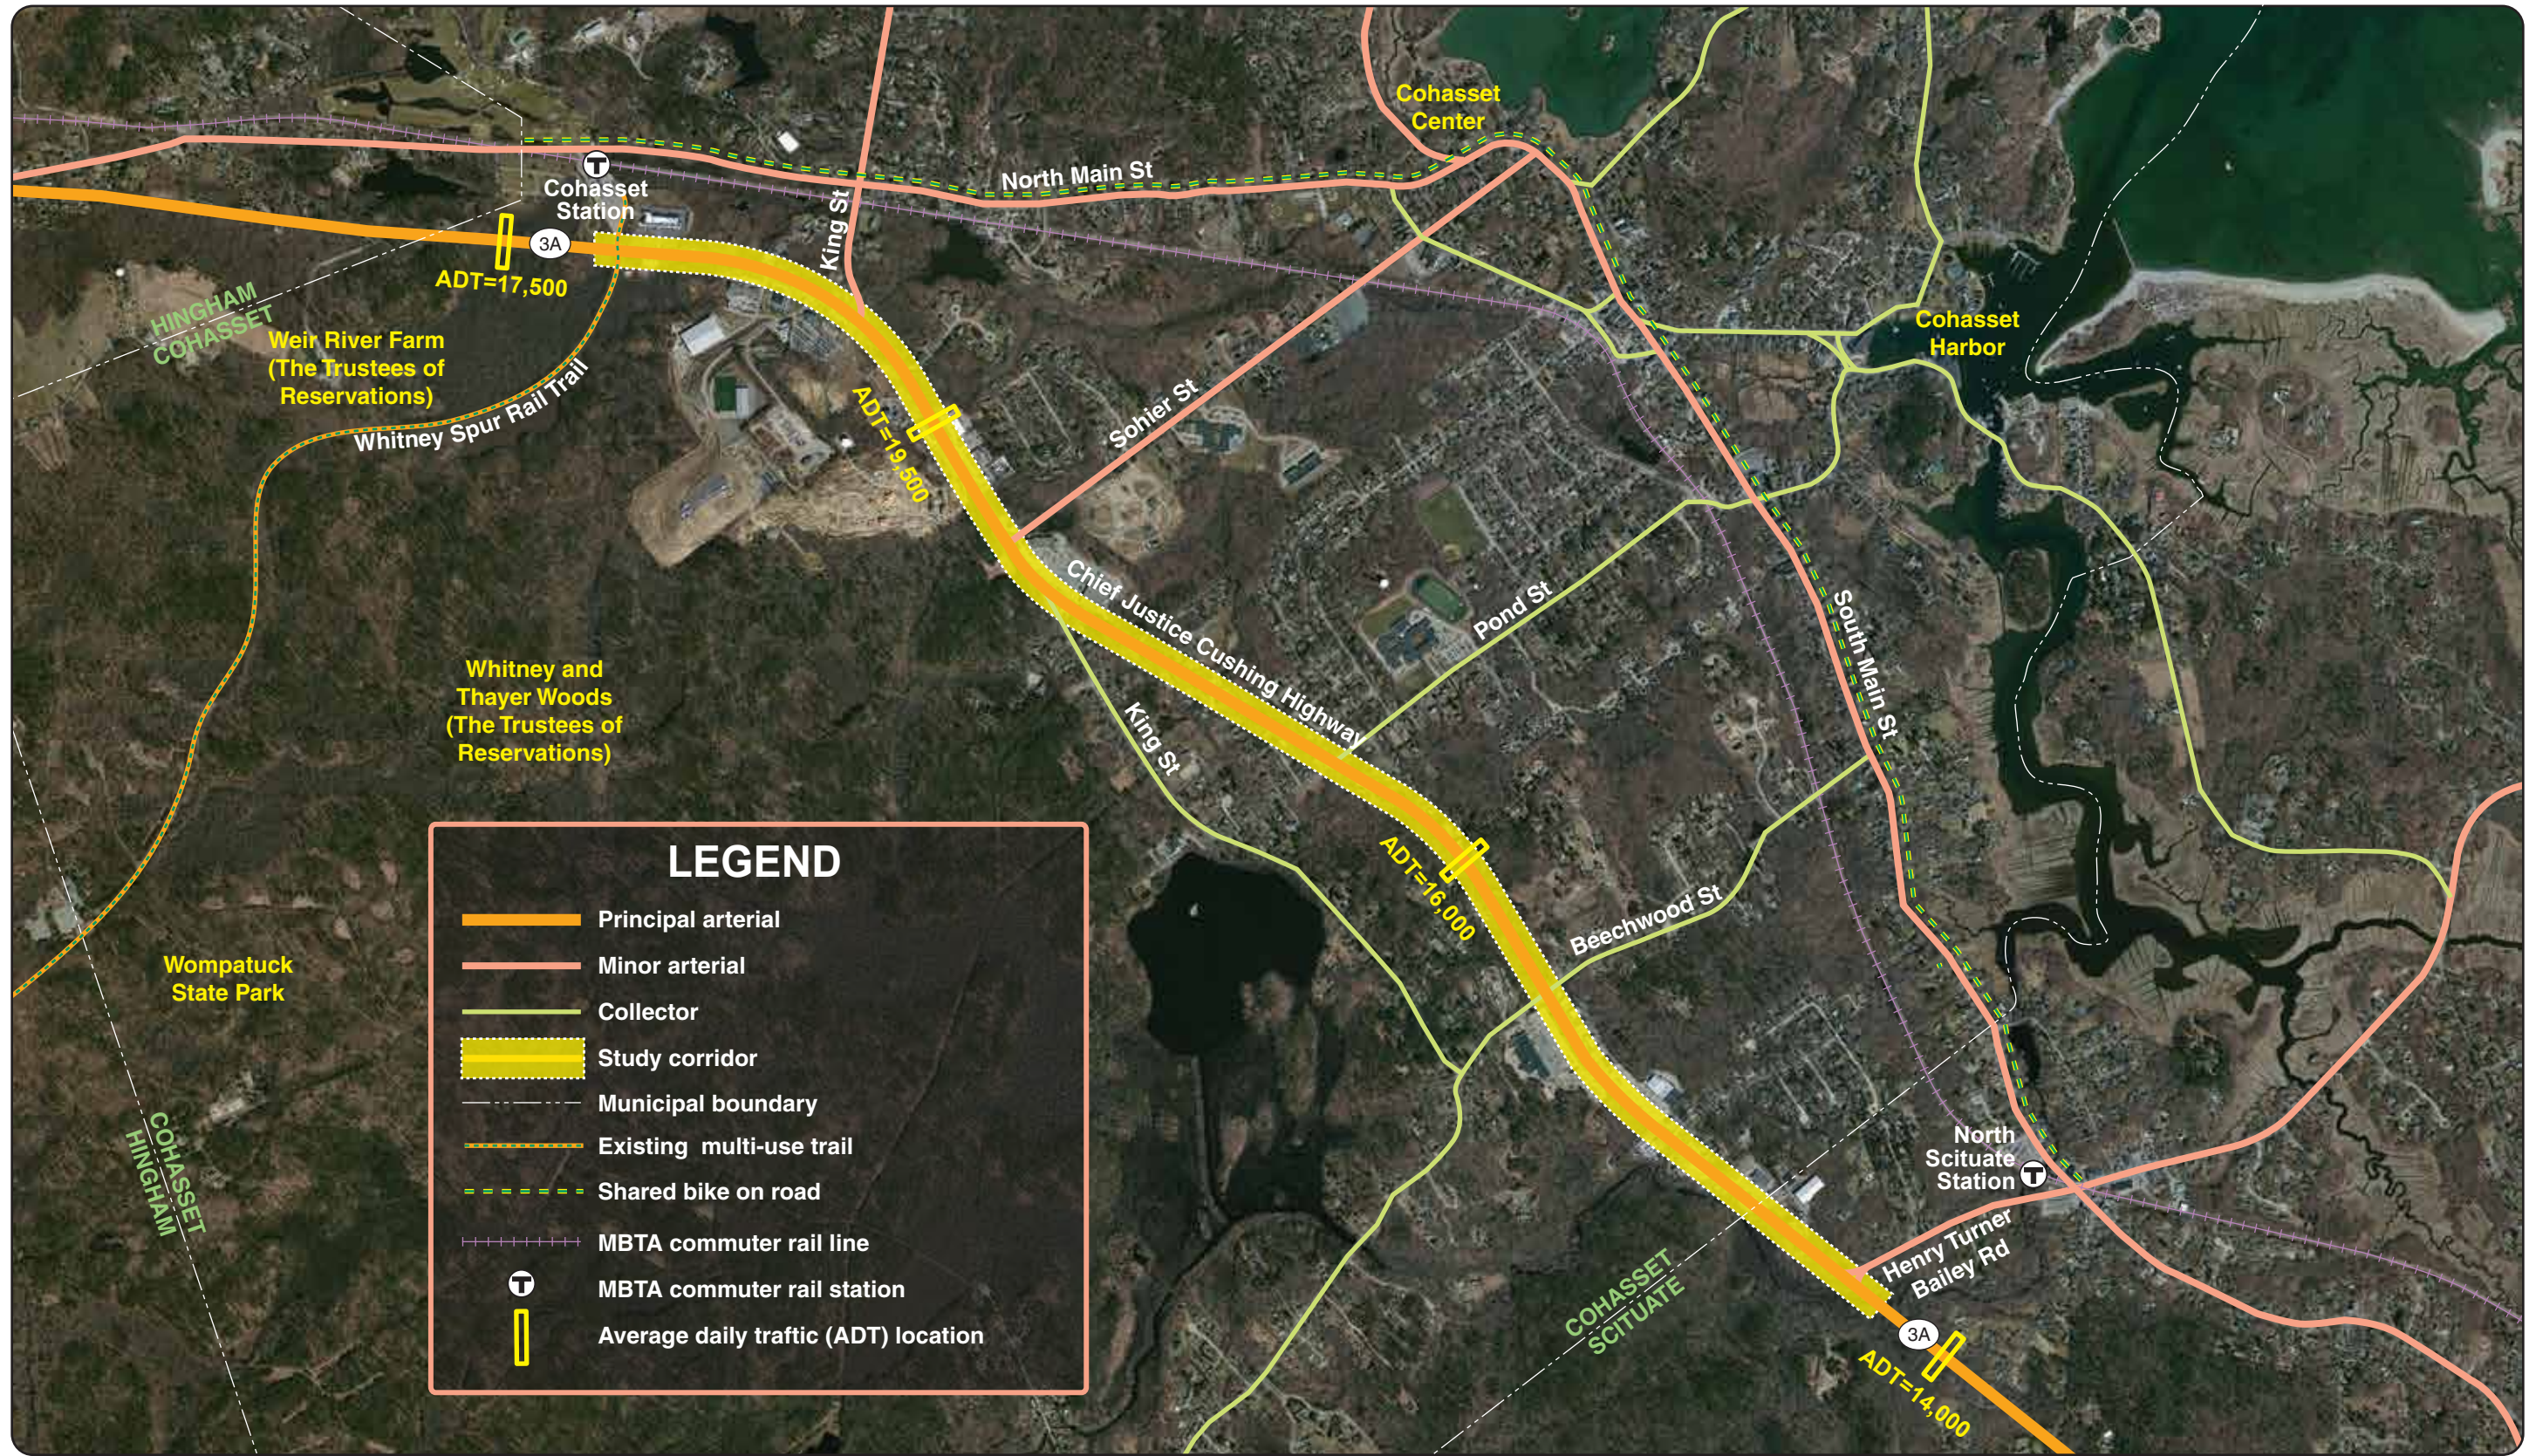
FIGURE 1
Study Corridor and Adjacent Major Transportation Facilities
Route 3A in Cohasset and Scituate

Figure 1 shows the location of the study corridor and major transportation facilities in the area. Most of the three-mile corridor selected for this study is located in Cohasset, with a short section in Scituate. The entire section is classified as a principal urban arterial. It is mainly a two-lane roadway (one travel lane in each direction), except for a four-lane section (two travel lanes in each direction) about a quarter mile long in a Cohasset business district south of Beechwood Street. The roadway's travel lanes are about 12 feet wide, with a shoulder of about two feet or less. There are no sidewalks on either side of the roadway and no exclusive bike lanes.

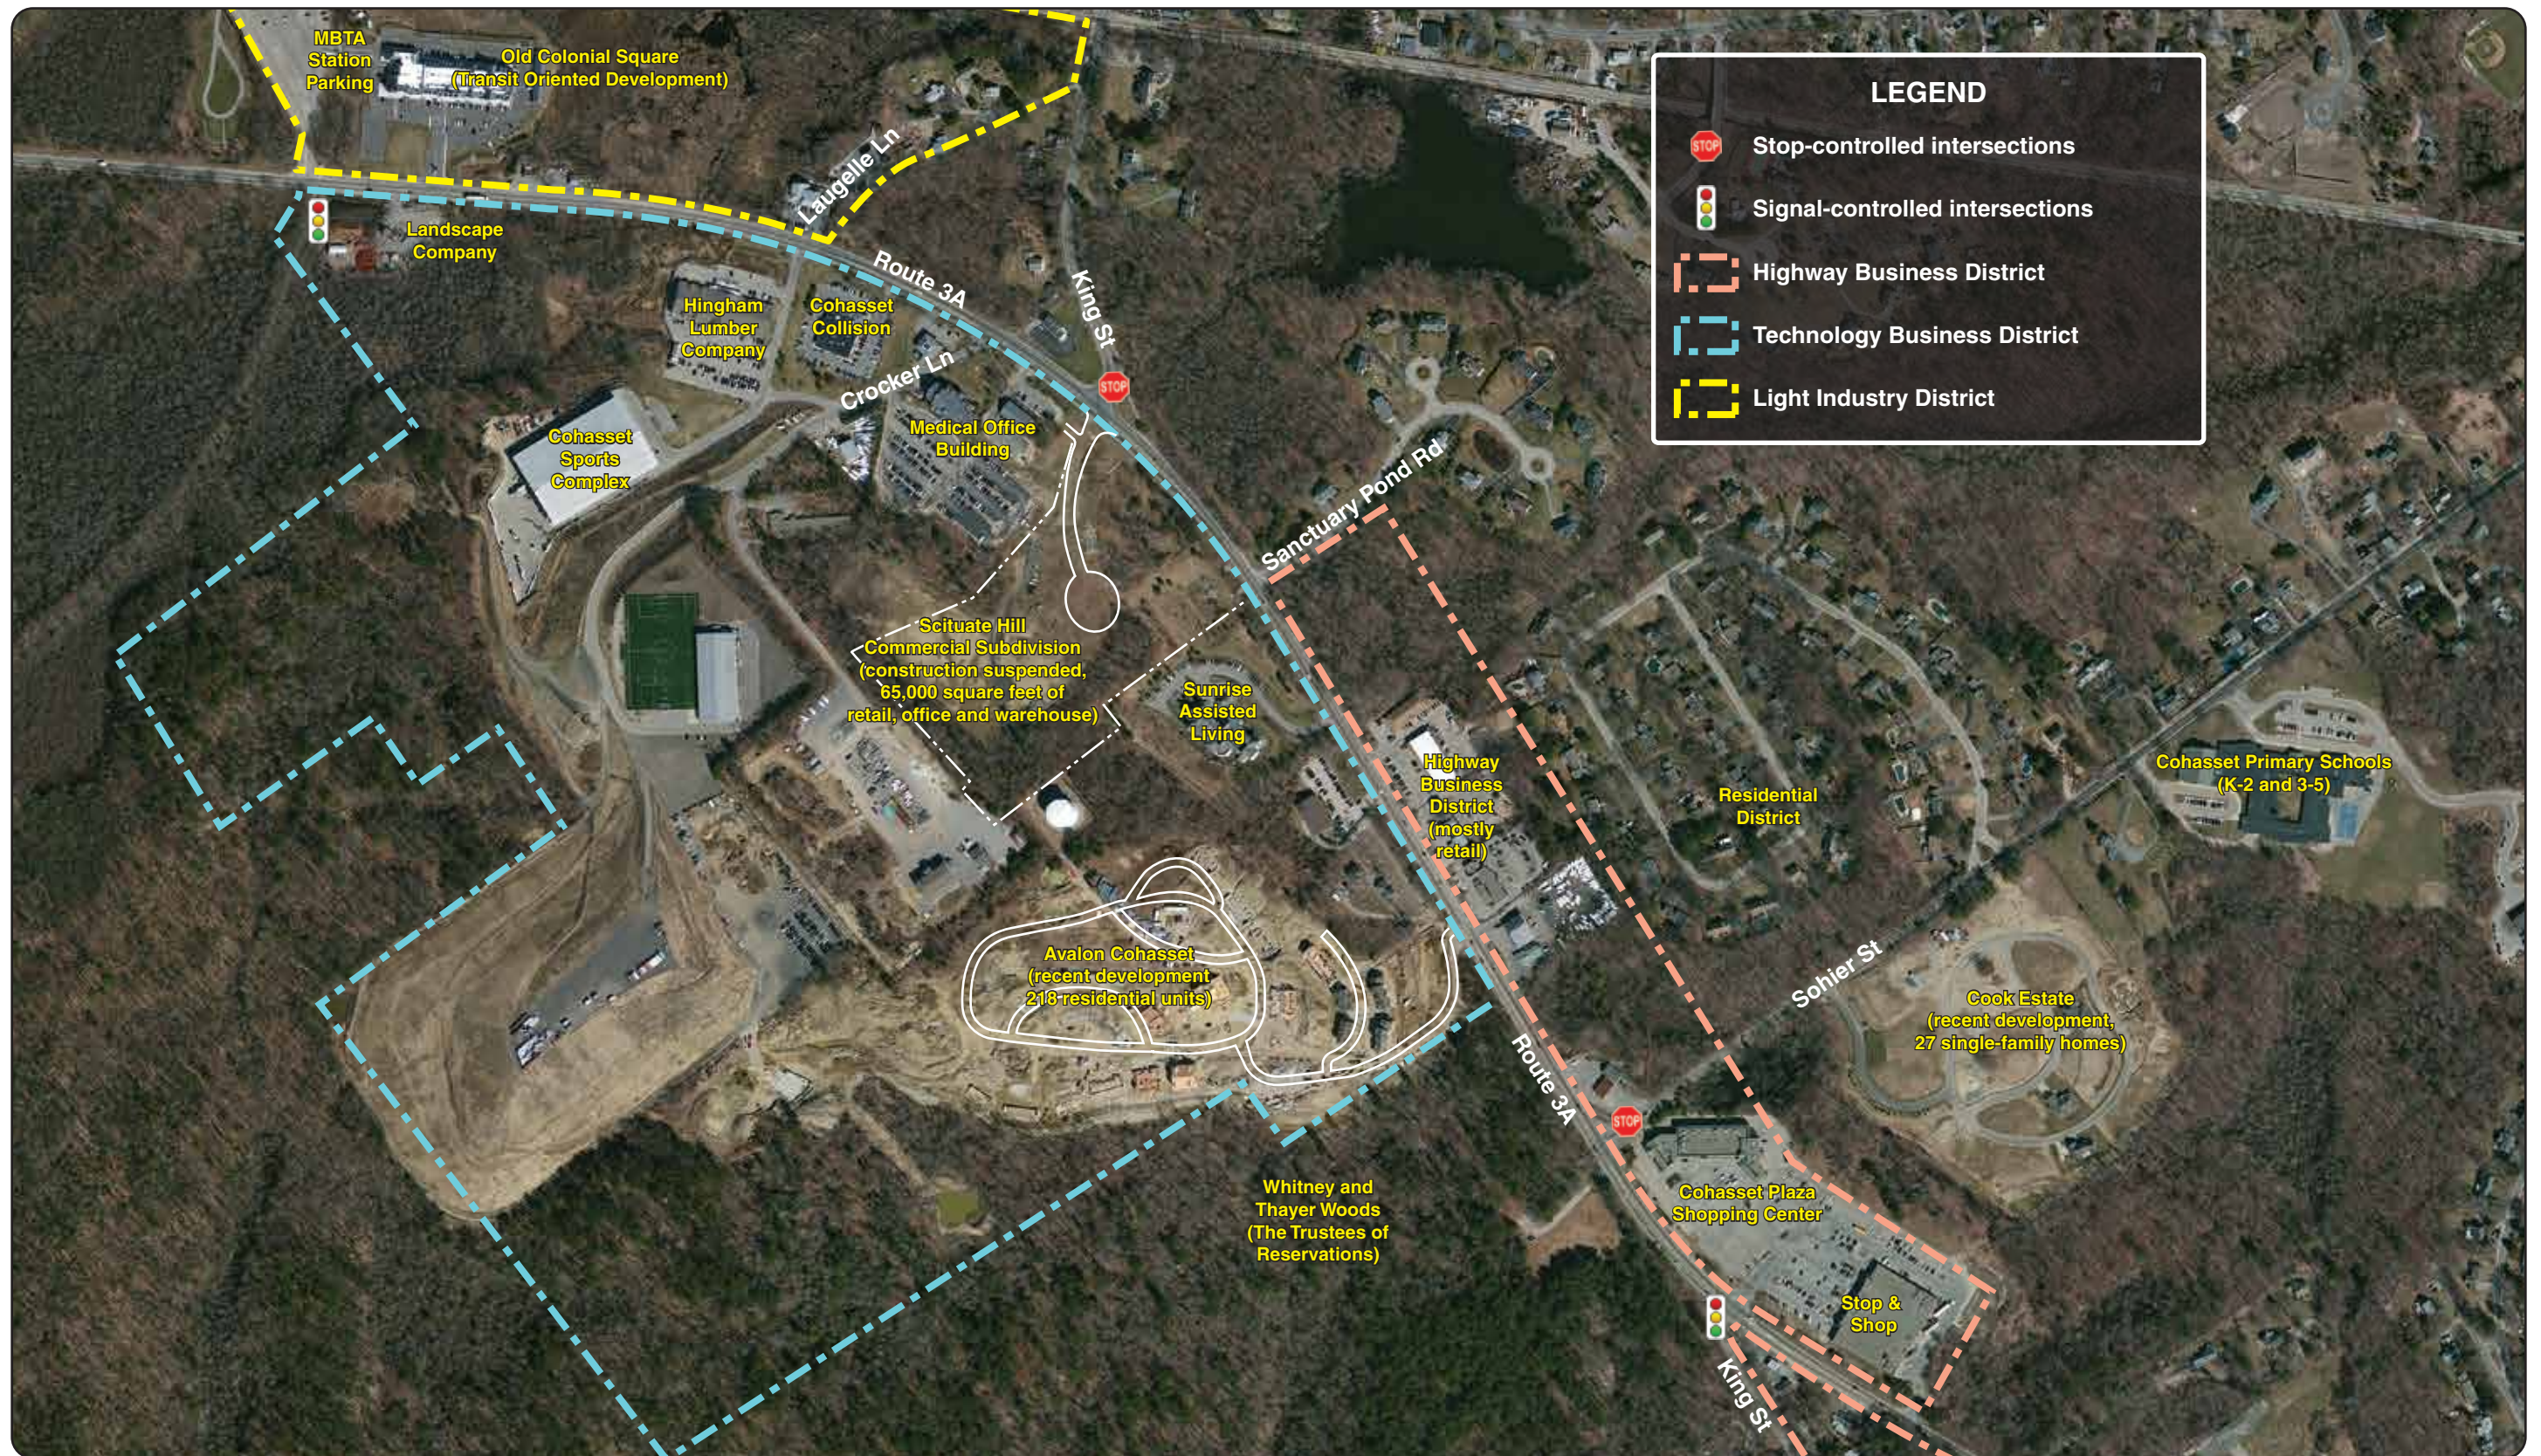
FIGURE 2
Existing Roadway Conditions and Adjacent Developments
Route 3A North Section

Figure 2 shows the existing roadway conditions and adjacent developments in the north section of the study corridor. The section contains two signalized intersections and two major unsignalized intersections.

The signalized intersection at Route 3A at the driveway of the MBTA Cohasset Station operates adequately because of light traffic to and from the driveway. The signalized intersection at Route 3A at King Street/Cohasset Plaza operates acceptably in general, although drivers on King Street and the peak direction of Route 3A experience some delays in the morning (AM) peak hour (detailed analyses in Section 3.3: Intersection Capacity Analyses).

Under a stop control, the side streets of the two unsignalized intersections, i.e., King Street and Sohier Street, operate unacceptably during the peak traffic hours. At times, drivers on Sohier Street experience extensive delays as a result of the surge of traffic from the adjacent primary schools and commuting traffic on Route 3A northbound.

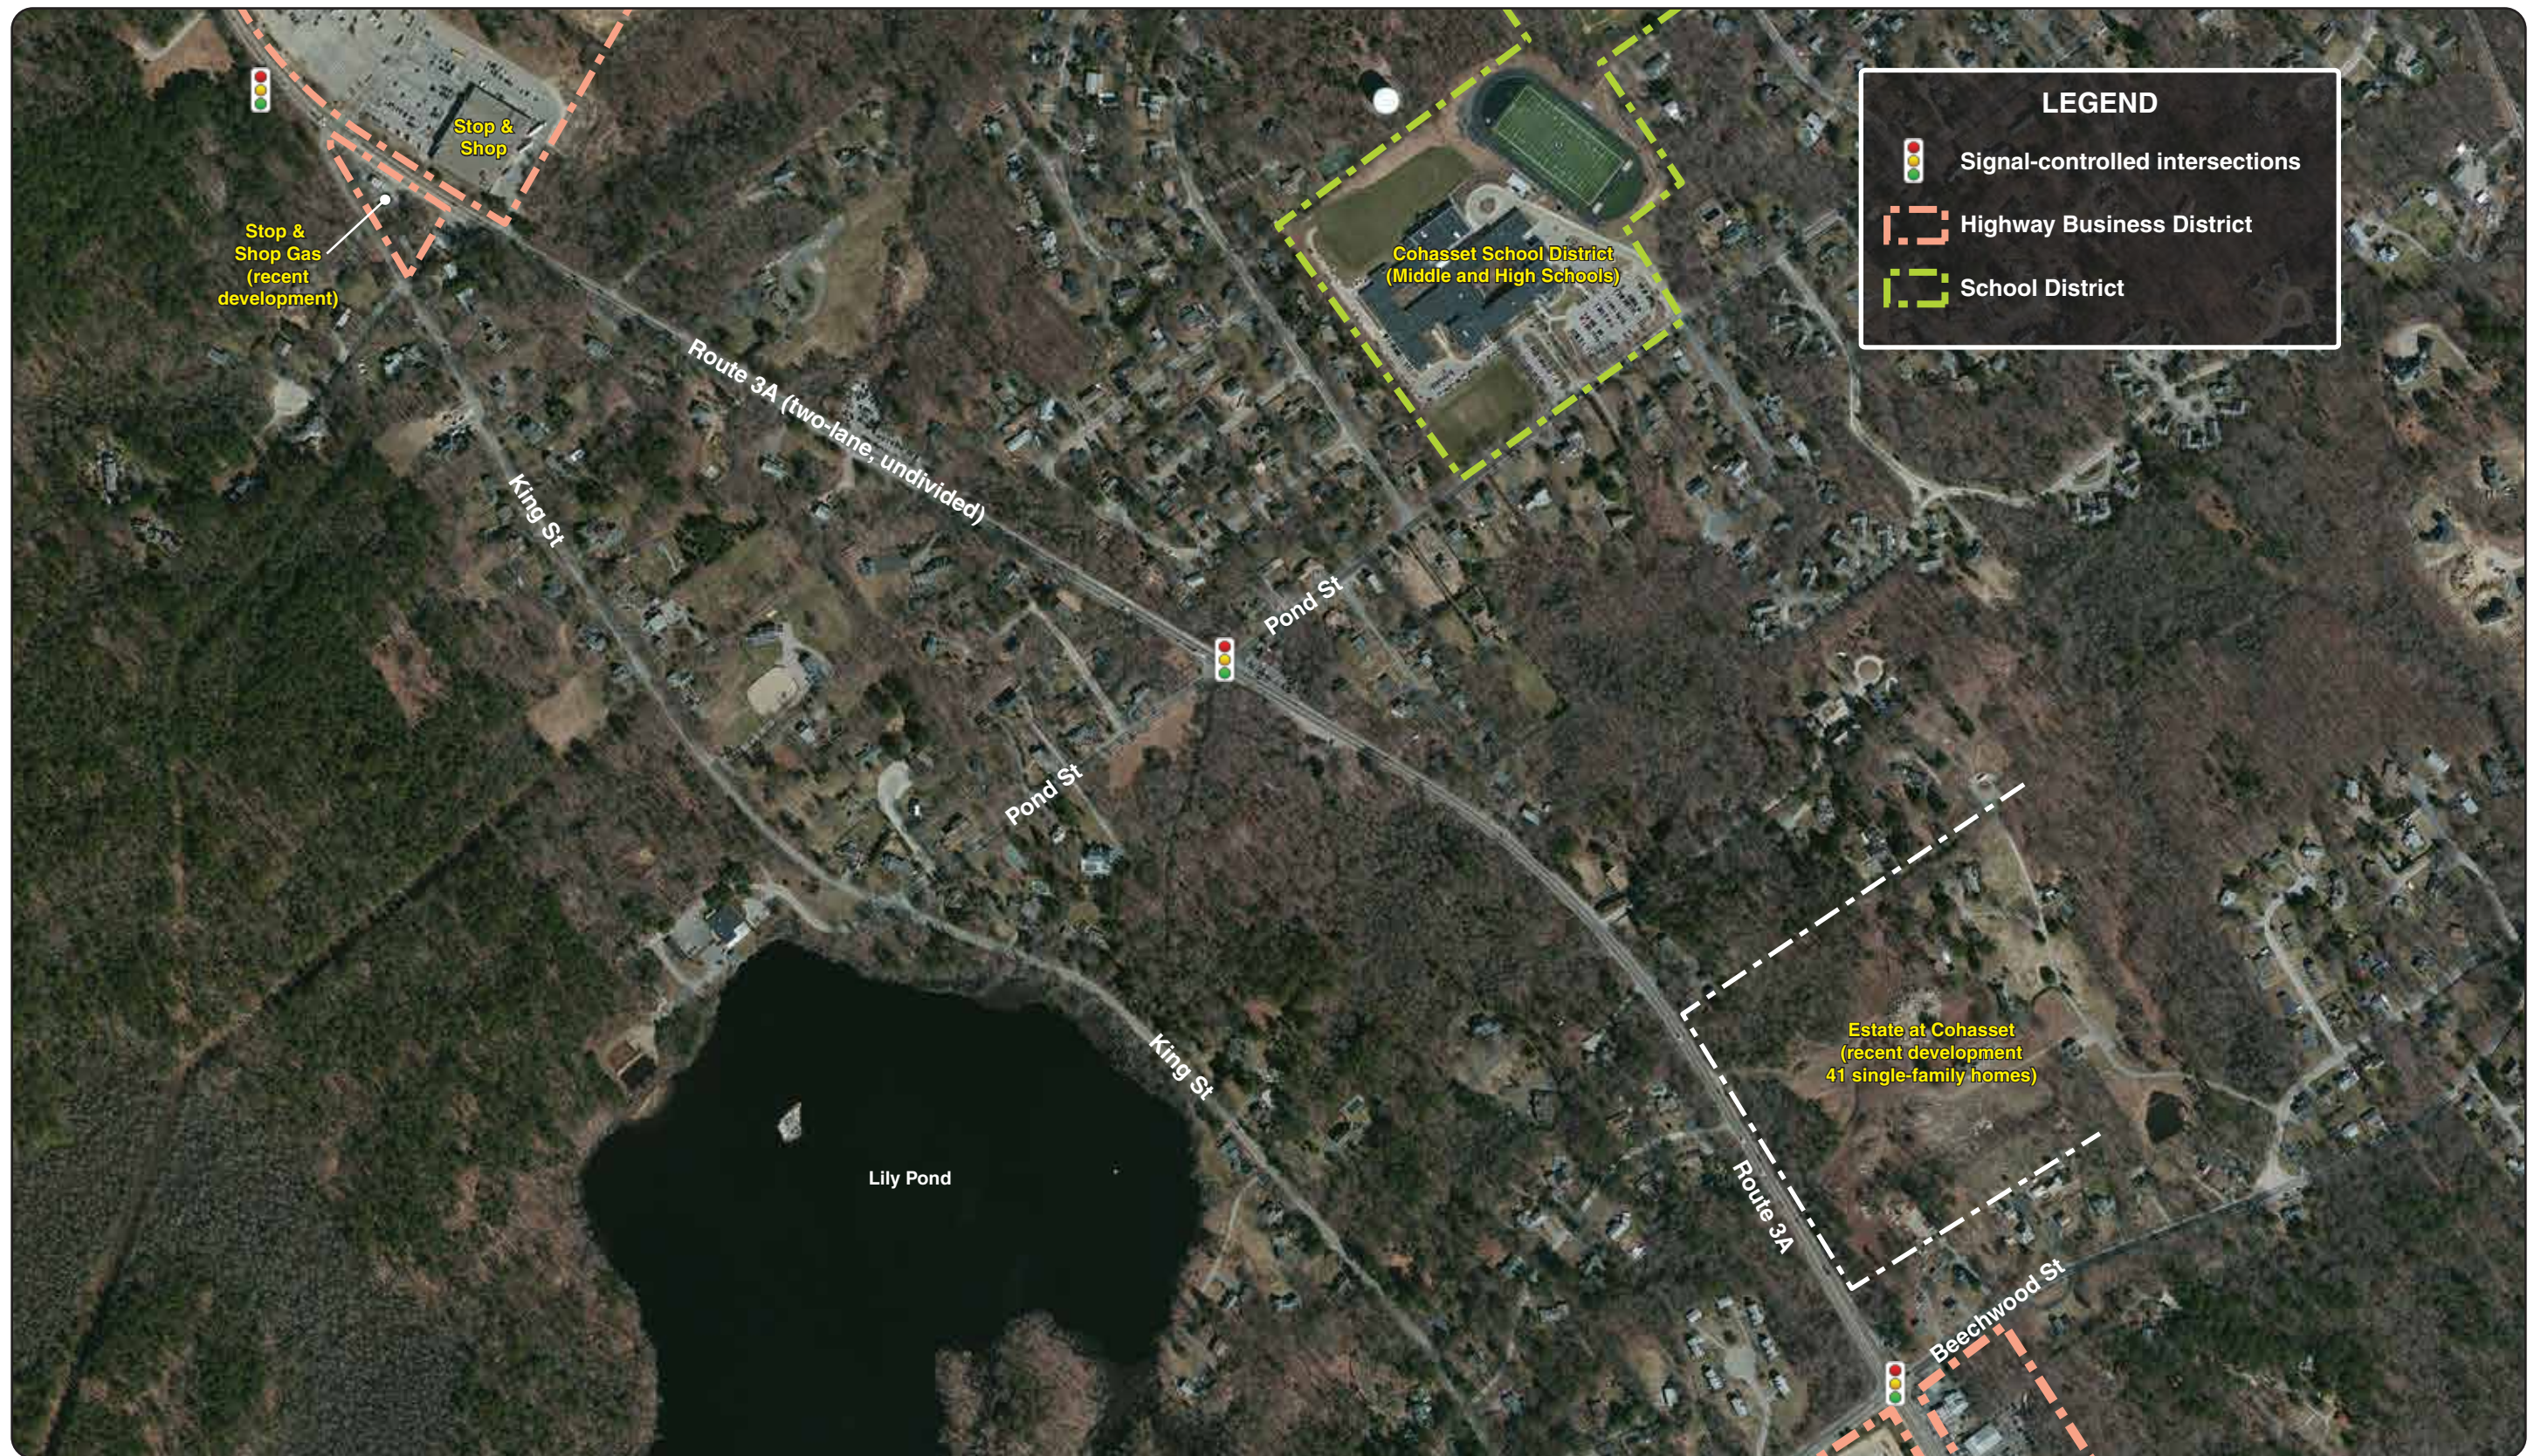
FIGURE 3
Existing Roadway Conditions and Adjacent Developments
Route 3A Middle Section

Figure 3 shows the existing roadway conditions and adjacent developments in the middle section of the study corridor. Route 3A in this section contains one signalized intersection (Route 3A at Pond Street), a few unsignalized intersections connecting to local streets, and a number of driveways (mostly from individual homes and some from businesses abutting Route 3A).

In general, the section is wooded with scattered single-family houses and a few businesses in between. Cohasset School District—located on Pond Street about 1,000 feet from Route 3A—is the major development in this section. The district contains the Town's public middle and high schools and attracts substantial traffic during school opening and closing periods. Although the district itself is not located on Route 3A, traffic at the intersection of Route 3A at Pond Street is affected by some of the school traffic from around 7:00 to 7:30 AM.

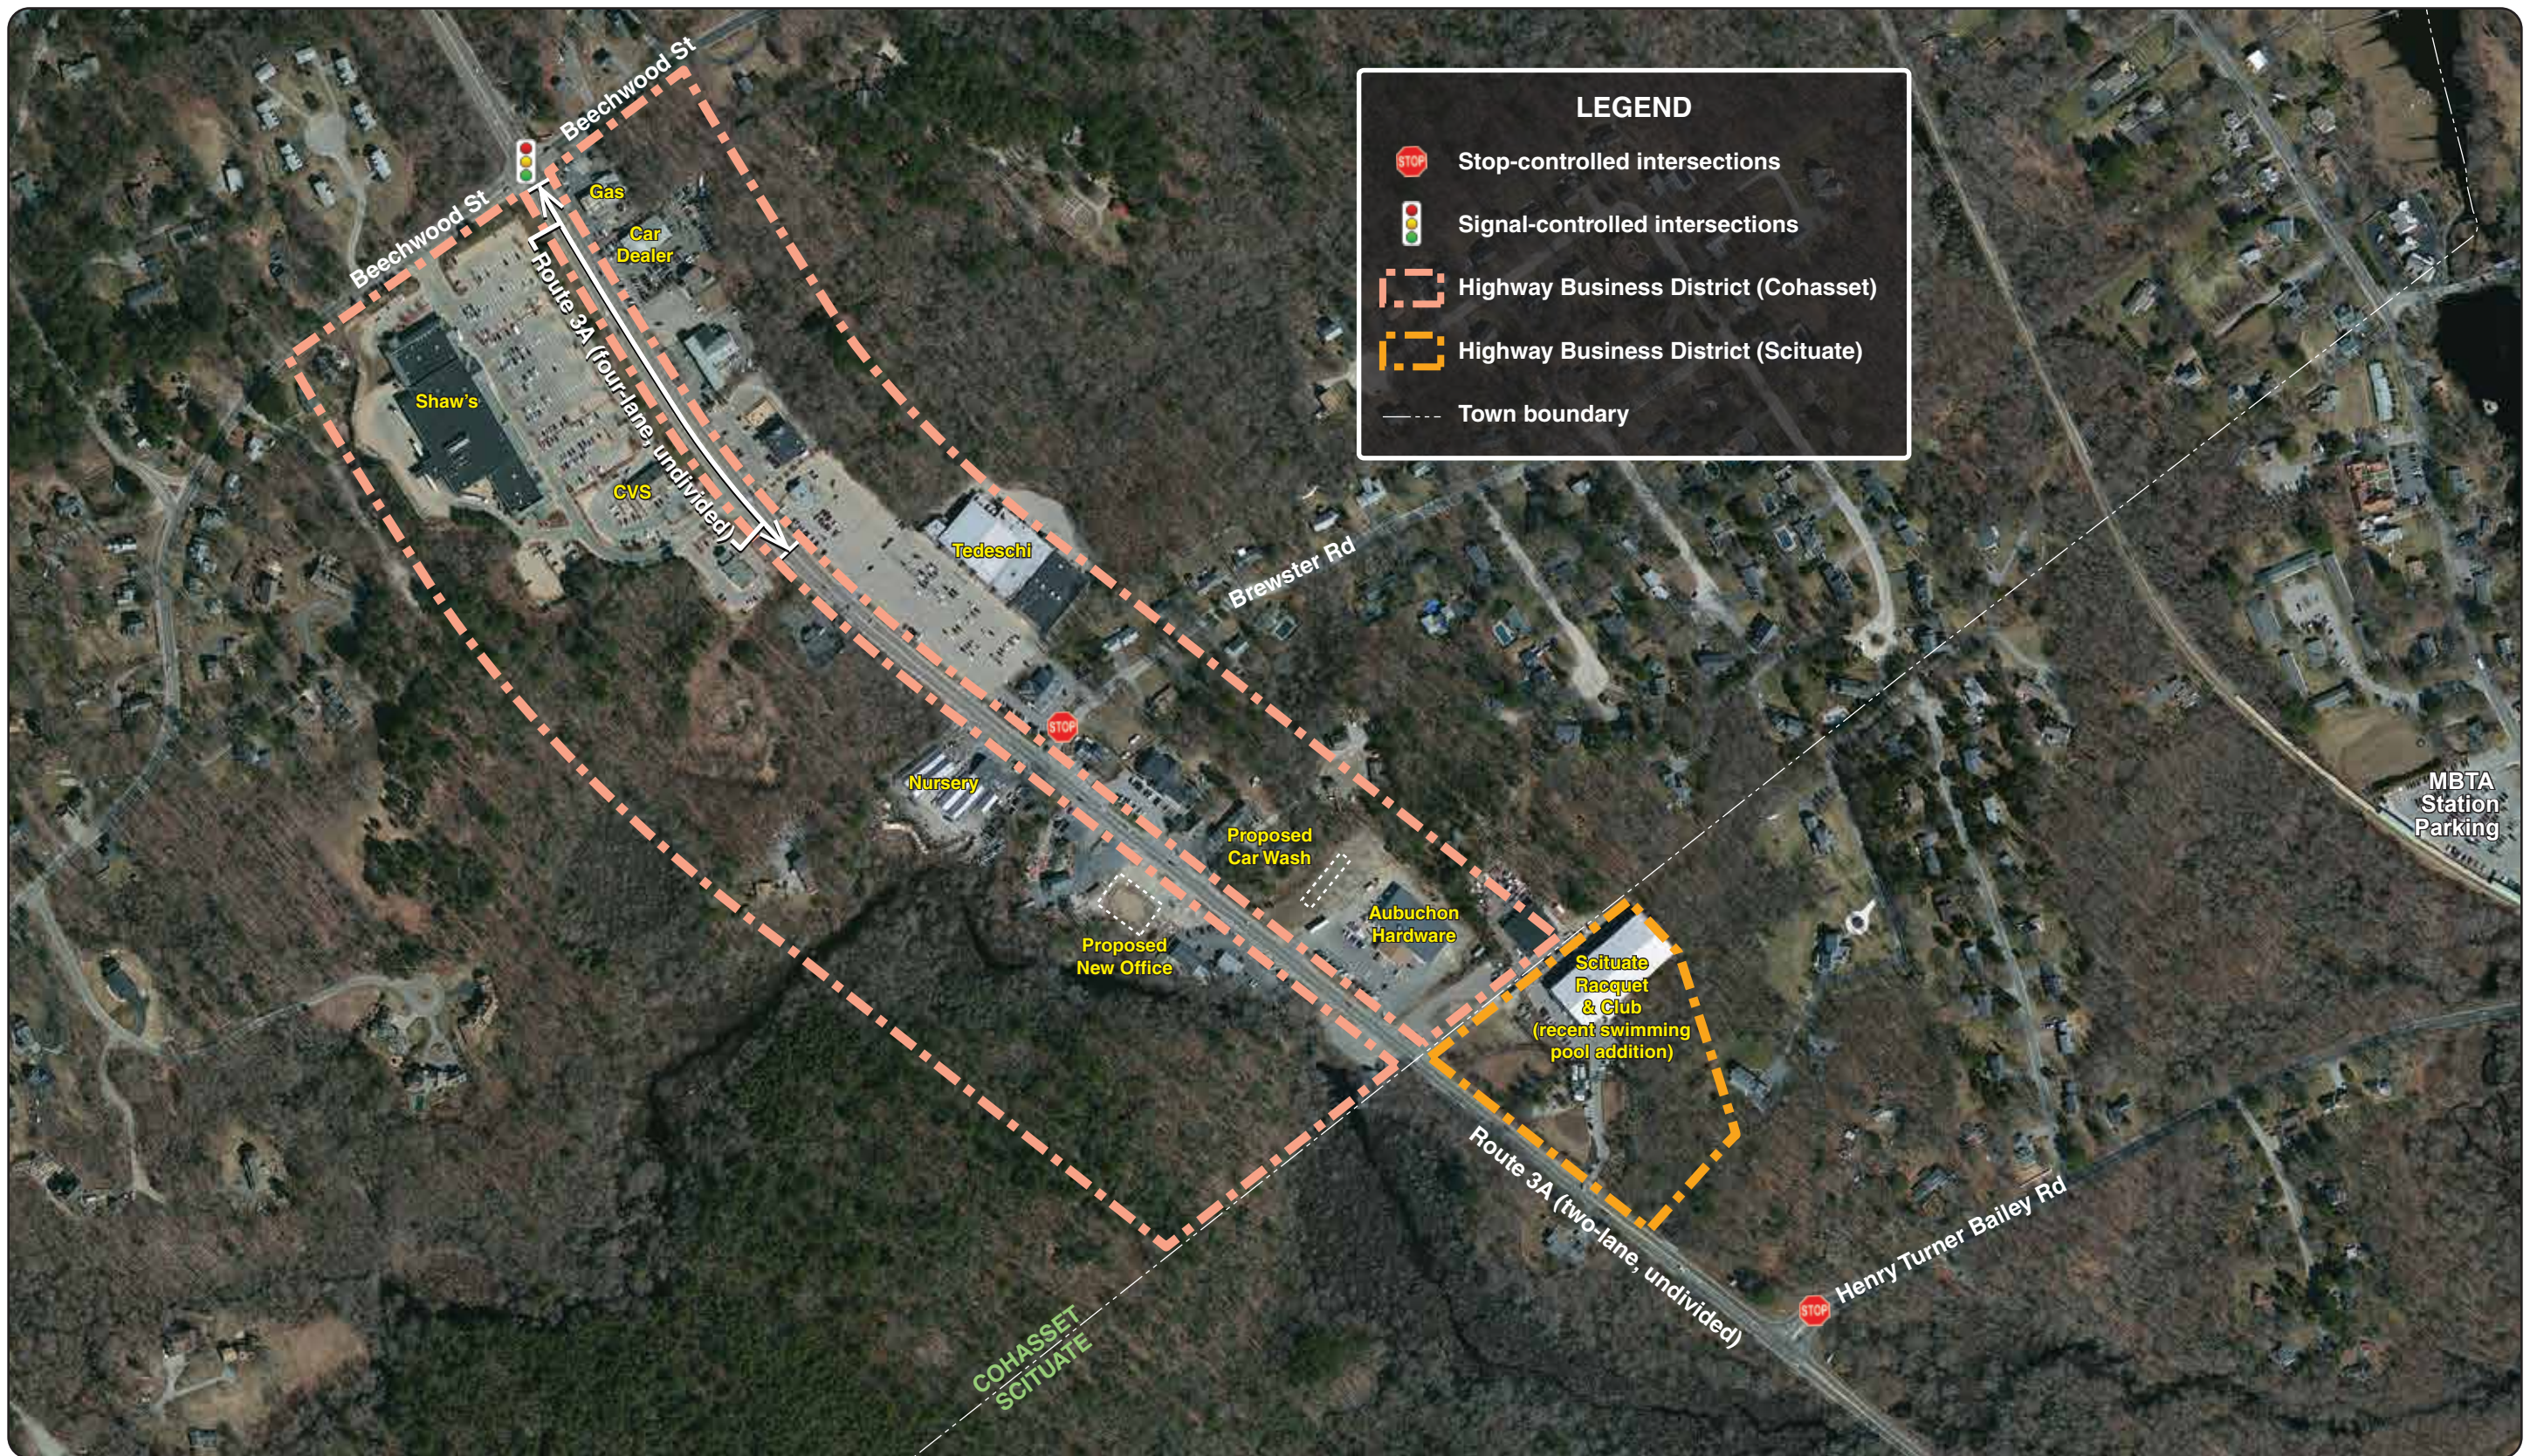
FIGURE 4
Existing Roadway Conditions and Adjacent Developments
Route 3A South Section

Figure 4 shows the existing roadway conditions and adjacent developments in the south section of the study corridor. This section contains mostly business districts and some vacant land.

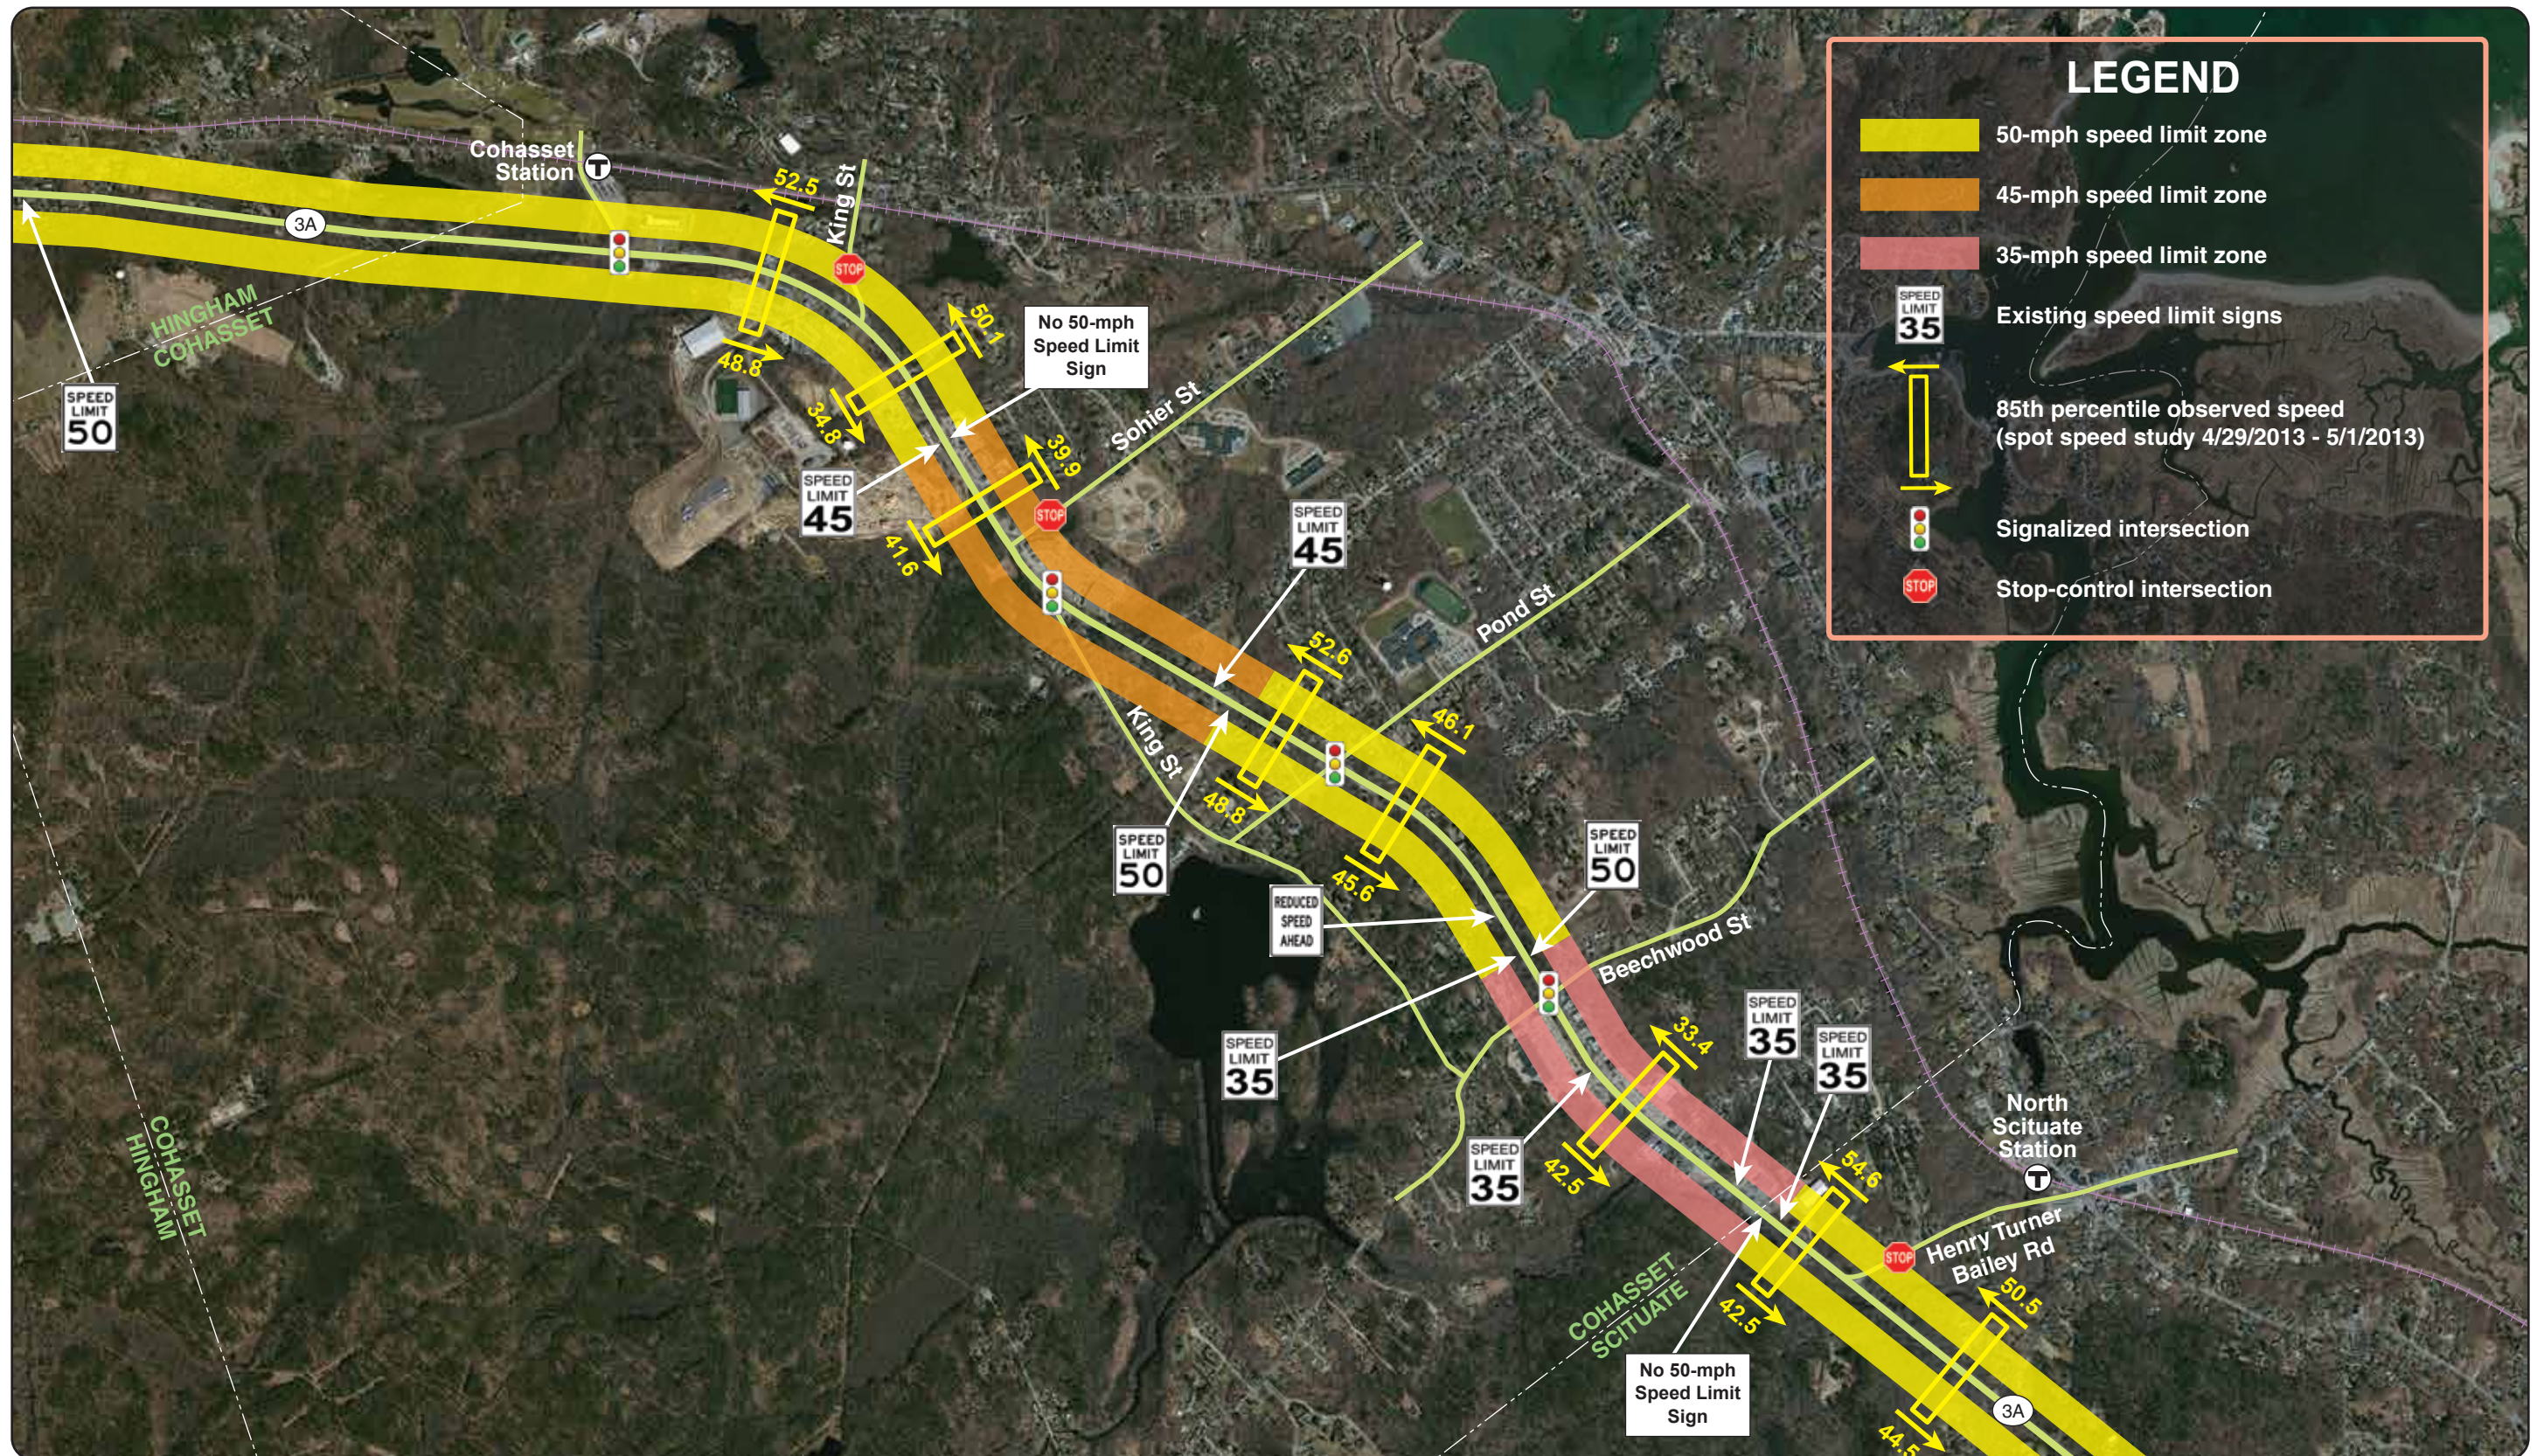
FIGURE 6
Existing Speed Controls and Observed 85th-Percentile Speeds
Route 3A in Cohasset and Scituate

Figure 6 shows the existing speed controls and observed 85th percentile travel speeds in the study corridor. Speed limits in the corridor are regulated in three ranges: 35-, 45-, and 50-mph. Most sections of the corridor are designated as 45- or 50-mph zones, except for the business district between Beechwood Street and the Cohasset/Scituate town line, which is a 35-mph zone.

As shown in Figure 6, the observed 85th percentile speeds generally conform to the safe speed requirement. The only location clearly outside the 85th percentile speed safe range is Route 3A southbound just past King Street, where the estimated 85th percentile speed is about 15 mph lower than the posted speed limit.¹¹ The approach is slightly uphill and in a horizontal curve formation. Traffic in the section also includes some vehicles just turning onto Route 3A from King Street and thus at a lower speed.

The observed 95th percentile speeds are all within the safe speed range, as they are generally higher than 50 mph in the 45- and 50-mph zones, and at nearly 40 mph northbound and nearly 50 mph southbound in the 35 mph zone.
