BOSTON REGION METROPOLITAN PLANNING ORGANIZATION

MEMORANDUM

DATE: January 23, 2014
TO: Boston Region Metropolitan Planning Organization (MPO)
FROM: Chen-Yuan Wang, MPO Staff
RE: Route 3A Subregional Priority Roadway Study in Cohasset and Scituate

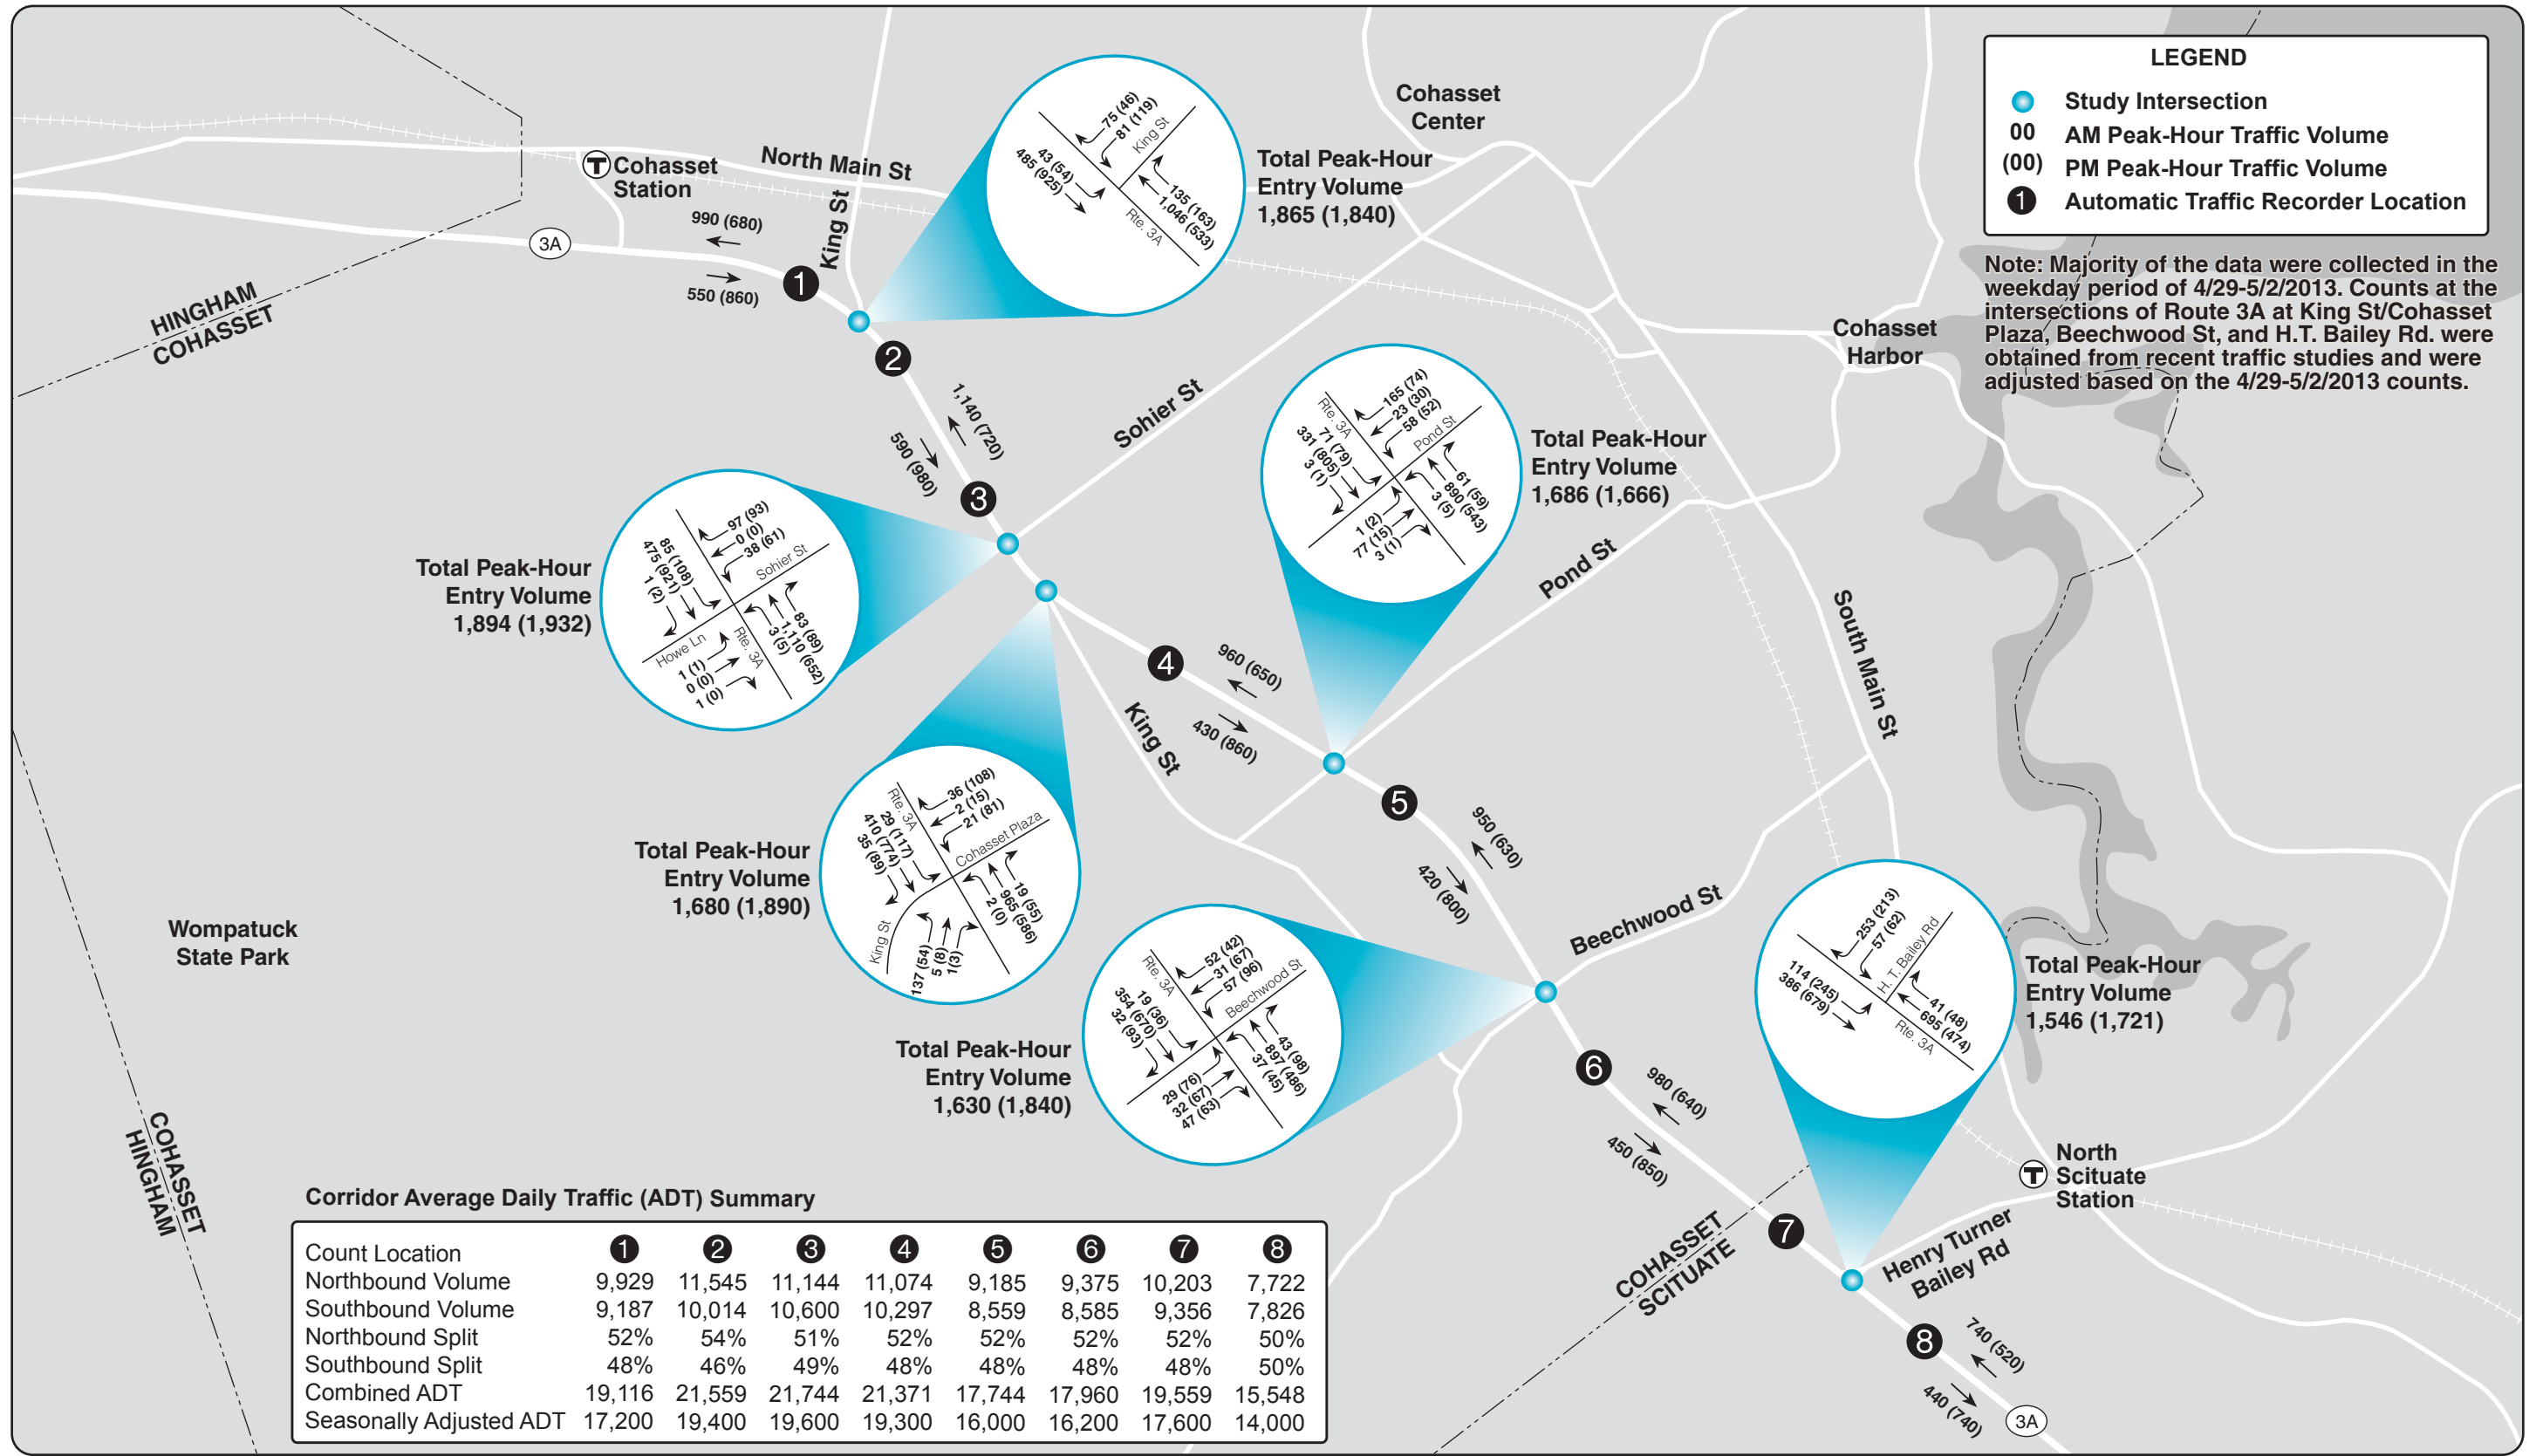
FIGURE 7
Traffic Volumes along the Corridor at Major Intersections
Route 3A in Cohasset and Scituate

Figure 7 shows traffic volumes along Route 3A and at major intersections in the study corridor. The volumes represent recently observed traffic flows in the

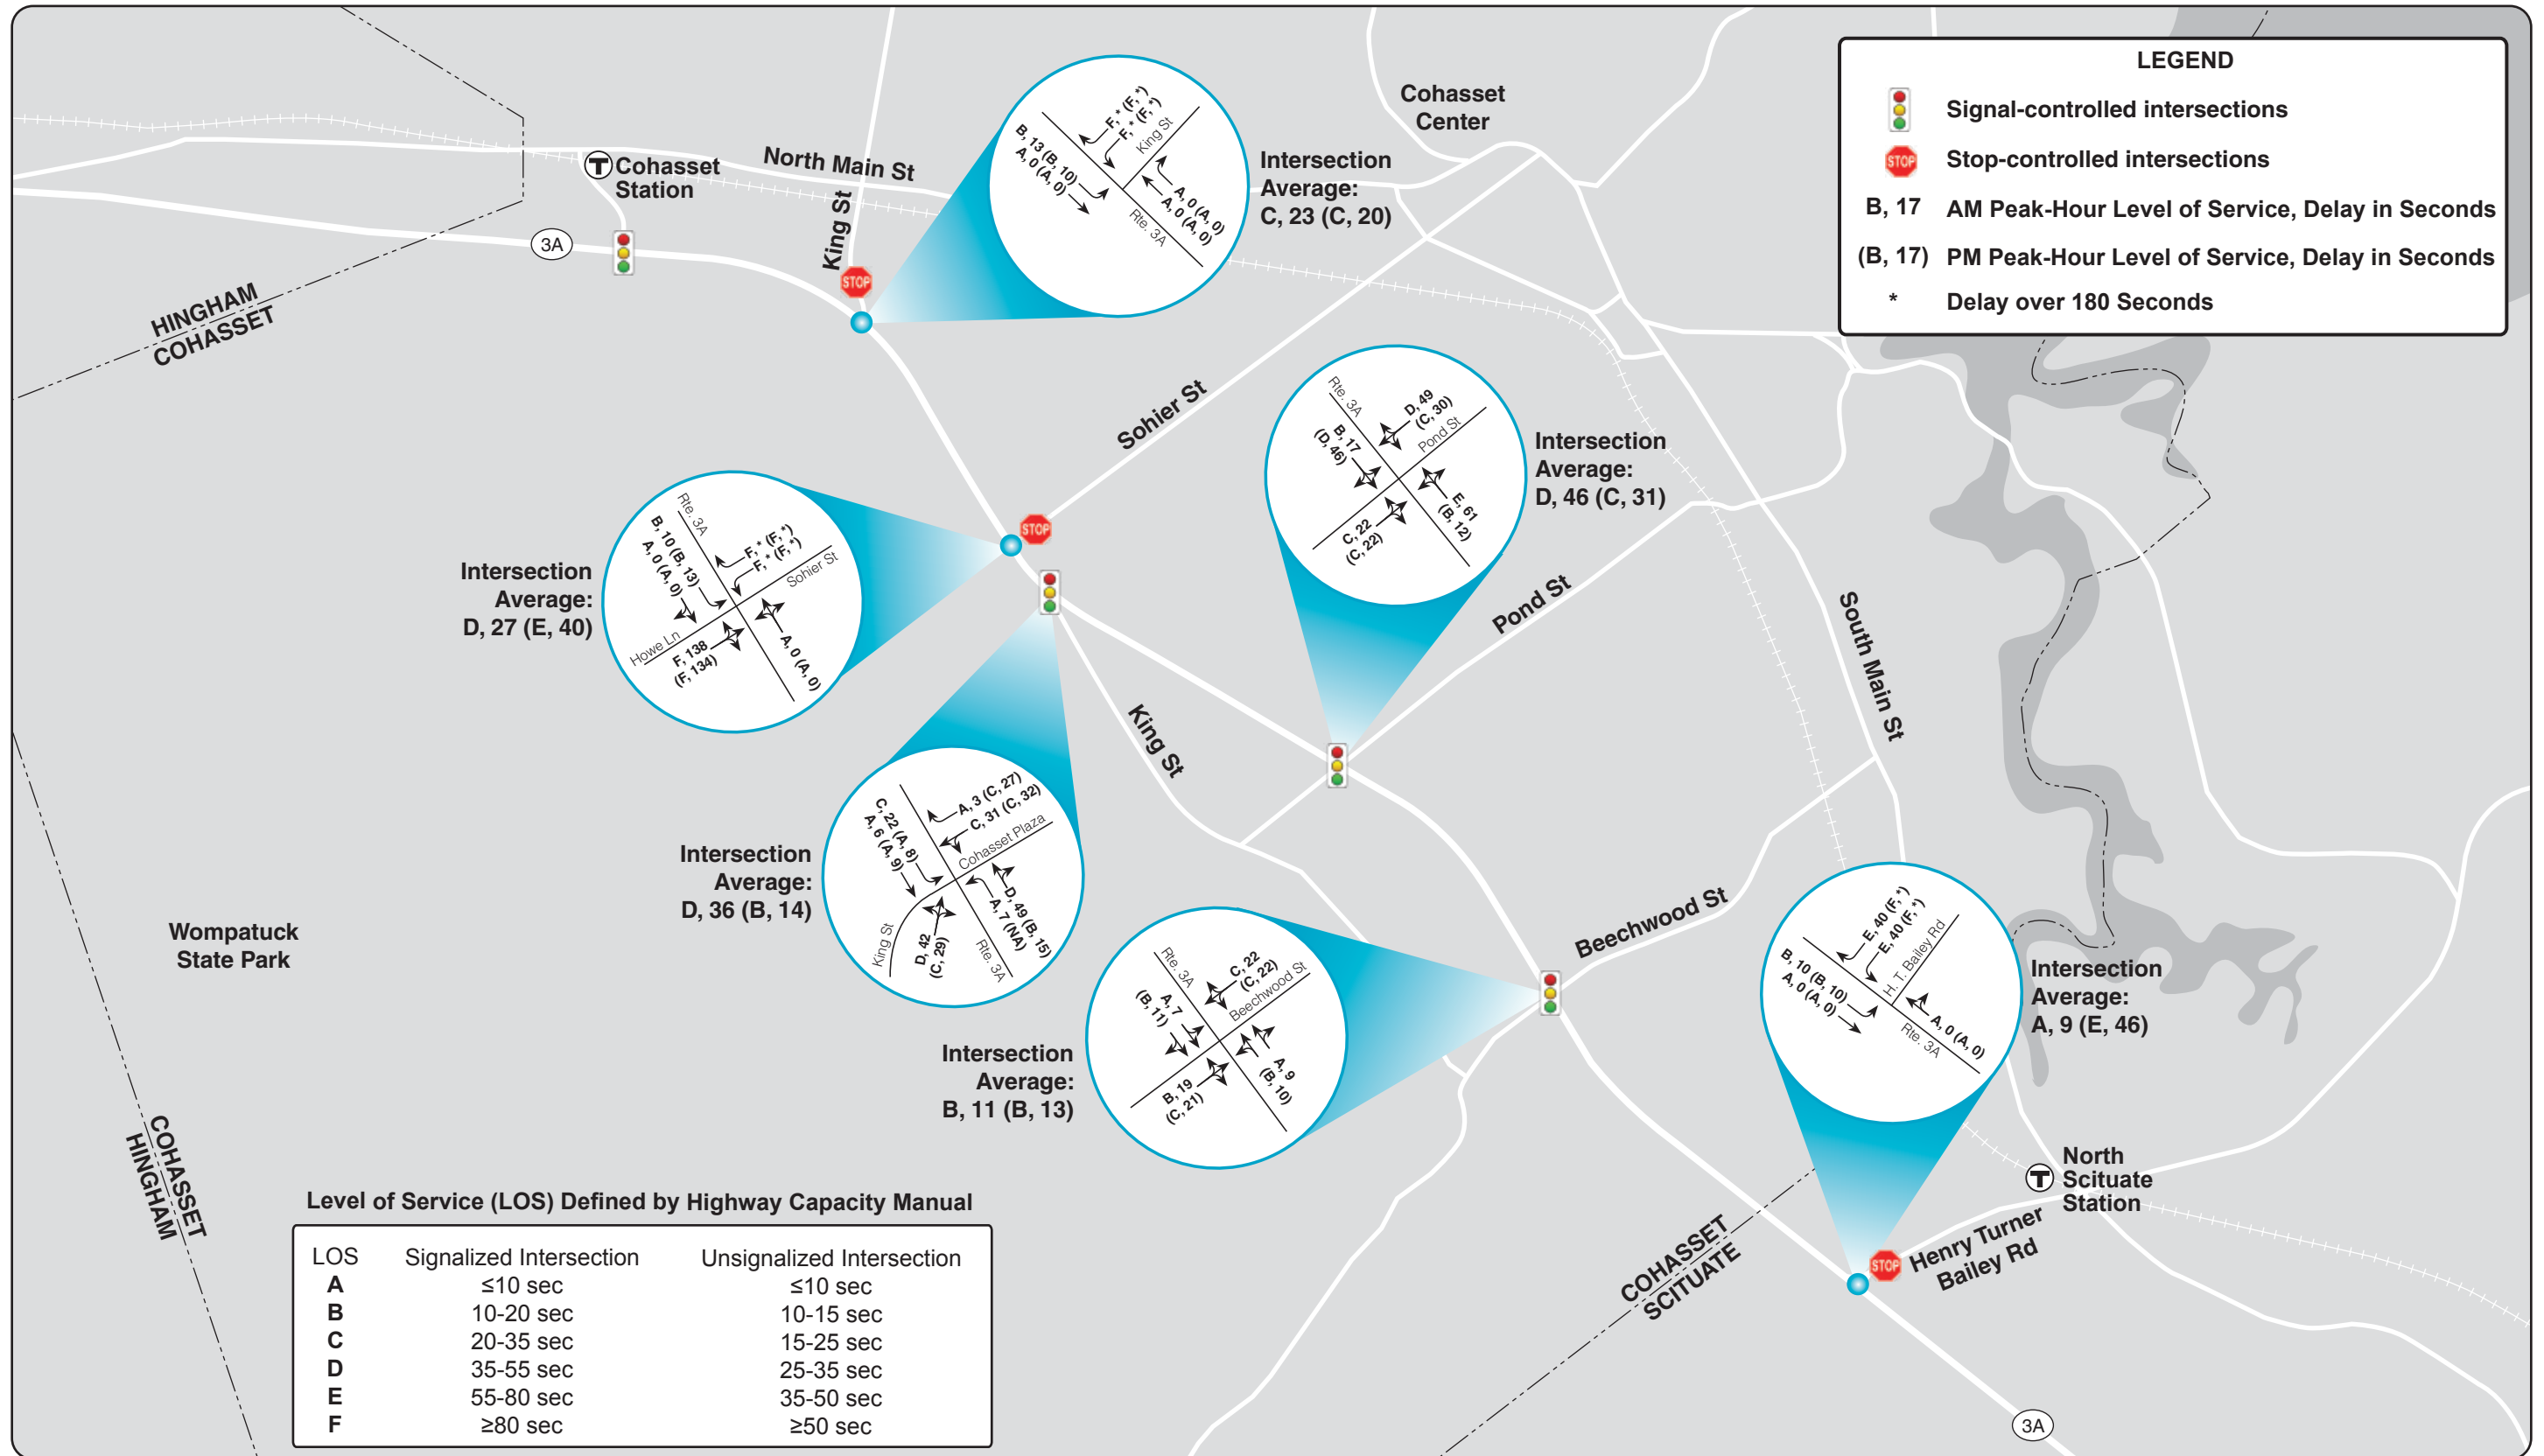
morning and evening peak hours of a typical weekday. As a reference, average daily traffic (ADT) volumes at eight locations in the corridor also are cited in Figure 7.

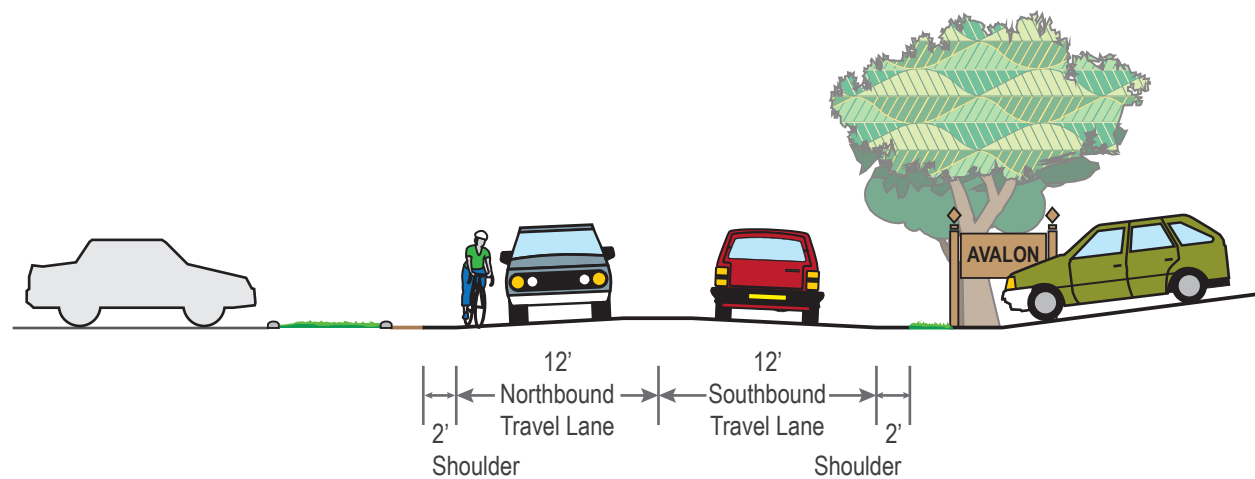
Two-Lane Cross-Section in North Business District

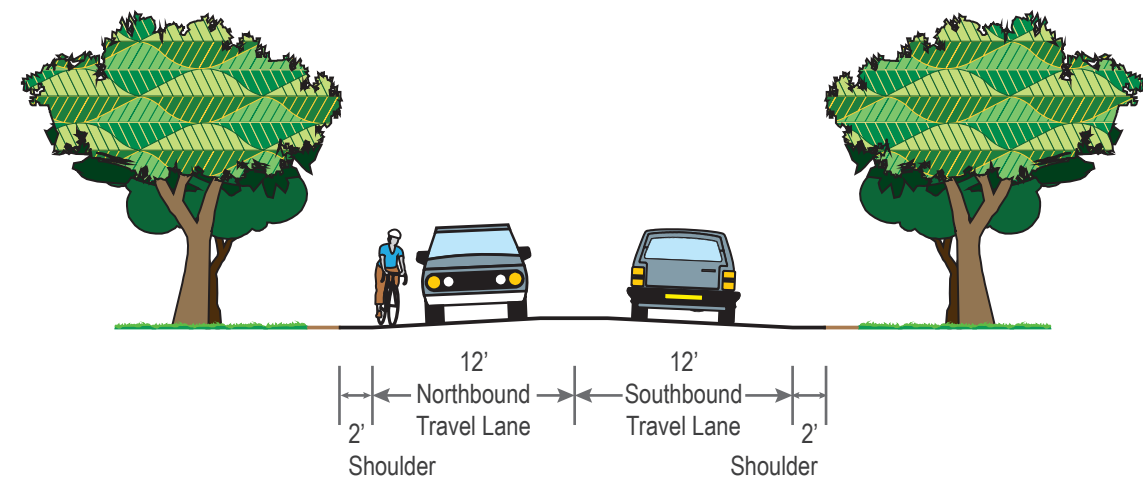
Two-Lane Cross-Section in Residential District

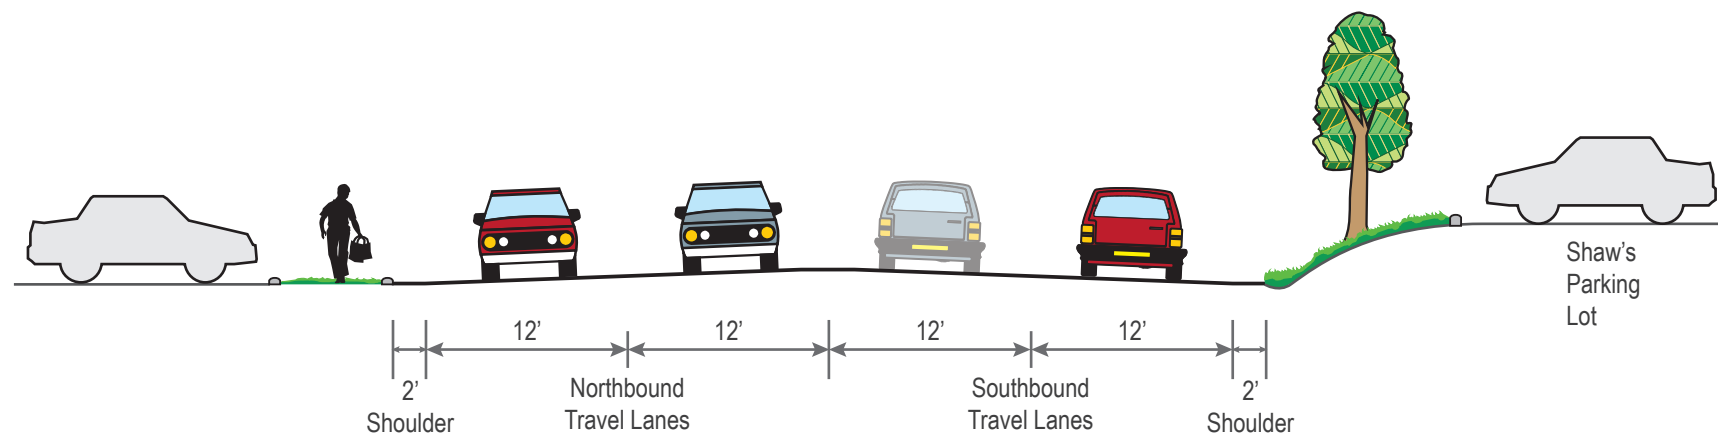
Four-Lane Cross-Section in South Business District

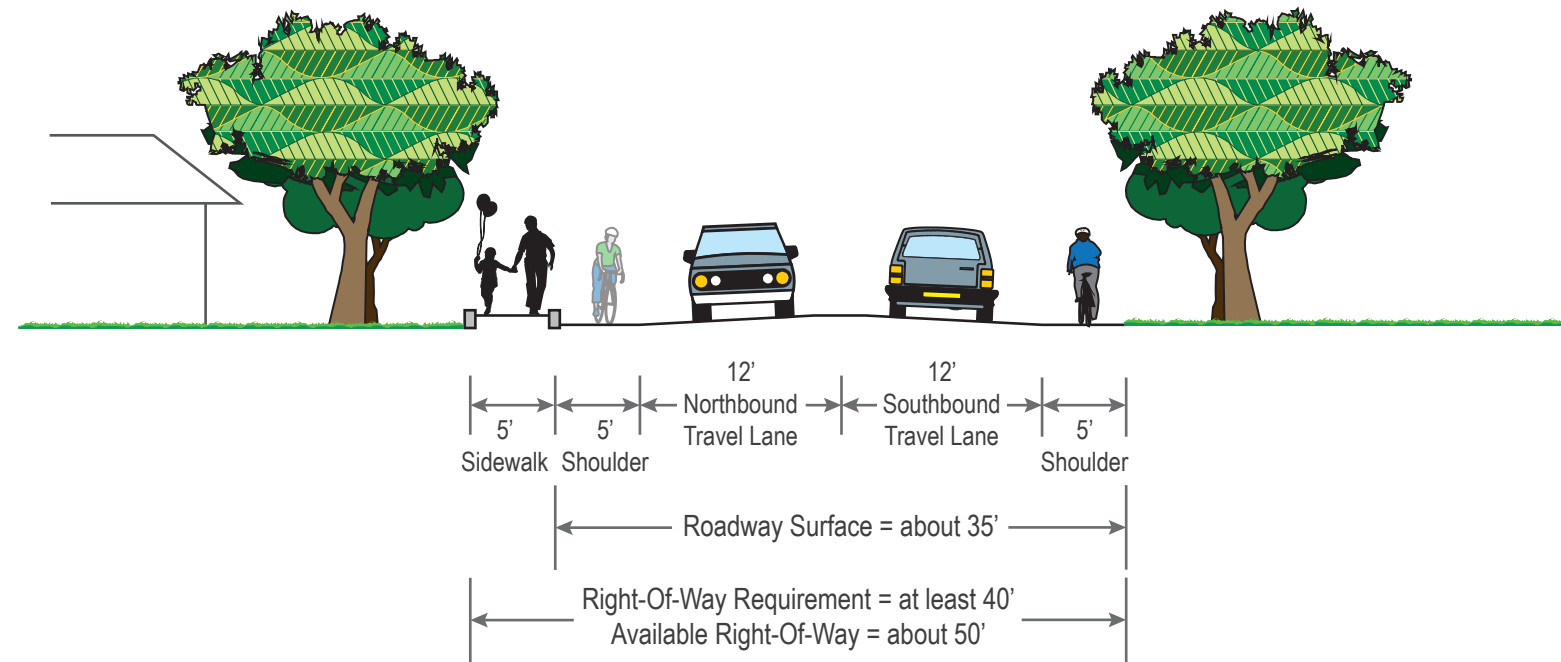
Proposed Cross-Section in Residential District

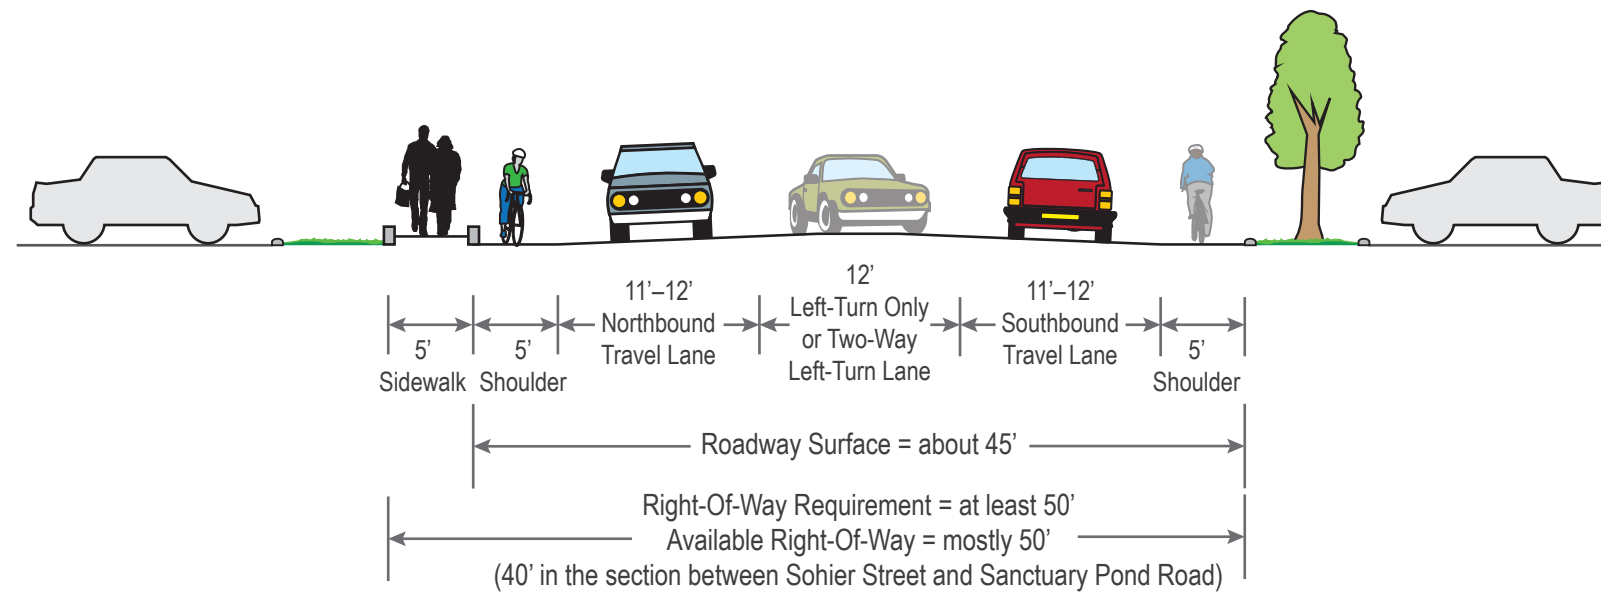
Proposed Cross-Section in Business Districts

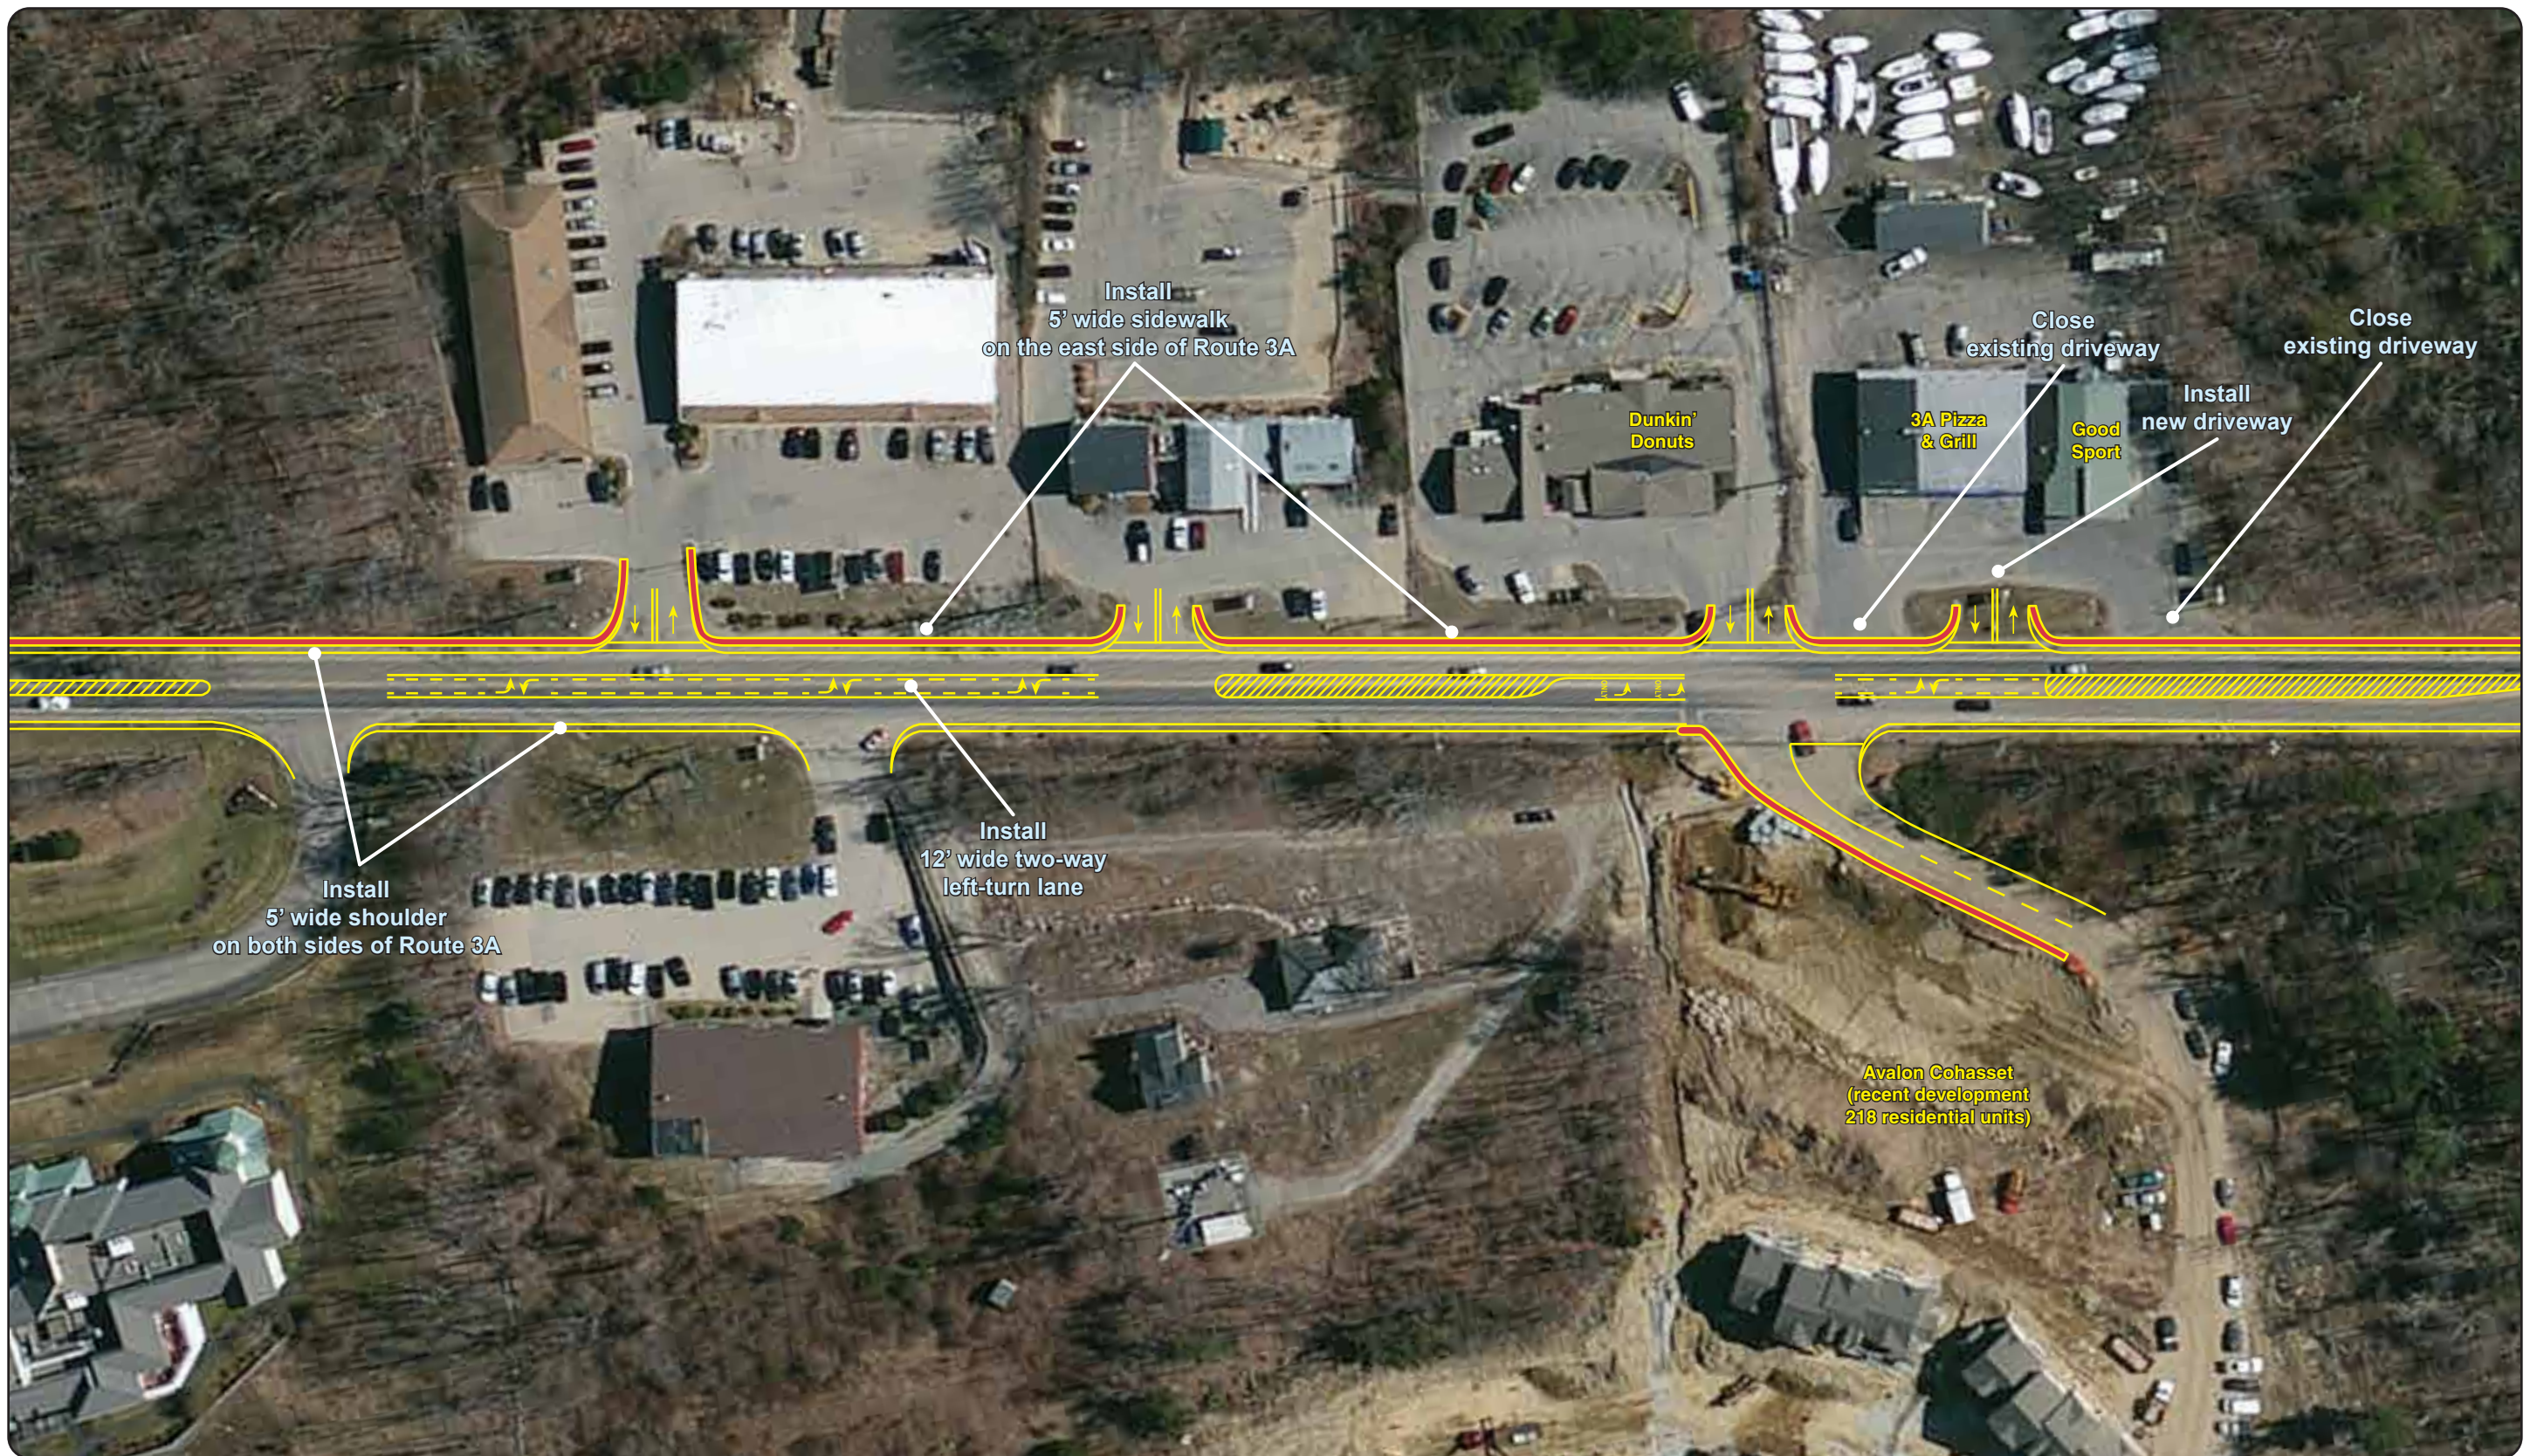
FIGURE 11
Proposed Long-Term Improvements Conceptual Plan
Route 3A North Section (1)

Figures 11 and 12 show the locations and layouts of the proposed long-term improvements in two parts of a conceptual plan for the north section of the study corridor. The conceptual plan was not created to scale, but in approximate proportion, in order to show how the proposed improvements would relate to their surroundings.

layouts of the proposed improvements for the section between Sanctuary Pond Road and Sohier Street (Figure 11) also could be applied to this area.

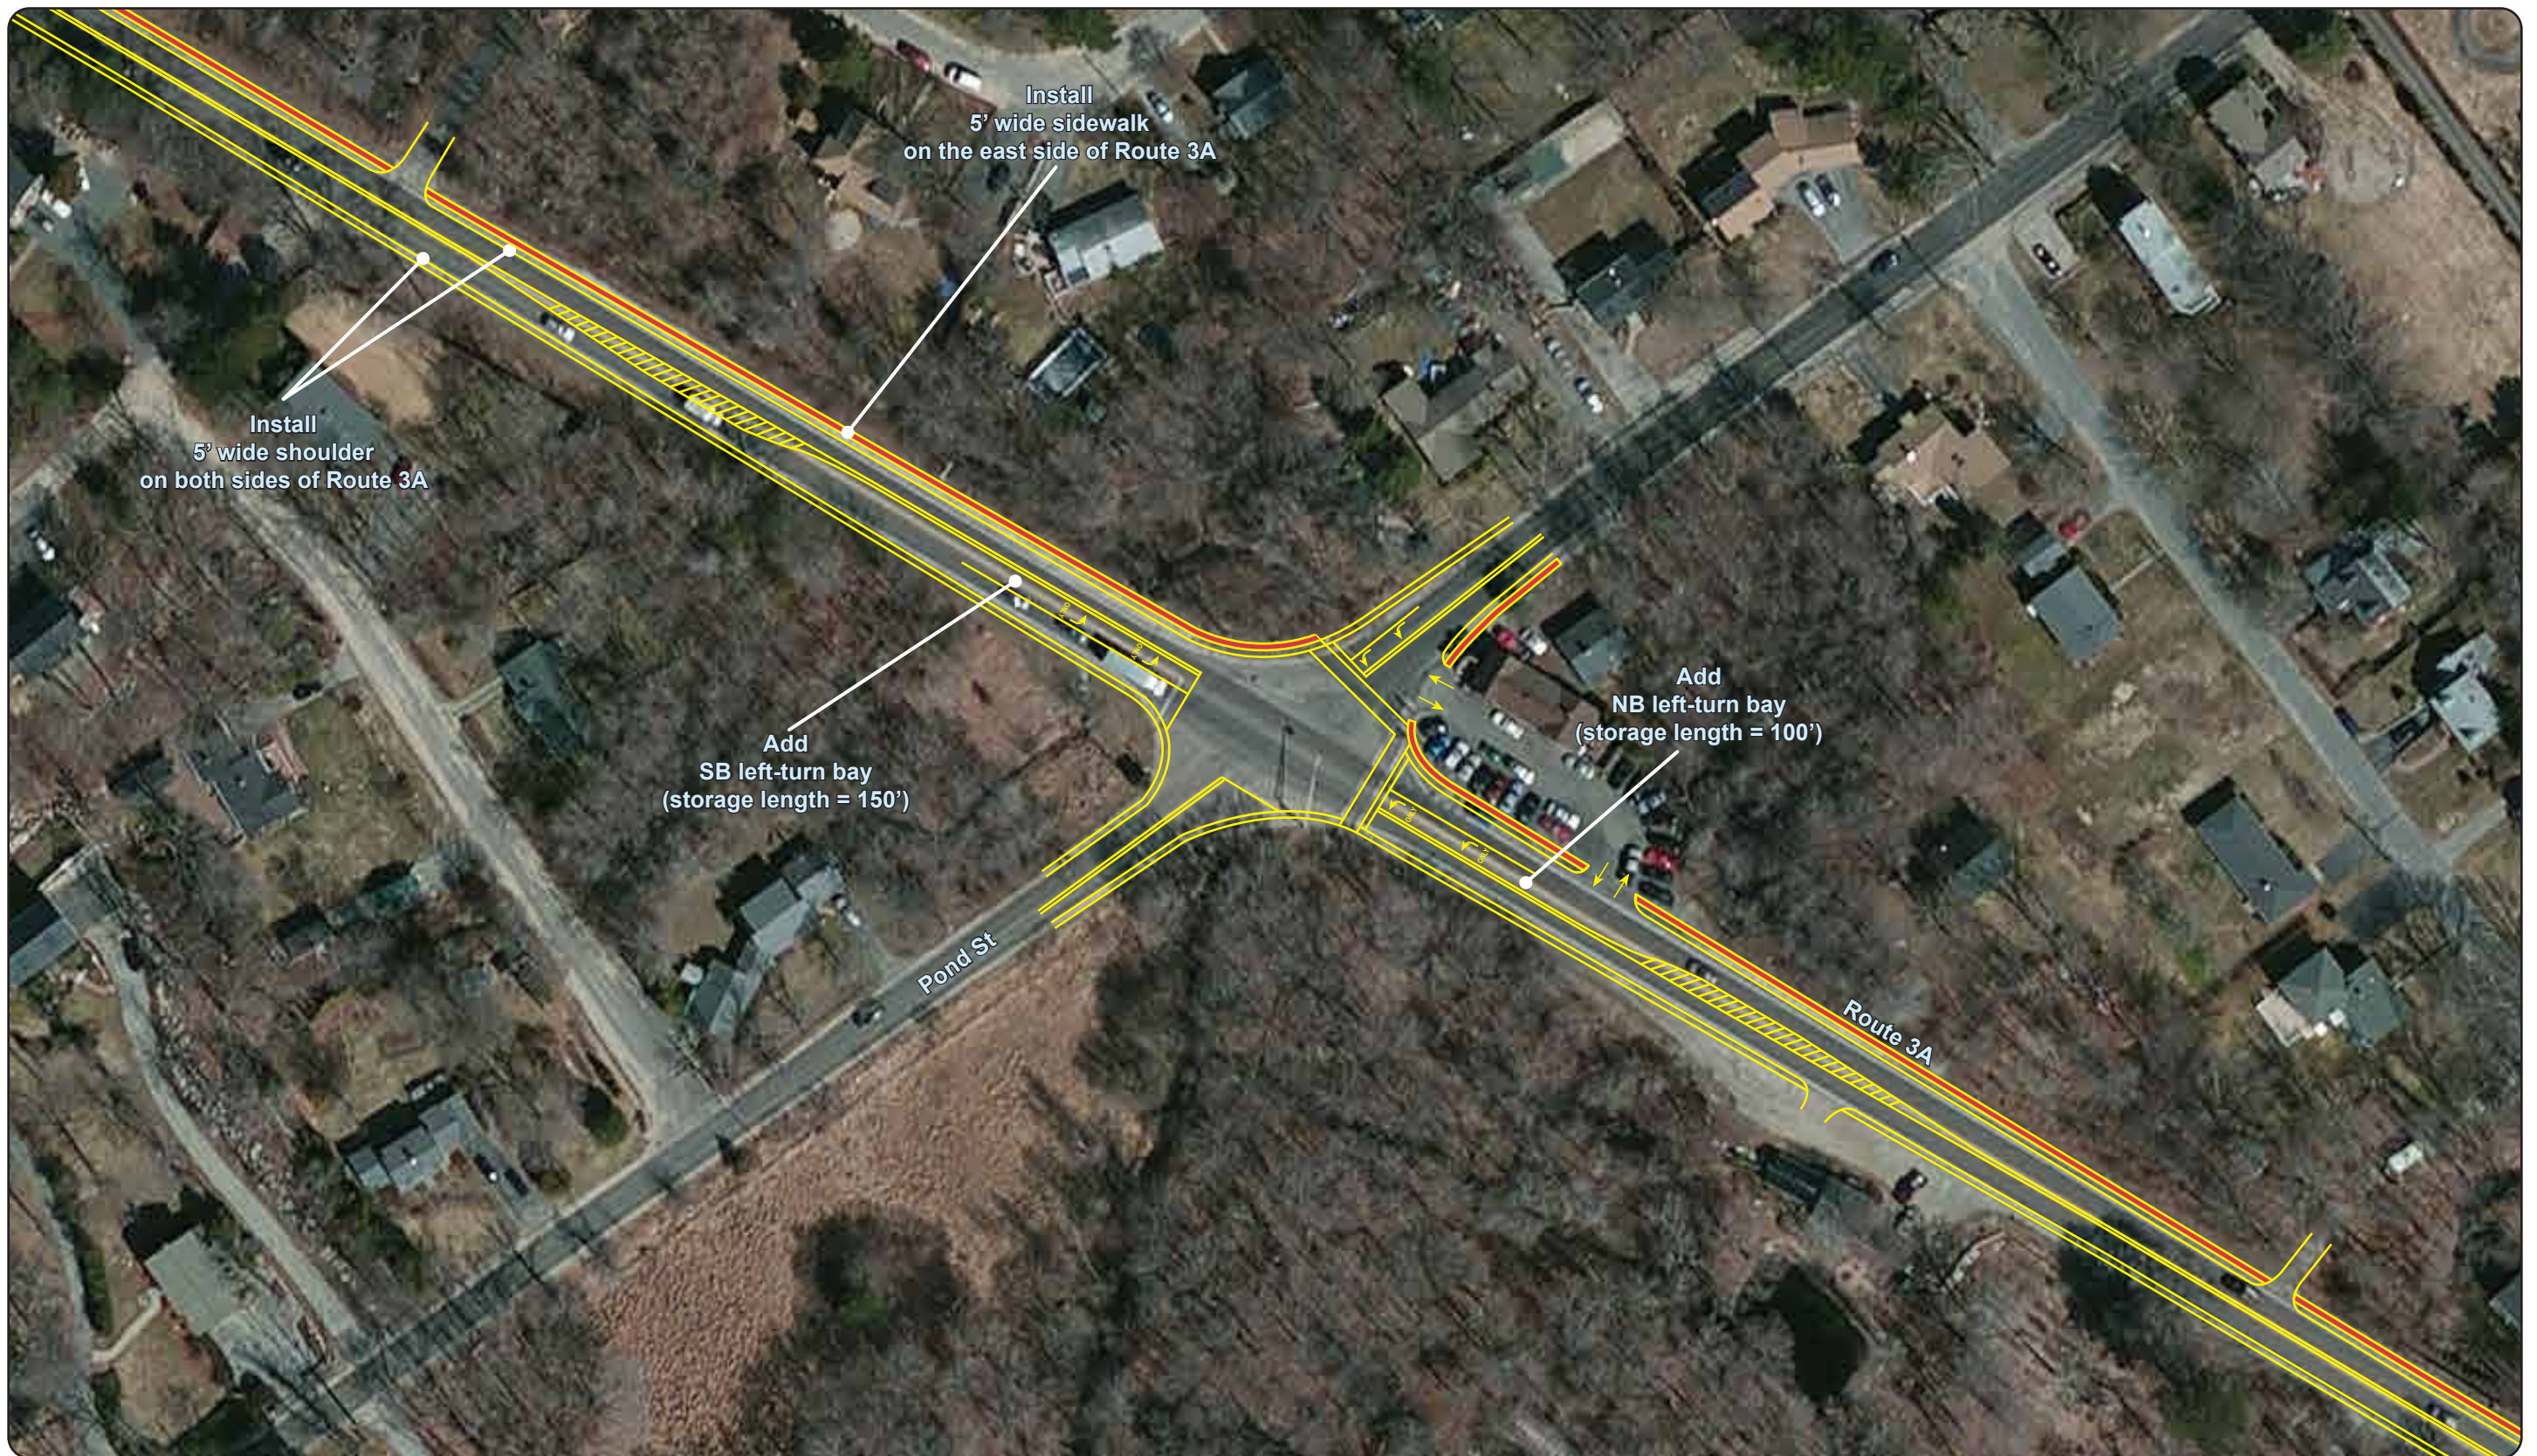
FIGURE 13
Proposed Long-Term Improvements Conceptual Plan
Route 3A Middle Section

Figure 13 shows the conceptual plan for the proposed long-term improvements in the vicinity of this intersection.

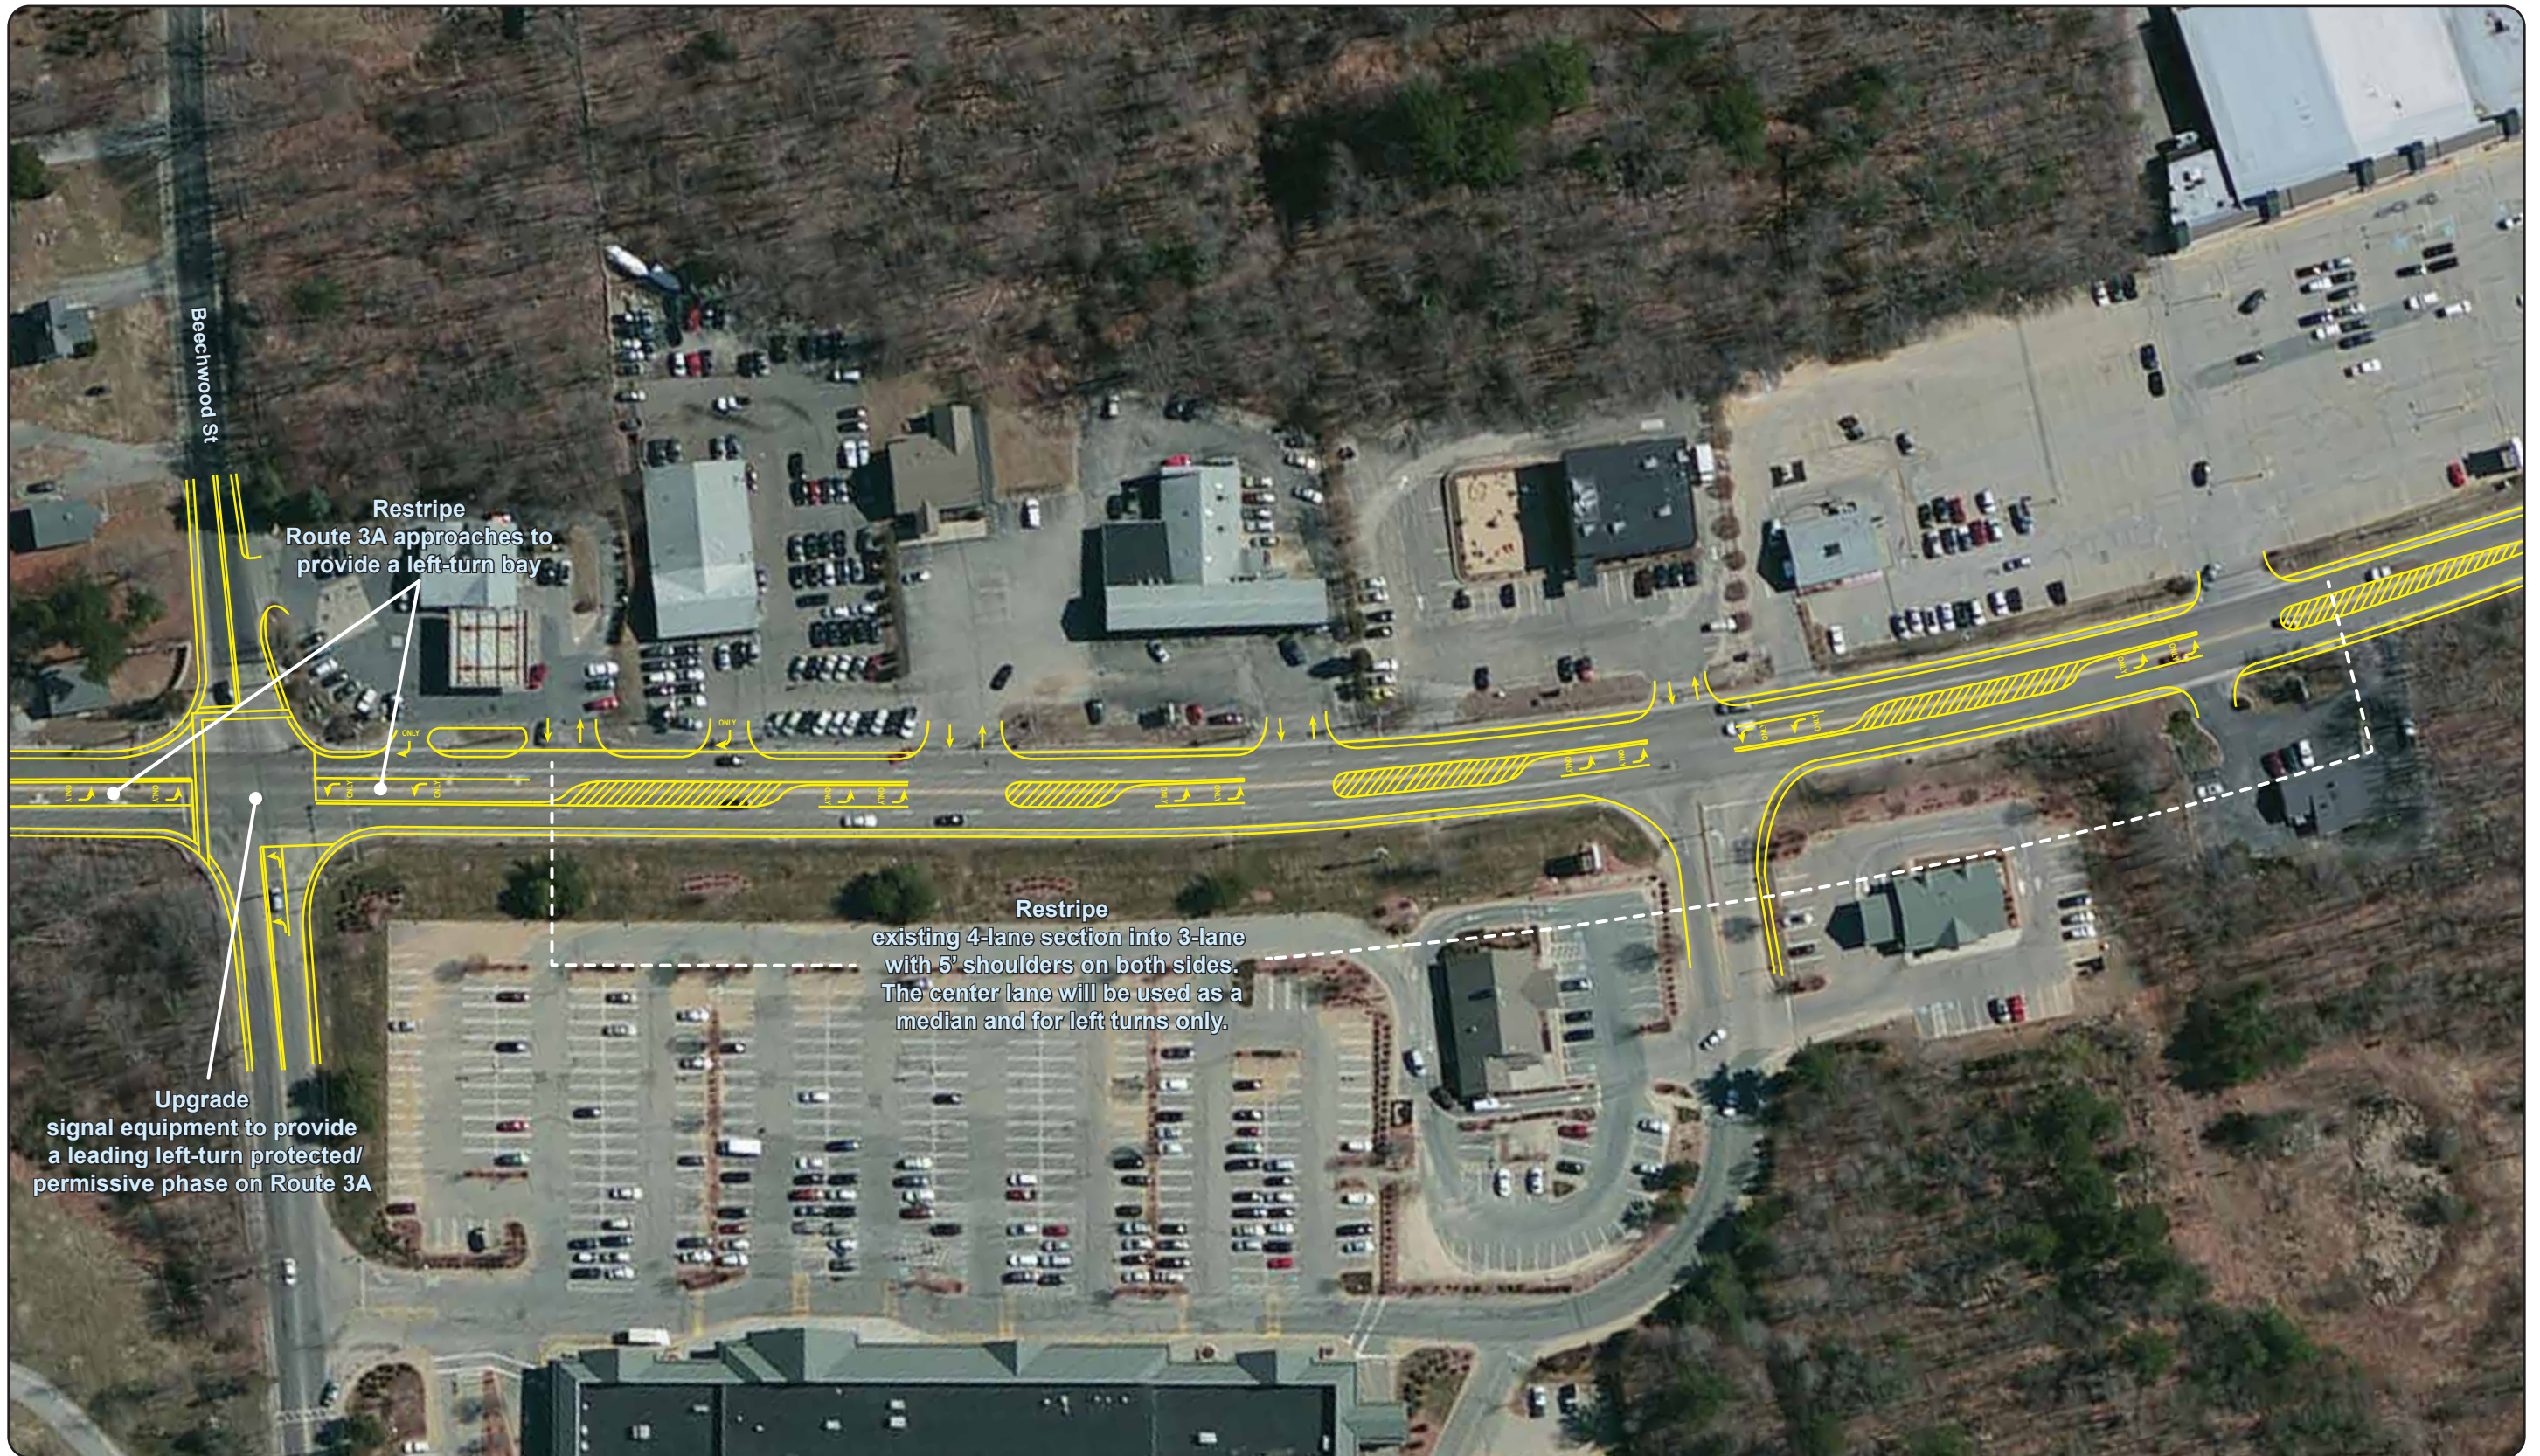
Figure 14 shows the proposed medium-term improvements for the Beechwood Street intersection and the section south of Beechwood Street. Figures 15, 16, and 17 show the proposed long-term improvements for the all the business districts in four parts of a conceptual plan for the south section.
