BOSTON REGION METROPOLITAN PLANNING ORGANIZATION

MEMORANDUM

DATE: January 23, 2014
TO: Boston Region Metropolitan Planning Organization (MPO)
FROM: Chen-Yuan Wang, MPO Staff
RE: Route 3A Subregional Priority Roadway Study in Cohasset and Scituate

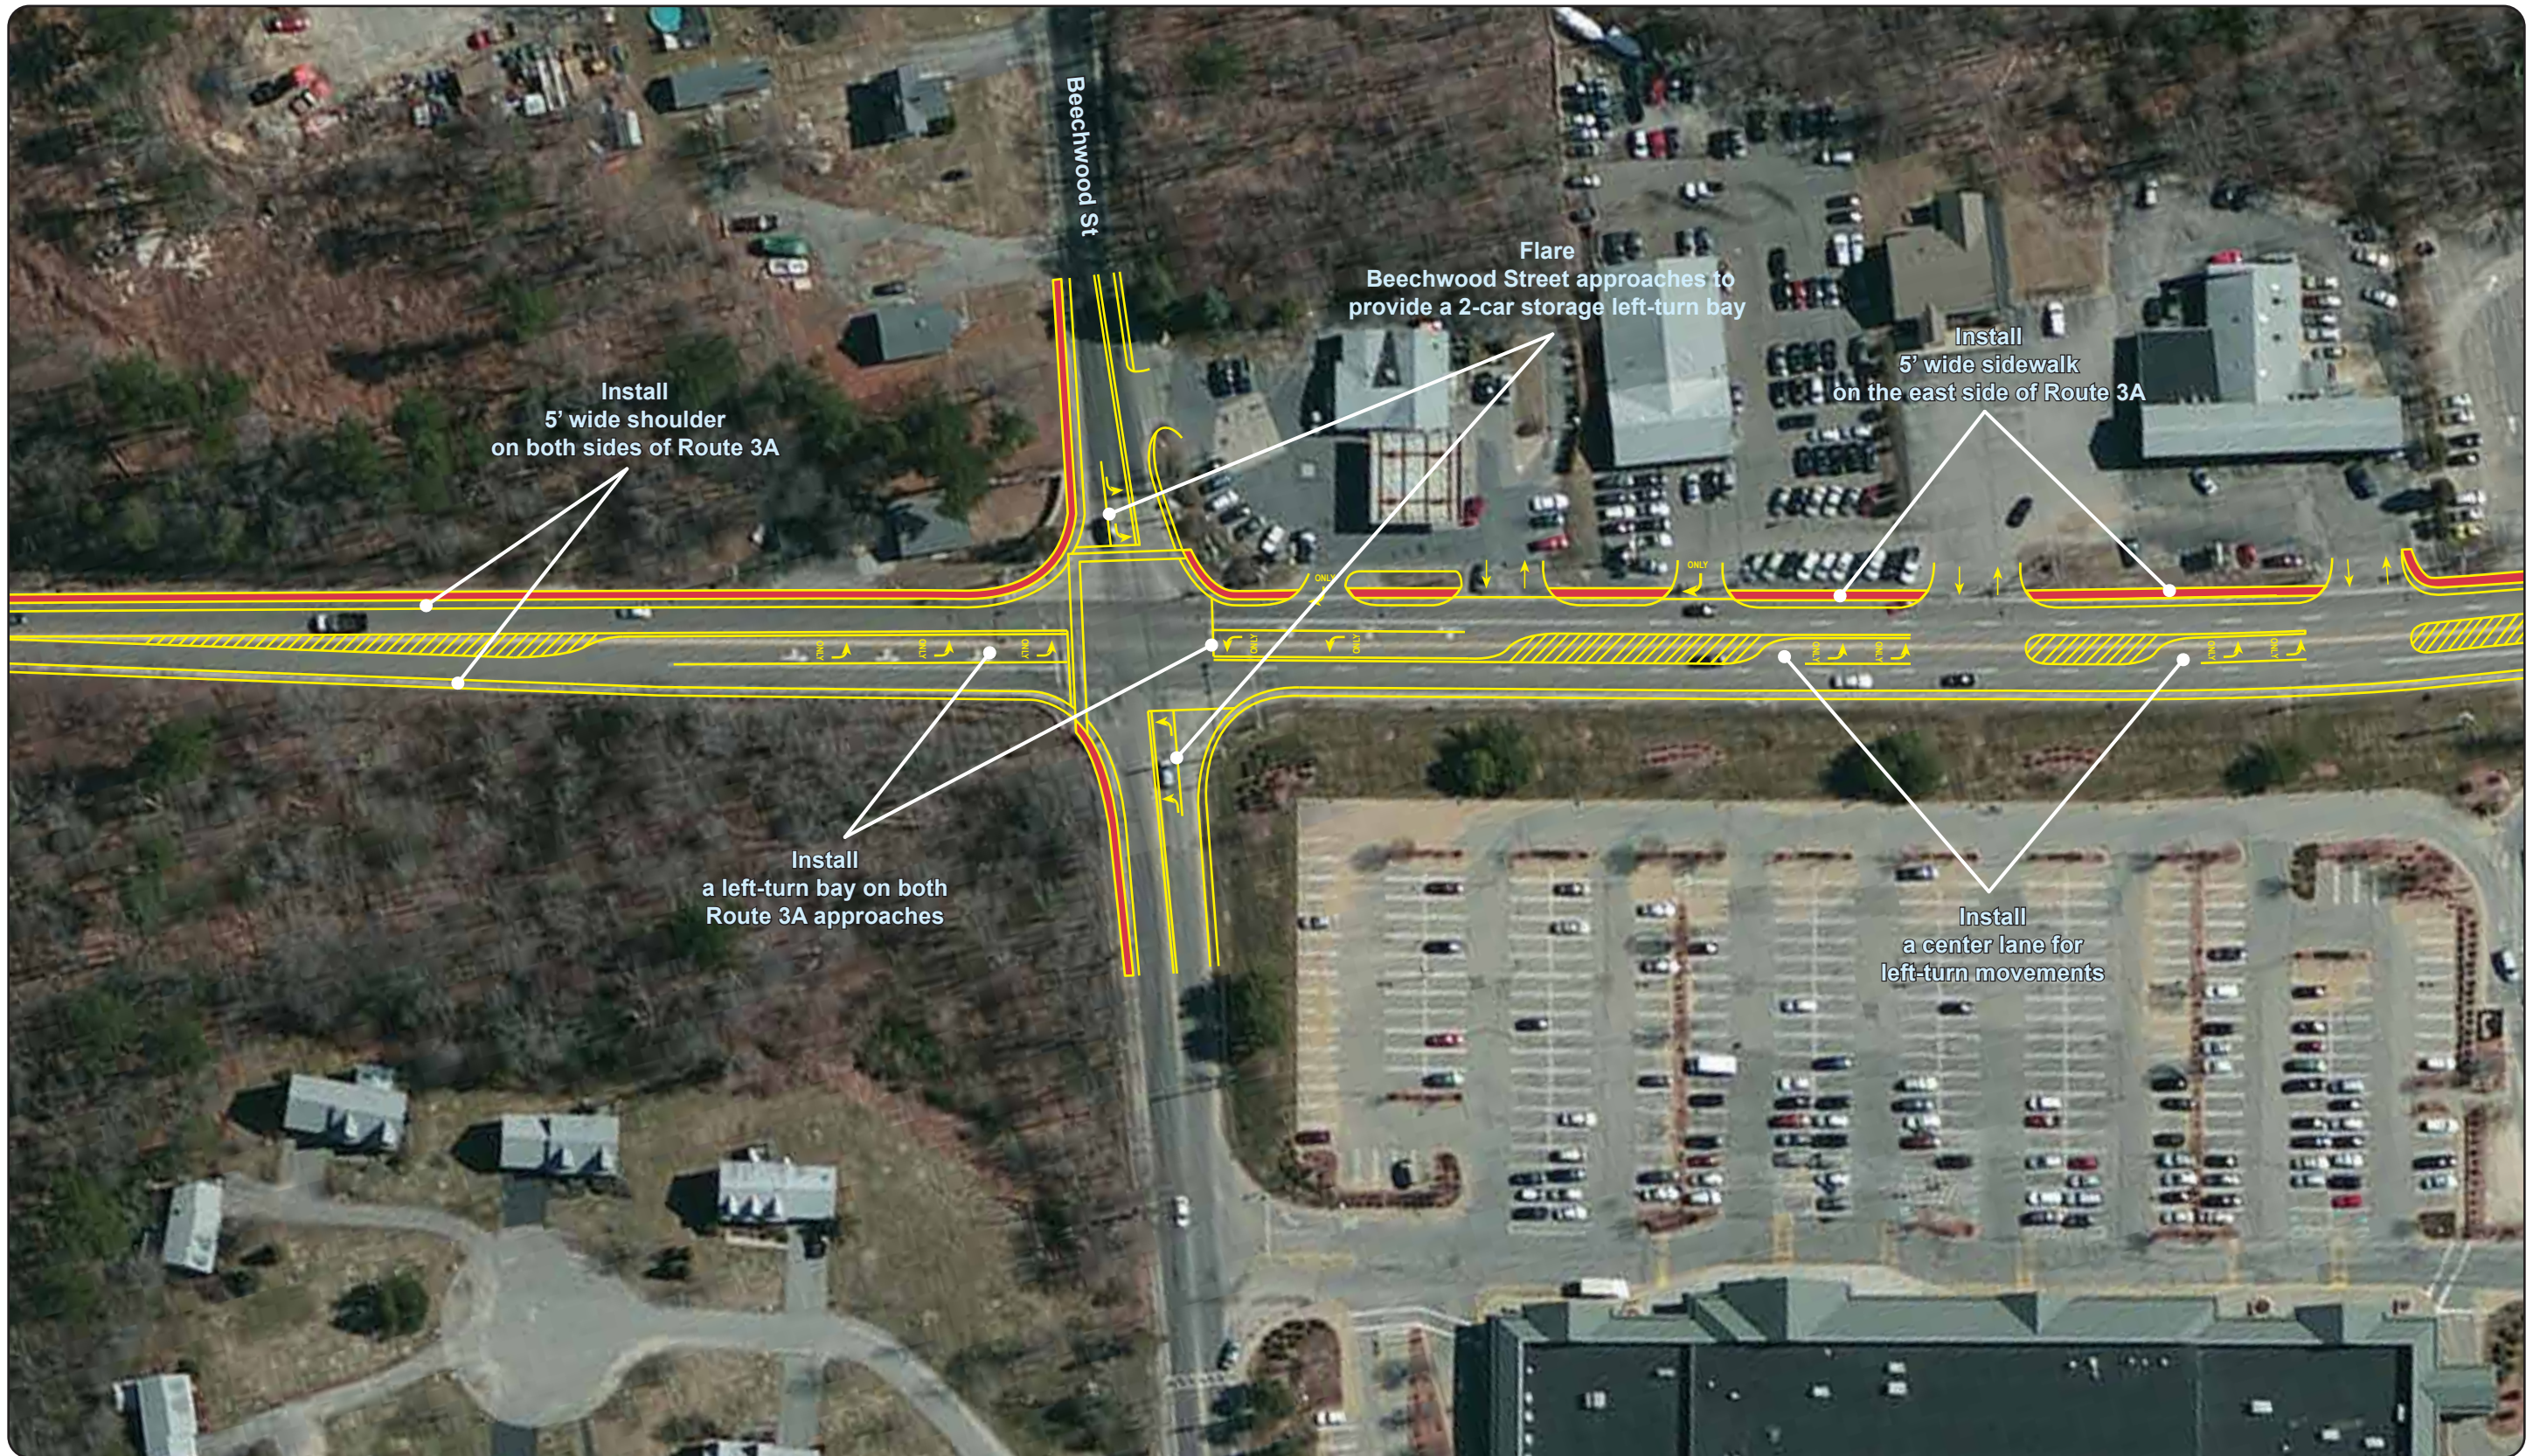
FIGURE 15
Proposed Long-Term Improvements Conceptual Plan
Route 3A South Section (1)

Figure 14 shows the proposed medium-term improvements for the Beechwood Street intersection and the section south of Beechwood Street. Figures 15, 16, and 17 show the proposed long-term improvements for the all the business districts in four parts of a conceptual plan for the south section.

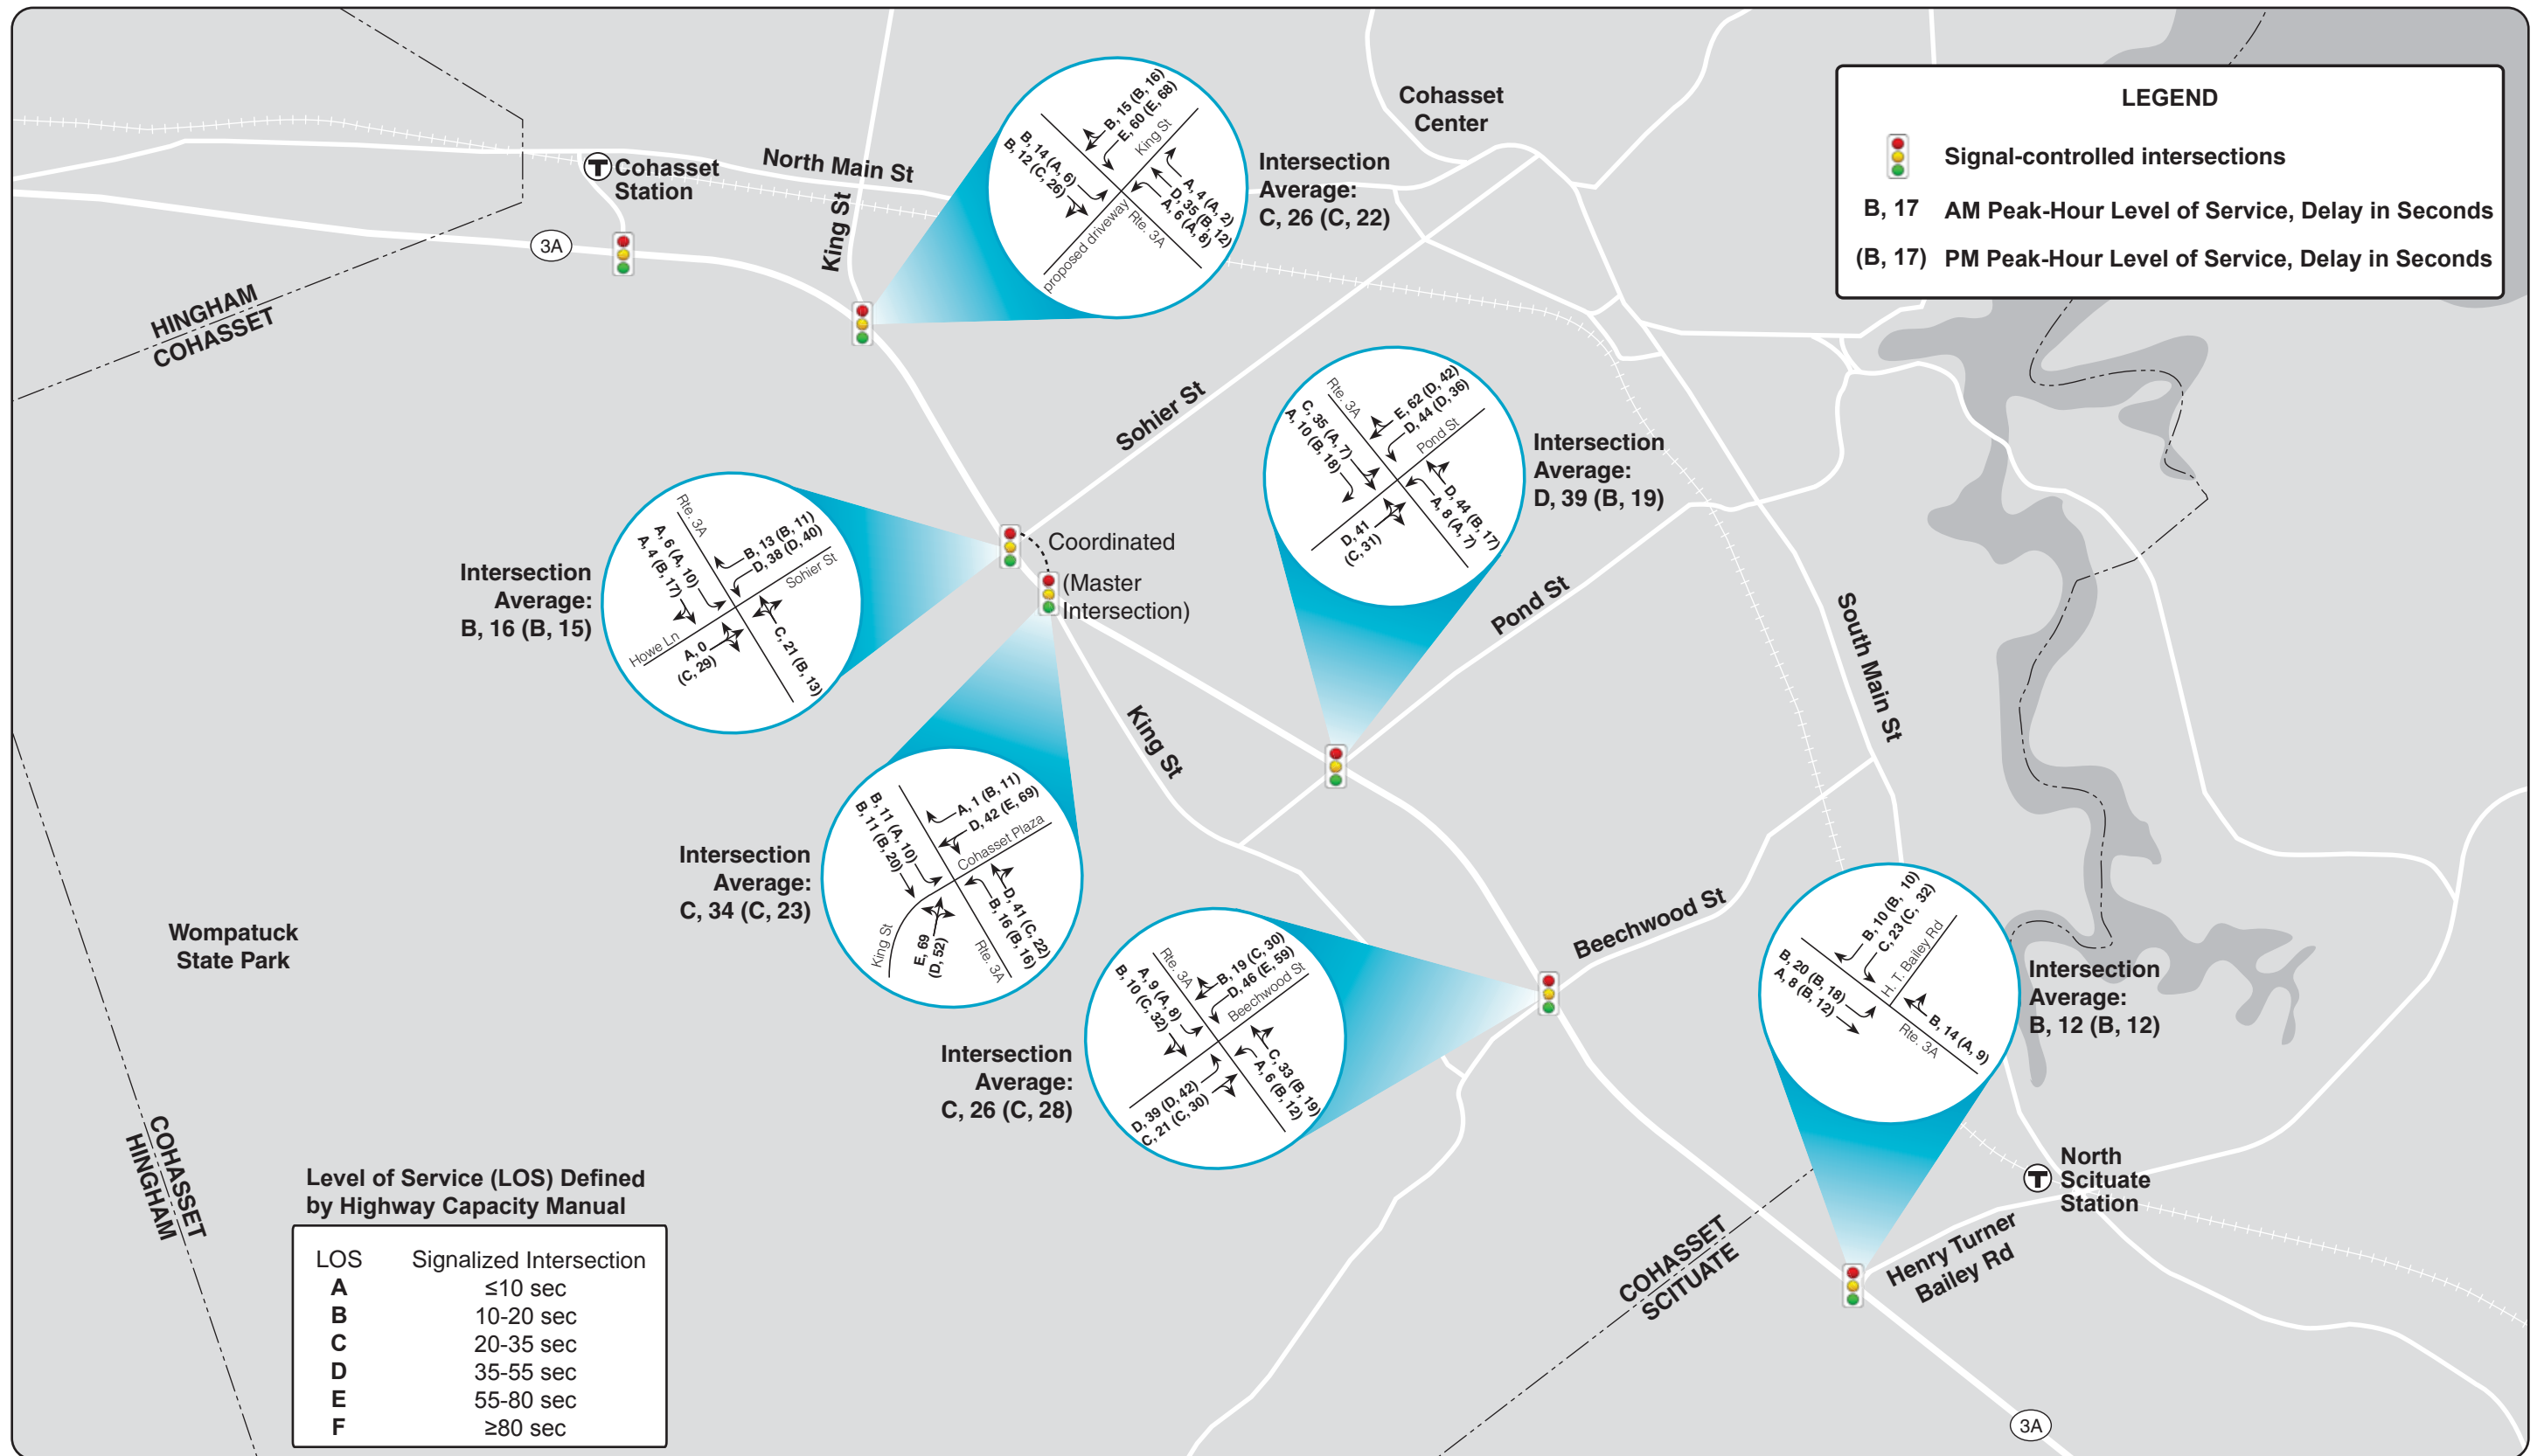
FIGURE 18
Intersection Capacity Analyses: Future Year (2020) Conditions with Proposed Long-Term Improvements
Route 3A in Cohasset and Scituate

In summary, with the proposed long-term improvements in the north, middle, and south sections of the study corridor, all intersections are expected to operate at a desirable or acceptable LOS under the projected 2020 traffic conditions (Figure 18). Analysis of the Beechwood Street intersection indicates that conversion of the four-lane section into a three-lane roadway would not seriously affect traffic operations on Route 3A.²⁵
