MEMORANDUM

DATE November 15, 2012
TO Boston Region MPO
FROM Seth Asante and Efi Pagitsas
MPO Staff
RE FFY 2012 Community Transportation Technical Assistance Program:
Danvers Rail Trail Crossing at Poplar Street

Introduction

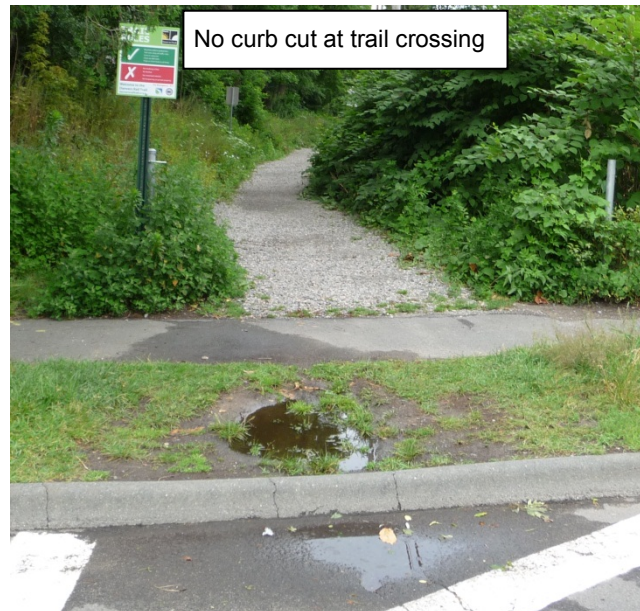
Figure 1 shows the study area, land use, and the Danvers Rail Trail crossing at Poplar Street. The trail crossing at Poplar Street is located about 450 feet east of the intersection of Locust Street and Poplar Street, a very busy signalized intersection. Poplar Street and Locust Street, in the vicinity of the Danvers Rail Trail crossing, are owned and maintained by the Town of Danvers. The land use in the vicinity of the rail-trail crossing is primarily residential, and the Holten Richmond Middle School is located about 0.4 miles east of the trail crossing.

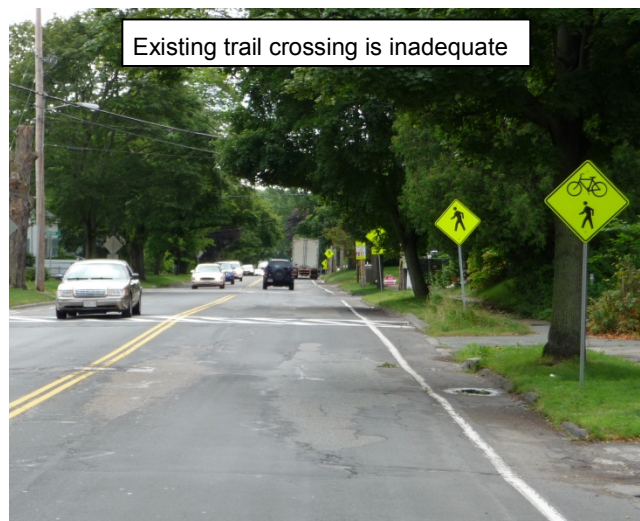
Poplar Street is part of Route 62, a major roadway connecting Middleton to the west and Beverly to the east. In addition, it is a major roadway providing access to Route 128, Interstate 95, and Route 1. It is classified as an urban principal arterial, and carries about 20,000 vehicles per weekday according to MassDOT roadway inventory file. The percent of heavy vehicles in the mix is in the range of 1 to 2 percent. During each peak hour (AM or PM), between 1,700 and 2,000 vehicles (both directions combined) cross the trail at Poplar Street (Figure 2).

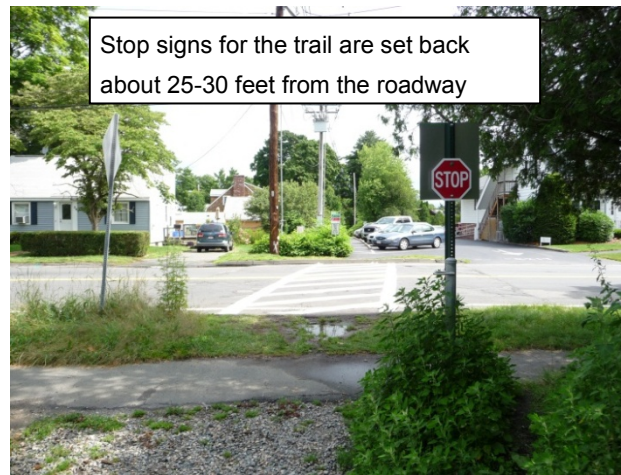
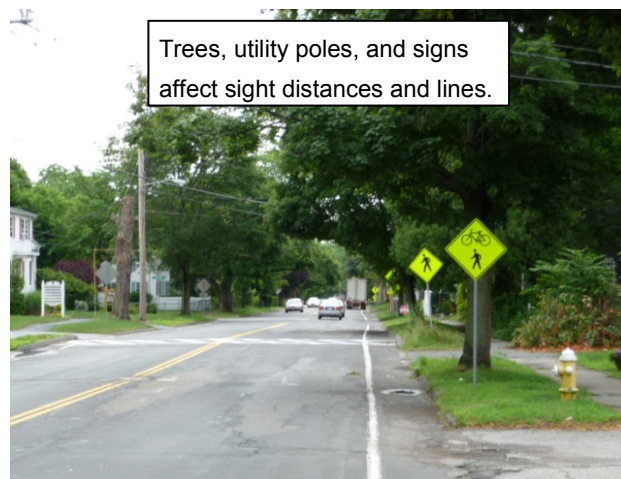
Trail user volume counts conducted in July 2011 by the Town of Danvers are shown in Figures 3 and 4. The counts were conducted by using video cameras along the trail. During the time when the trail-user volume counts were conducted, the trail was not officially open; hence the number of users was expected to increase after its official opening, last month (June 2012). The results of the counts indicate that the highest number of trail users occurs on weekends—between 233 and 261 people. The counts also show that there is significant usage during the workdays; during each of the AM, midday, and PM peak hours, an average of about 20 people use the Poplar Street trail crossing. The Town of Danvers submitted recent trail counts conducted between August 4 and August 11 at the Poplar Street crossing looking south of the trail (Table 1). During the counting, it was observed that some trail users turn back at the Poplar Street intersection and do not cross it. In addition, it was observed that of over 600 bike riders, only one walked their bike.

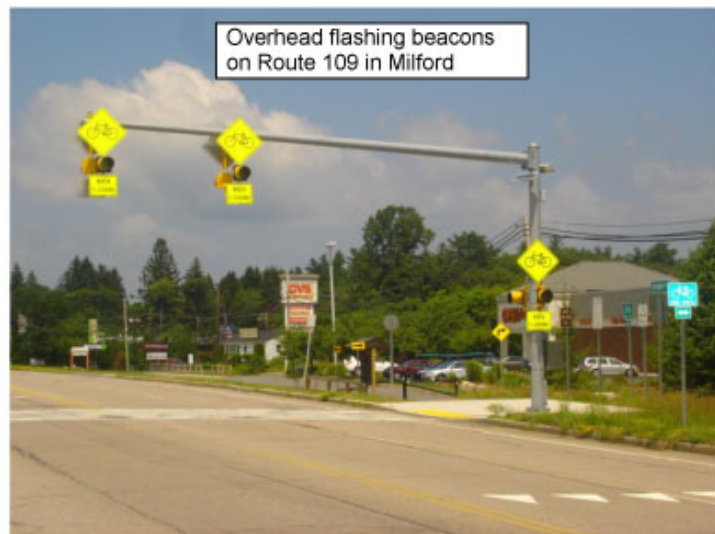
FIGURE 5
Signing and Pavement Markings for
Proposed Trail Crossing at Poplar Street

Figure 5 shows the proposed signing and pavement markings for the Poplar Street trail crossing. Figure 6 shows the pedestrian-activated flashing beacon proposed for the Danvers trail crossing at Poplar Street. The assembly consists of the installation of the four-beacon system at the Poplar Street trail crossing. For each approach to the trail's crosswalk, a pedestrian-activated flashing beacon is installed on the left and right sides of the roadway at the crosswalk. The flashing beacon is mounted directly below the standard crosswalk or trail crosswalk warning signs, including W11-15 (shared-use trail crossing) and W11-15P (trail crossing) signs, and above the diagonal downward arrow (W16-7p) plaque. Another flashing beacon is mounted above the shared-use trail crossing sign. In addition to the flashing beacon system, the following crosswalk improvements are proposed for the trail crossing at Poplar Street:

Figure 5: Signing and Pavement Marking for Proposed Trail Crossing at Poplar Street

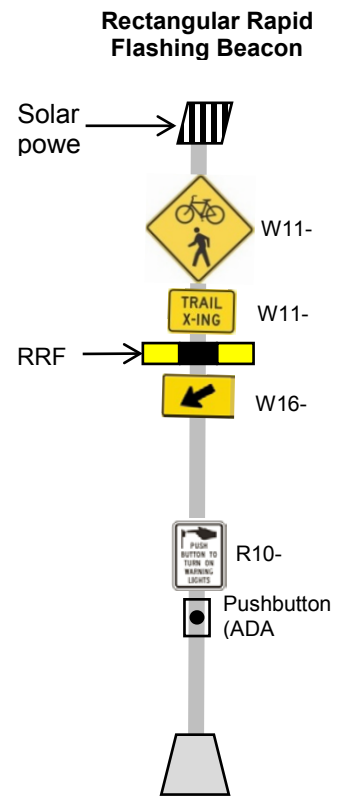
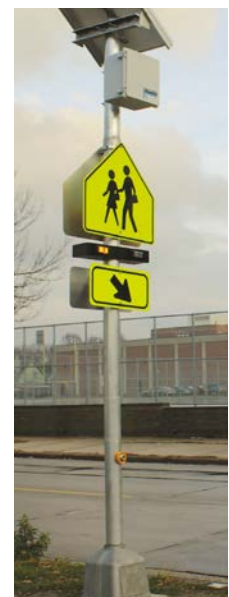
RRFB by TAPCO (Traffic & Parking Control Co.)

RRFBs are pedestrian-activated amber LEDs that supplement warning signs at midblock crosswalks. They can be activated by pedestrians manually by a push button or passively by an automated pedestrian detection system (video or infrared). RRFBs remain dark (not active) until they are activated. RRFBs use a wig-wag flash patterning similar to emergency flashers on police vehicles, and may be installed on either two-lane or multi-lane roadways. RRFBs typically receive power by stand-alone solar panel units, but may also be wired to a traditional power source.

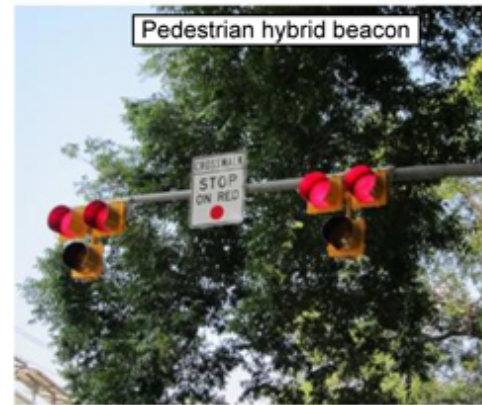
A PHB consists of:

- Two red lenses above a single yellow lens
- A crosswalk sign (R10-23) stop on red shown in the above PHB
- Pedestrian signal heads that provide "walk" and "don't walk" signals with or without a countdown display to inform pedestrians when it is safe to cross
- Pedestrian push-button activation (ADA-compliant) and an R10-25 sign at the roadside to activate the warning device

A pedestrian hybrid beacon, also known as the High-Intensity Activated crossWalk (HAWK) beacon, is a special type of hybrid beacon used to warn and control traffic at an unsignalized marked crosswalk to assist pedestrians in crossing a street or highway. It is usually considered for installation to facilitate pedestrian crossings at a location that does not meet traffic signal warrants, or at a location that meets traffic signal warrants but when a decision is made not to install a pedestrian crossing signal. Independent studies conducted by the Texas Transportation Institute found a PHB to be nearly as effective as a pedestrian crossing signal, with 97 percent motorist compliance.

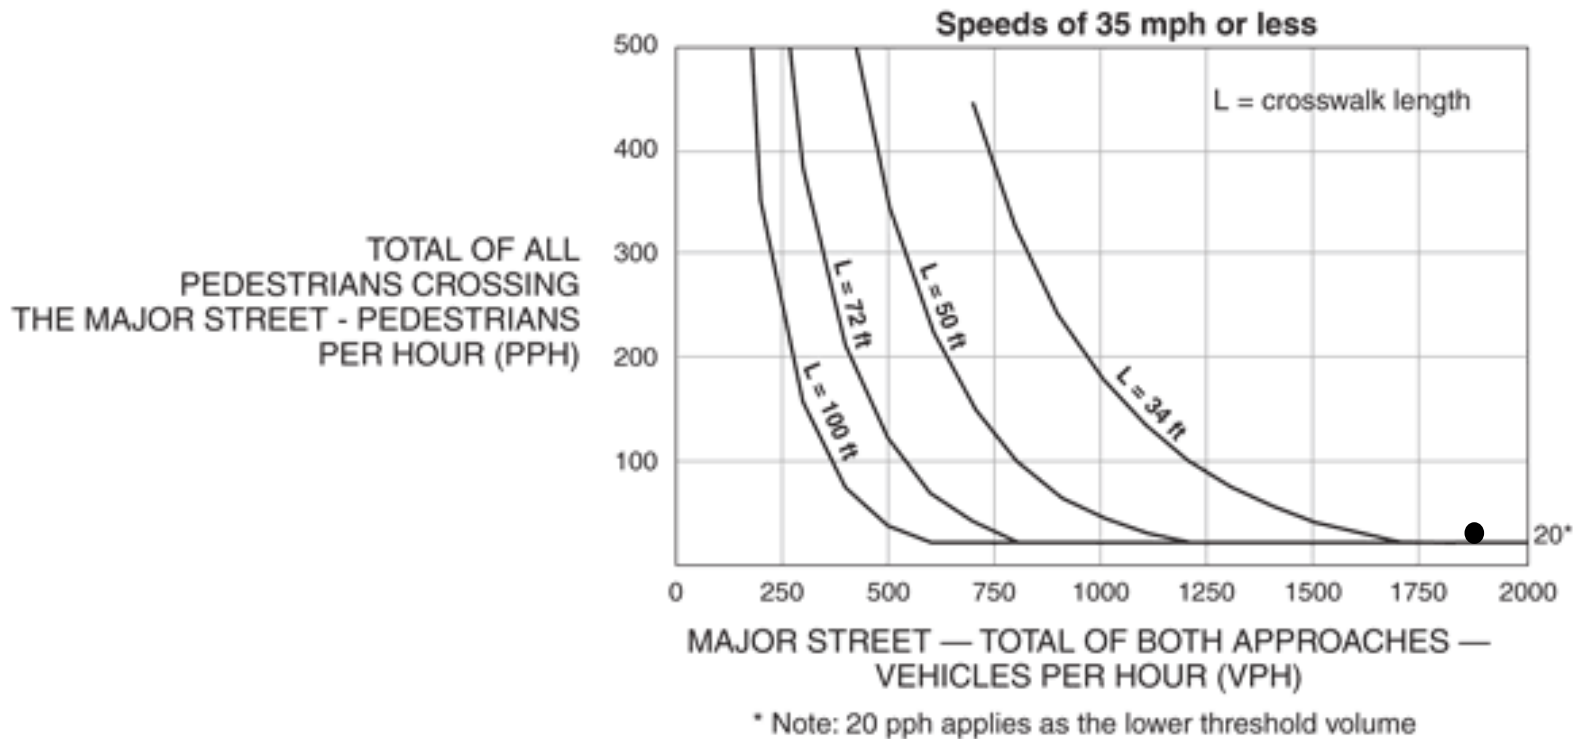
FIGURE 8
Guidelines for the Installation of Pedestrian Hybrid Beacons
on Low-Speed Roadways

The Danvers Rail Trail crossing at Poplar Street meets the guidelines specified in the MUTCD for the installation of PHBs on low-speed roadways. At the trail crossing, Poplar Street has a posted speed limit of 35 mph, 1,700–2,000 vehicles per hour during the AM and PM peak hours, a crosswalk length of 35 feet, and 20 pedestrians per hour during peak hours. The MUTCD guidance states that for a major street where the posted speed limit or the 85th-percentile speed is 35 mph or less, the need for a pedestrian hybrid beacon should be considered if the engineering study finds that the plotted point representing the vehicles per hour on the major street (the total of both approaches) and the corresponding total of all pedestrians crossing the major street for one hour (any four consecutive 15-minute periods) of an average day falls above the applicable curve in Figure 8 for the length of the crosswalk.

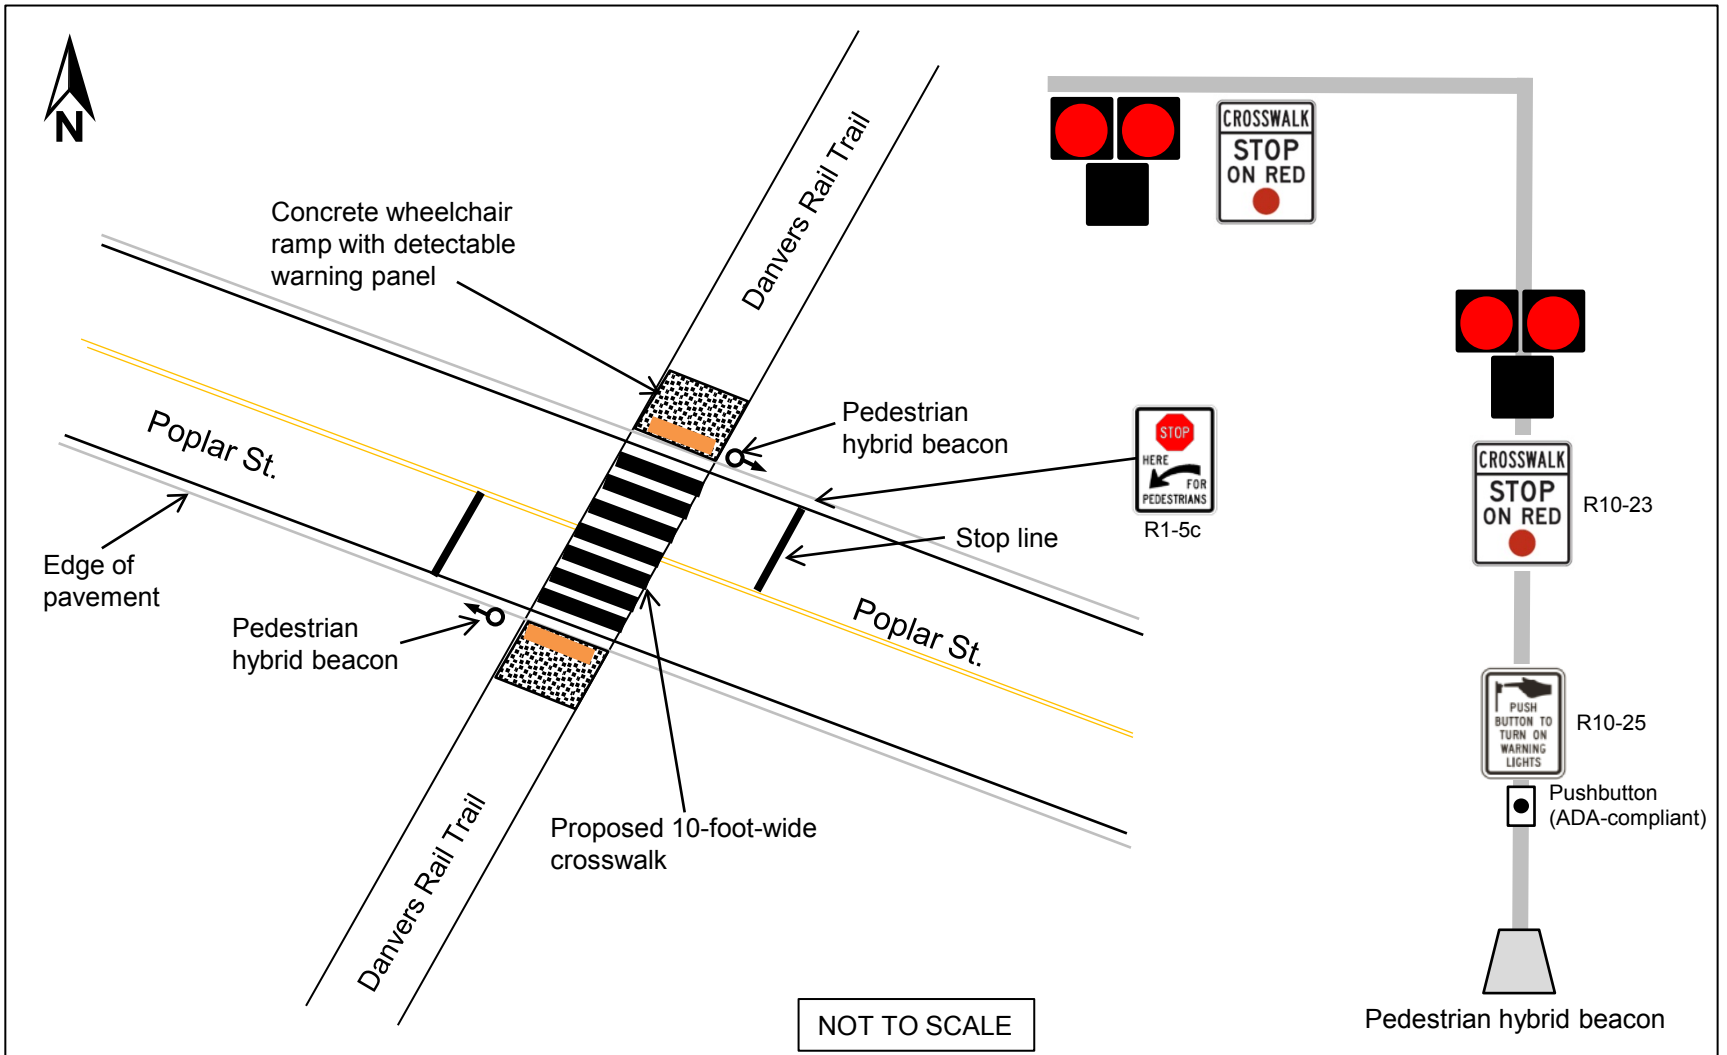
FIGURE 9
Pedestrian Hybrid Beacon and Crosswalk Assembly

Figure 9 shows a PHB and crosswalk assembly proposed for the trail crossing at Poplar Street. The PHB assembly consists of the installation of a four-beacon system. For each approach to the trail's crosswalk, a PHB is installed on the left side and right side of the roadway at the crosswalk. In addition to the PHB, trail crosswalk warning signs, including W11-15 (shared-use trail crossing) and W11-15P (trail crossing) are installed at each approach in advance of the trail crossing. The crosswalk assembly at the PHB consists of high-visibility crosswalk markings (ladder-style markings) and a stop bar approximately 50 feet from the crosswalk. In addition, the following crosswalk improvements are proposed for the trail crossing:

- Curb cuts
- Concrete wheelchair ramps leading from the trail to Poplar Street
- A detectable warning panel at the end of the ramps for ADA compliance

Installing PHBs at the Poplar Street trail crossing is estimated to cost between \$50,000 and \$70,000. This includes two poles for Polar Street, two PHB indications in each direction, pedestrian countdown indications that are /ADA-compliant, signs on Poplar Street, trail, an interconnection with nearby signals, and wig-wag red flashing. The cost also includes curb cuts, concrete wheelchair ramps leading from the trail to Poplar Street, and detectable warning panels at the ends of the ramps for ADA compliance
