Bicycle and Pedestrian Improvements in Six Urban Centers

Central Transportation Planning Staff of the **Boston Region Metropolitan Planning Organization**. The MPO is composed of state and regional agencies and authorities, and local governments.

February 2010

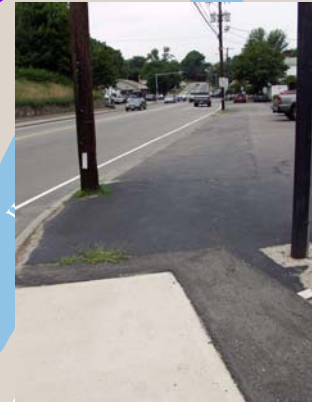
New curb ramps but no sidewalk separation
