Appendix A: Comments and Selection Process

1. Review Comments
2. Selection of Study Locations
3. Public Participation

Summary of District 3 Comments on Route 9 REPORT CLIENT REVIEW.docx
Author: Leary S. Text Date: 5/31/2022 2:15:13 PM

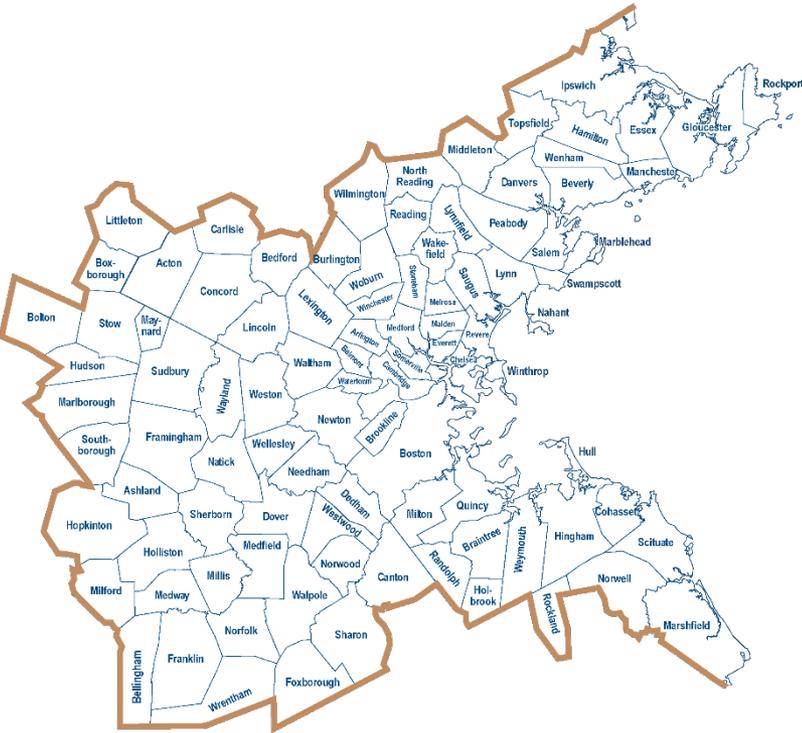
Pedestrian Report Card Assessment (PRCA): Roadway Segment

Route 9 in Framingham without improvements

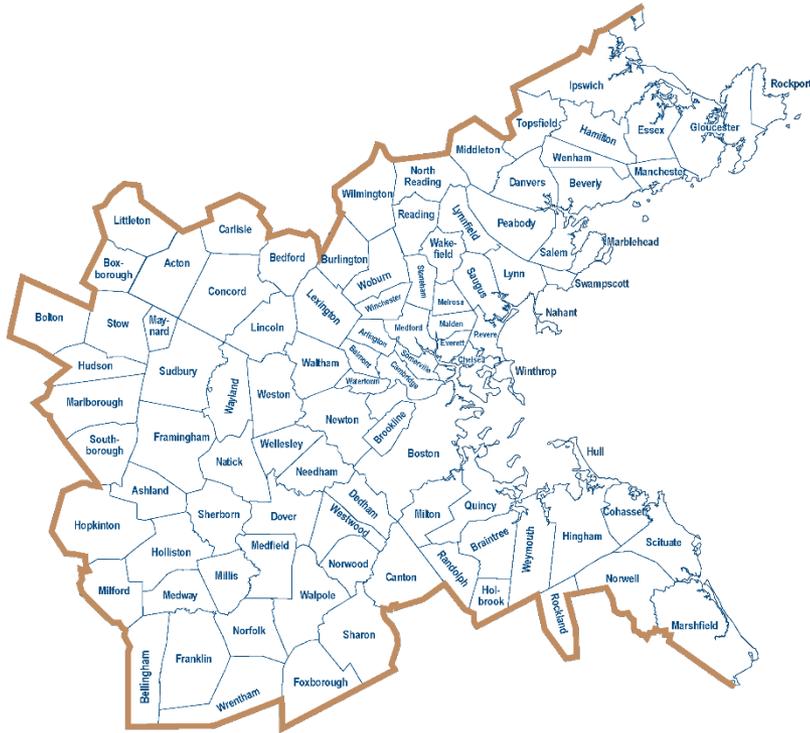
Pedestrian Report Card Assessment (PRCA): Roadway Segment

Route 9 in Natick without improvements

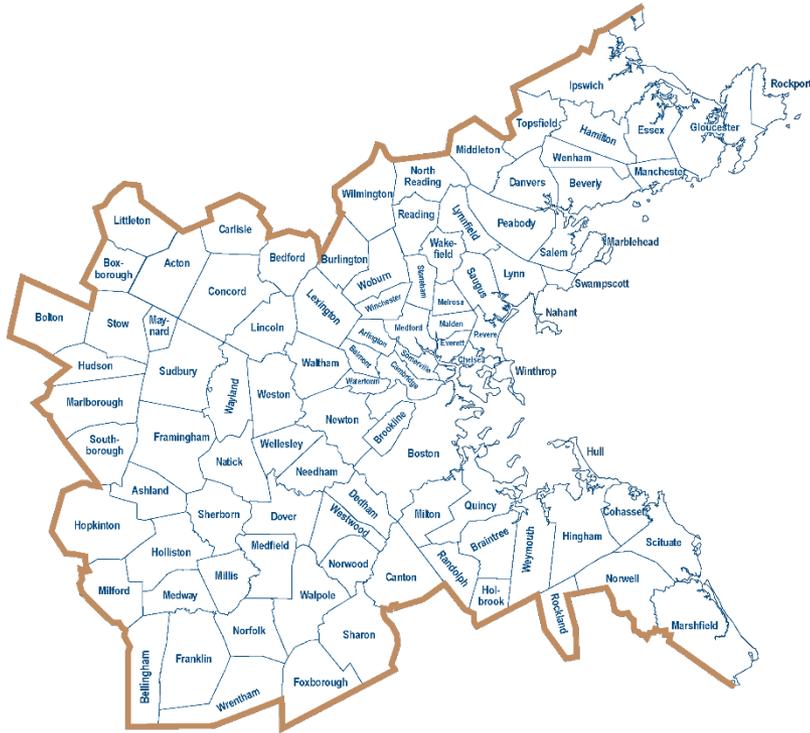
Pedestrian Report Card Assessment (PRCA): Roadway Segment

Route 9 in Framingham with improvements

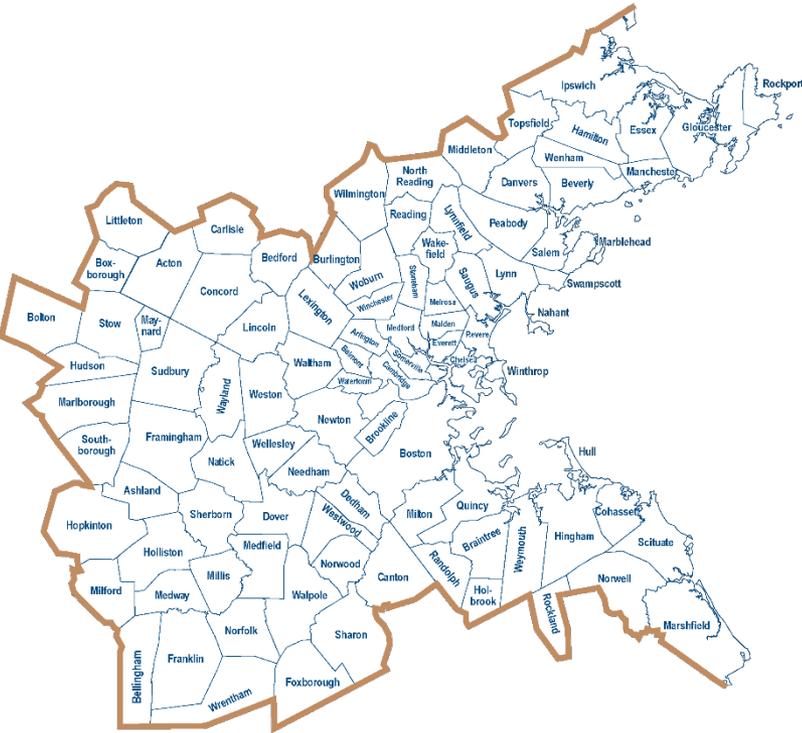
Pedestrian Report Card Assessment (PRCA): Roadway Segment

Route 9 in Natick with improvements

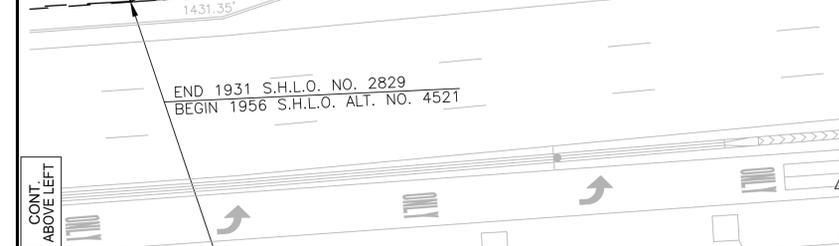
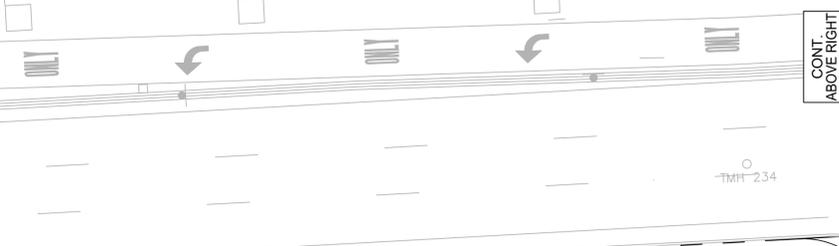
R&S EXIST TS CONTROLLER
PROP TS 2 TYPE 1 ATC CONTROLLER
PROP 4G LTE ANTENNA MTD TO TOP OF CABINET
RET EXIST CABINET & SERVICE CONNECTION

PROP DSRC
MTD ON 15' EXTENSION BRACKET

1. SEE SHEET 57 FOR TRAFFIC SIGNAL DATA.
2. RETAIN ALL EXISTING TS EQUIPMENT AND ALL TS CONDUIT UNLESS OTHERWISE NOTED.
3. RETAIN ALL EXISTING SIGNS AND PAVEMENT MARKINGS UNLESS OTHERWISE NOTED.
4. EXTENSION BRACKETS SHALL BE POSITIONED TO PROVIDE OPTIMAL LINE OF SIGHT PER RADIO/DSRC MANUFACTURER RECOMMENDATIONS WHILE AVOIDING PHYSICAL CONTACT WITH EXISTING OVERHEAD WIRES.
5. THE CONTRACTOR SHALL BE RESPONSIBLE FOR SETTING PROPOSED DETECTION ZONES AS SHOWN ON THE PLANS, AND ADJUSTING/READJUSTING DETECTION ZONES IN THE PRESENCE OF THE ENGINEER.
