MEMORANDUM

DATE March 1, 2012
TO City of Malden
FROM Steven P. Andrews and Chen-Yuan Wang, MPO Staff
RE FFY 2011 Safety and Operations Analyses at Selected Boston
Region MPO Intersections: Main Street at Mountain Avenue

FIGURE 1
Main Street at Mountain Avenue, Malden

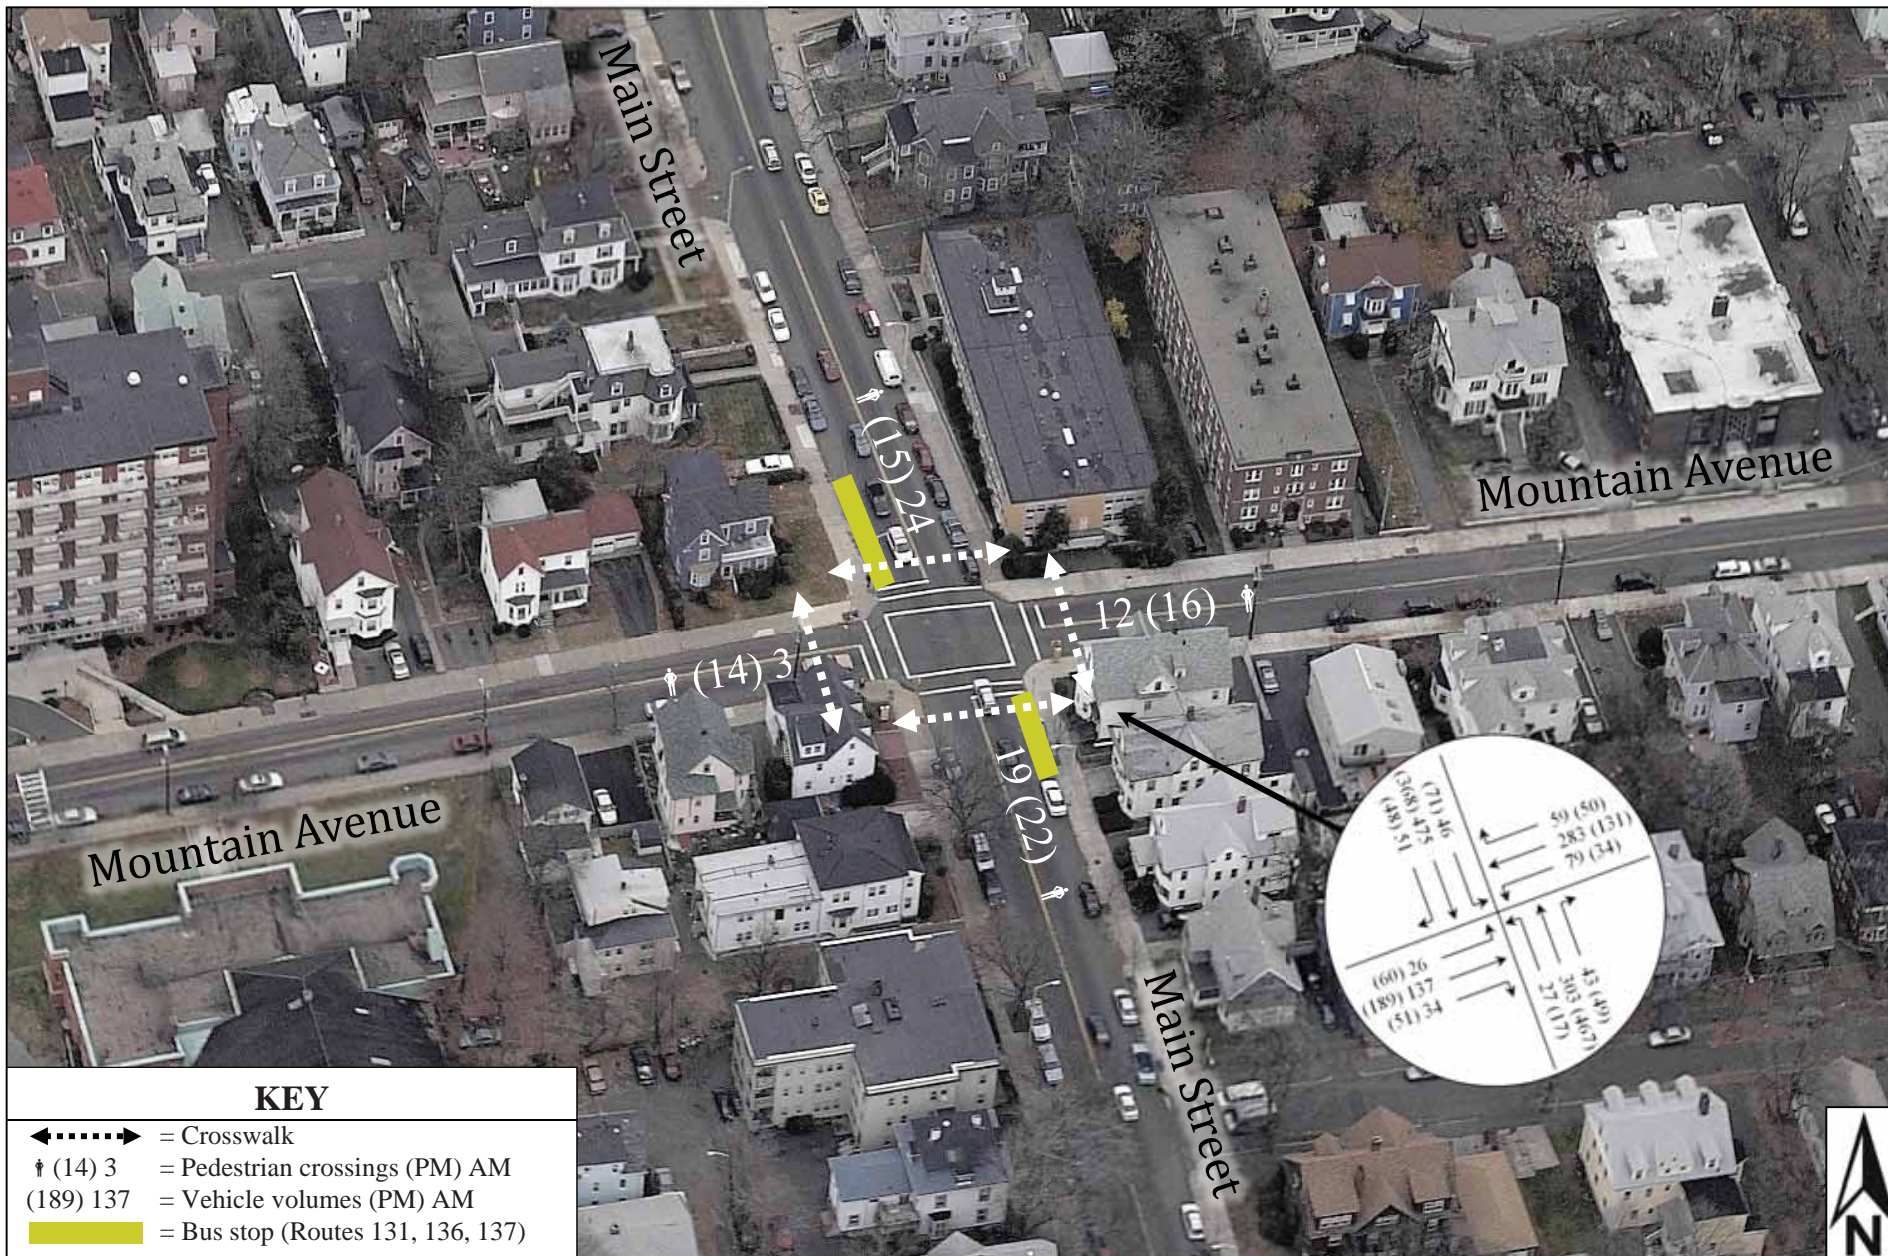
Figure 1 shows the intersection layout and the area nearby. The intersection has a normal layout. Approaching the intersection, the Main Street northbound approach is one lane, which is shared by all movements. At the intersection, an MBTA bus stop abuts the northbound approach. When no bus is present, which is most of the time, vehicles use the bus stop to make right turns. Similarly, the Main Street southbound approach is one lane wide flanked by parking until just before the intersection, where an MBTA bus stop is often used as a right-turn lane. When vehicles on Main Street make left turns, through and right-turning vehicles swerve into the bus lane to bypass the turning vehicle. The Mountain Avenue eastbound approach is one lane wide until the intersection. One-hour parking is permitted along the south side of Mountain Avenue; however,

beginning approximately 150 feet to the west of the intersection, parking is not permitted. Some vehicles use this space to make right turns and bypass vehicles turning left. All of the vehicles traveling westbound on Mountain Avenue use a single lane to make all movements.

Crosswalks are installed across all of the approaches. The crosswalks are very worn out. This, coupled with a lack of standard pedestrian signals, makes the intersection not very pedestrian-friendly. Curb cuts are present at all approaches. The curb cuts do not have tactile strips. Each curb cut serves two crosswalks. Sidewalks are present and in good condition.

The two MBTA bus stops serve Routes 131, 136, and 137. Headways between buses are fairly long: five or fewer buses stop at each stop during the peak hours. Both bus stops are located on the near sides of the intersection. When buses are not present, vehicles use the bus stops as short right-turn lanes.

All of the signal heads are post-mounted and positioned about eight to nine feet high. They are located on the four corners of the intersection. Each approach receives two signal indications, but because the signal heads are low, they can be difficult to see from far away.

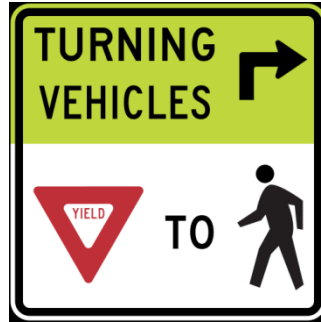
FIGURE 2
MUTCD Sign R10-15: Turning Vehicles Must Yield to Pedestrians

In the interim, before the intersection is upgraded, staff suggest that additional signage at the intersection might help pedestrians cross safely. The 2009 Manual on Uniform Traffic Control Devices (MUTCD) lists sign R10-15 as an acceptable sign to “remind drivers who are making turns to yield to pedestrians.” Figure 2, taken from the MUTCD, shows the R10-15 sign. In its current state, this sign seems to suggest that right turning vehicles should yield to pedestrians. In order to remind vehicles turning left and right to yield, staff suggest removing the right-turn arrow. The text “TURNING VEHICLES,” on a fluorescent yellow-green background, would fill the top portion of the sign. If modifying the sign is not feasible, the original version is also acceptable. One sign would be mounted at each corner of the intersection. Each vehicle sees two signal heads: one on the near side of the intersection on the left, and another on the far side of the intersection on the right. Placing the sign underneath signal housing on the far-side signal post would likely be the most visible location for the sign. The cost of these signs would be relatively minimal, likely costing less than a few thousand dollars. The signs could be reused if the intersection is upgraded.
