Bicycle and Pedestrian Improvements in Six Urban Centers

Central Transportation Planning Staff of the **Boston Region Metropolitan Planning Organization**. The MPO is composed of state and regional agencies and authorities, and local governments.

February 2010

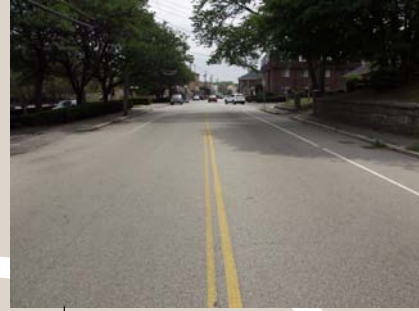
Potential for bike lanes

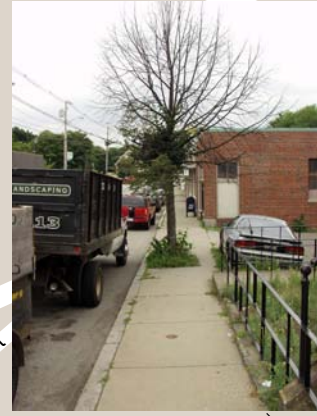
Unhealthy street tree

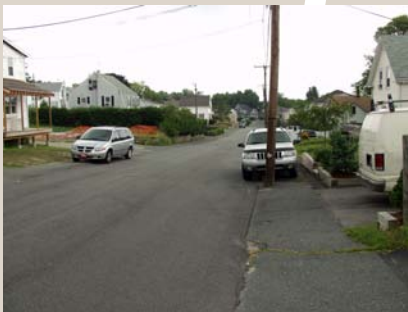
Lack of separation leads to parking issues

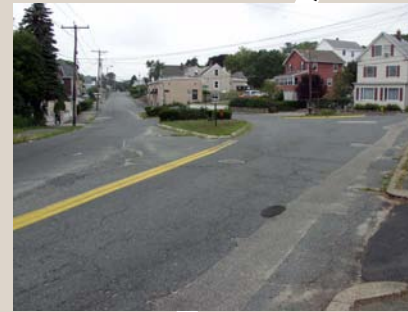
No crossings for pedestrians

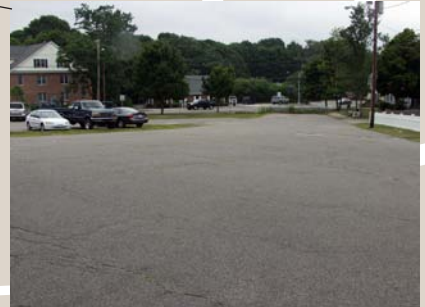
Large paved area
